# St Swithun-upon-Kingsgate

## Winchester

### Historical graffiti survey report

Date of survey: 21<sup>st</sup> February 2025

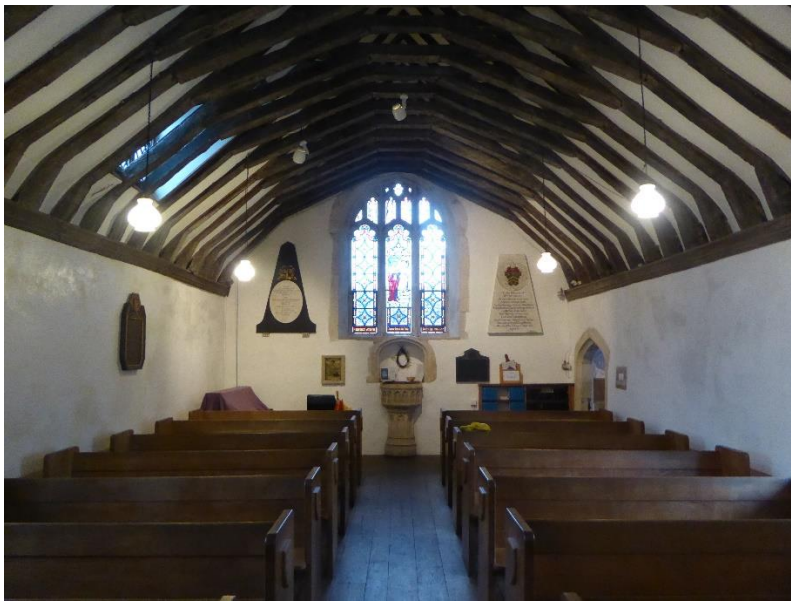
*Fig 1. Interior looking west, showing north doorway*

Graffiti is commonly found at the entrances to churches, made by those who wished to mark their presence as they entered a holy space. Here, there is graffiti around the north doorway (Fig 1).

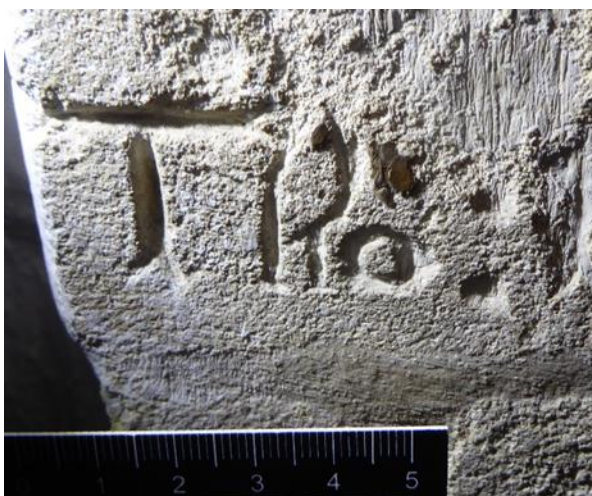
*Fig 2. North doorway, east jamb. Tho.*

On the east jamb are initials or perhaps part of the name Thomas (Fig 2), and pairs of initials TD and ER occur in the same area.

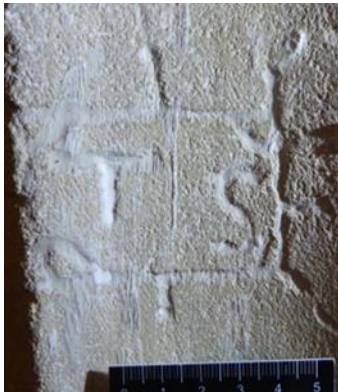
On the west of the doorway are the initials TS carved within an elaborate box (Fig 3).

*Fig 3. North doorway, west jamb. Boxed initials TS*

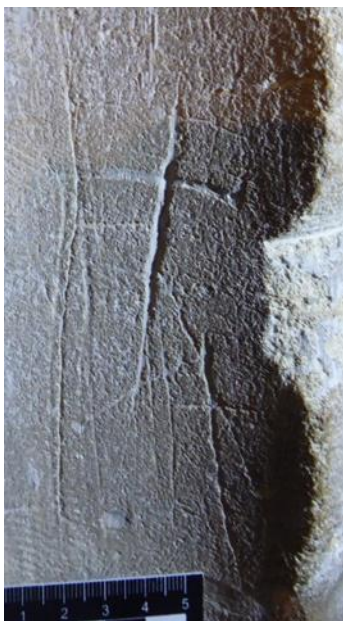
*Fig 4. North doorway, west jamb. Crosses*

The north doorway is also one of the few places within the church where crosses are found, and there are two on the west jamb (Fig 4) and a very faint one, obscured by layers of paint and limewash on the outside wall, west of the doorway.

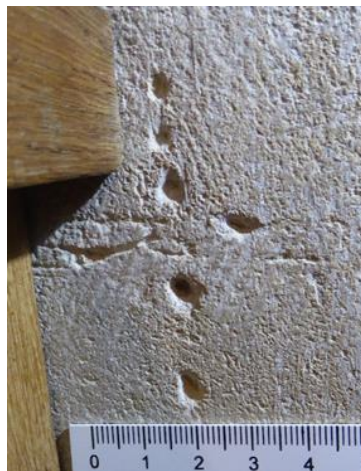
*Fig 5. North doorway, west side. Drilled holes forming cross*

Another cross shape formed from small, drilled holes within an incised outline is on the west side of the doorway (Fig 5). Such crosses may have been left by pilgrims on their way to the cathedral, or parishioners, as symbols of personal devotion. It is thought that small drill holes such as these might have been made by those who wished to remove stone dust from a consecrated space to use in folk remedies and cures. There are certainly many accounts of pilgrims removing stone from saints'

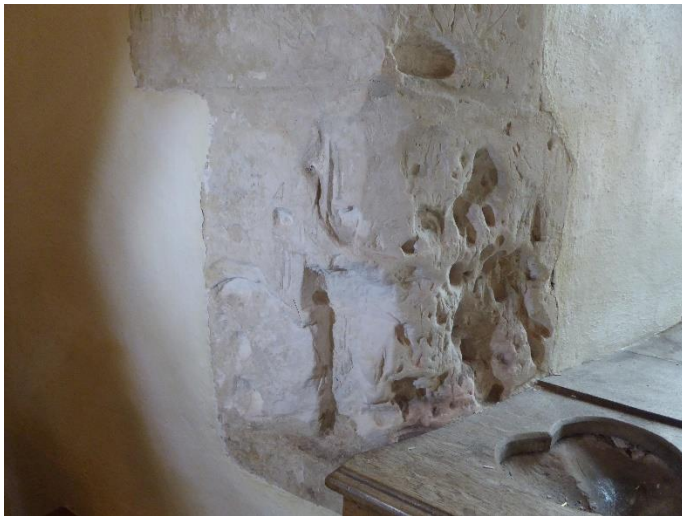
*Fig 6. South window 1, east jamb. Weathered stone*

There is a lot of graffiti around the south windows, and the lower parts of the stone surrounds are very worn, weathered and gouged (Fig 6). This may have been caused by exposure to the elements when the building had fallen into disrepair in the 17<sup>th</sup> century, or the result of human activity. Much of the graffiti may have been made when the church was out of use, and some is actually dated to this time, for example, directly beneath south window 2, on the stone surround, is incised the name T. Phillips, with the date 1650 (Fig 7).

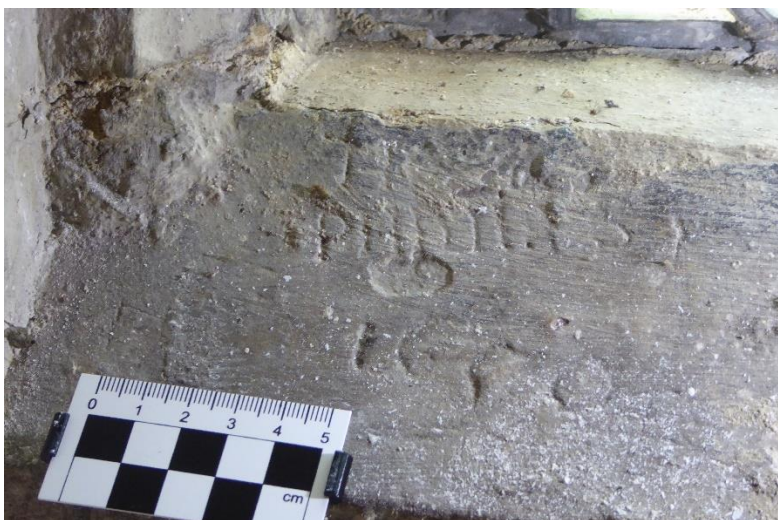
*Fig 7. South window 2. T Phillips 1650*

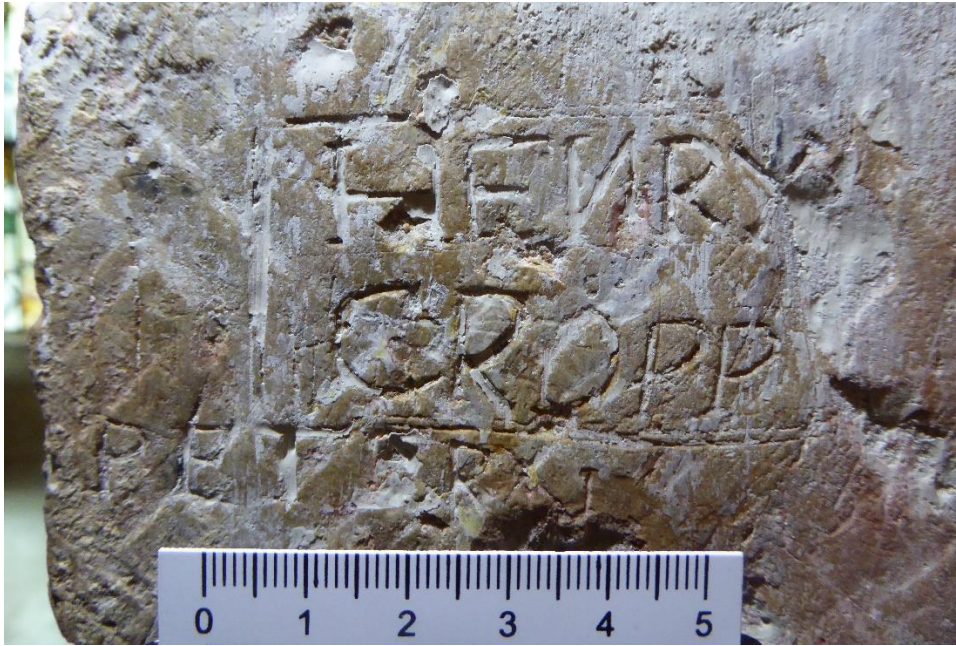
*Fig 8. South window 2, west side. Henry Cropp*

Another name, Henry Cropp, occurs on the west side of this window, with another name, Peter, written underneath (Fig 8). There are more letters, possibly names, on the edge of the windowsill, but they are indecipherable (Fig 9).

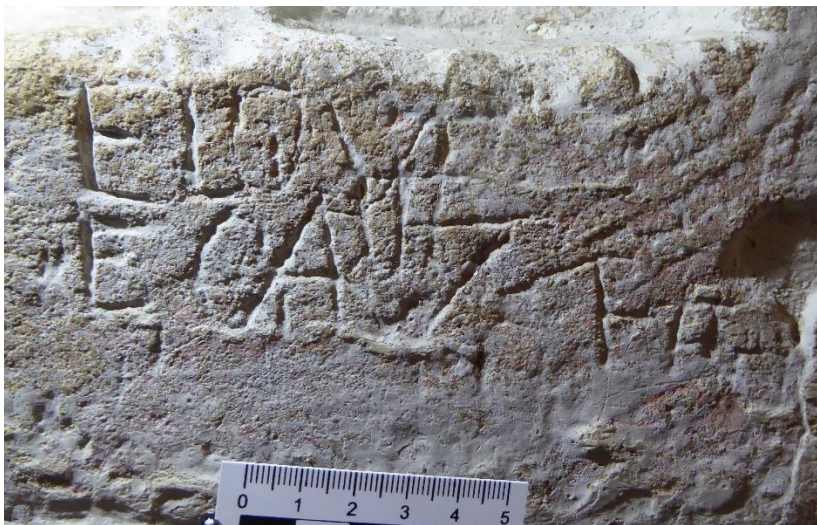
*Fig 9. South window 2, sill. Illegible text, probably names*

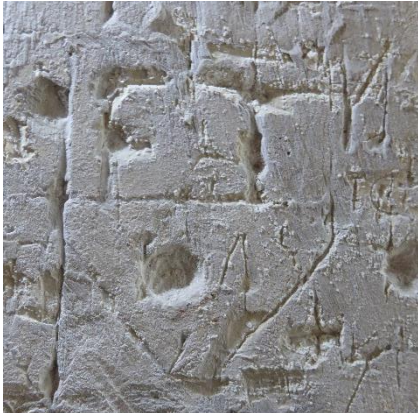
*Fig 10. South window 2, east jamb. Shield with initials CT*

There is a shield shape containing the initials CT on the east jamb of south window 2 (Fig 10). The creator of this graffiti may have wanted to confer more status to their initials by depicting them within a shield.

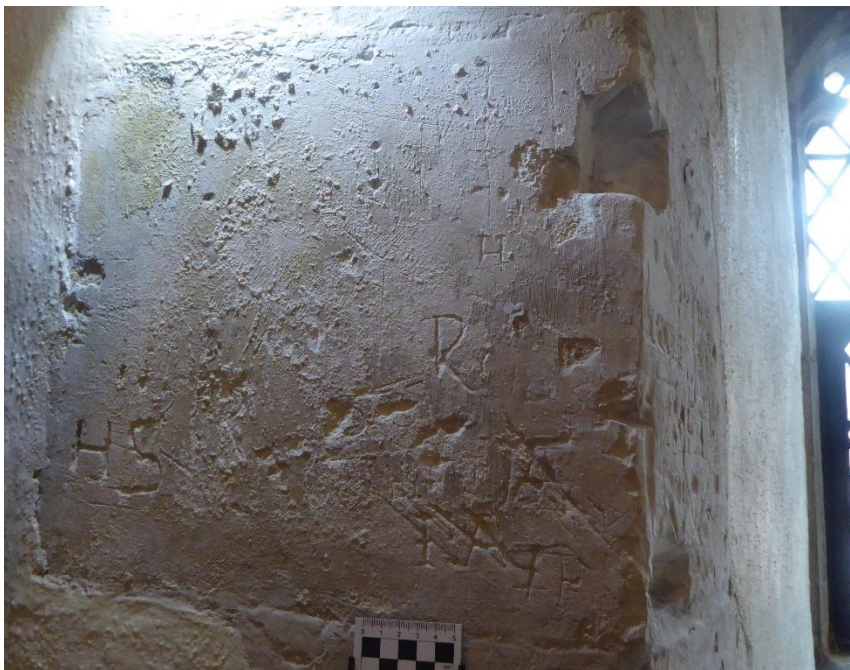
On the surface of the same block of stone that faces into the nave are several single and pairs of initials (Fig 11). Among these are at least two instances of the initials IA (Fig 12),

*Fig 11. South window 1, east side, initials*

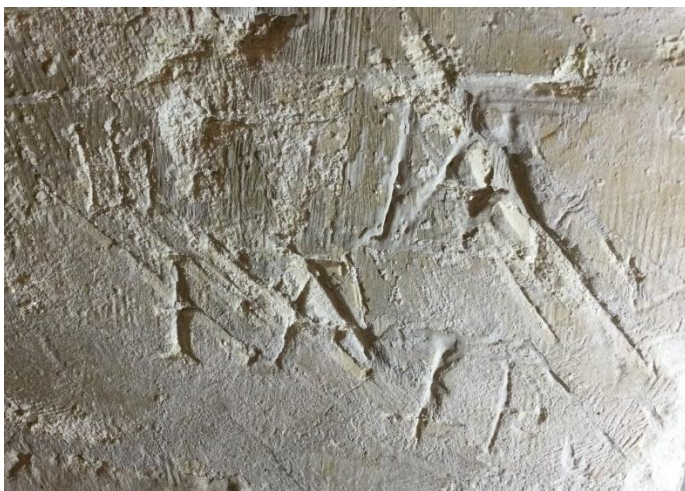
*Fig 12. South window 1, east side. close-up of repeated initials IA*

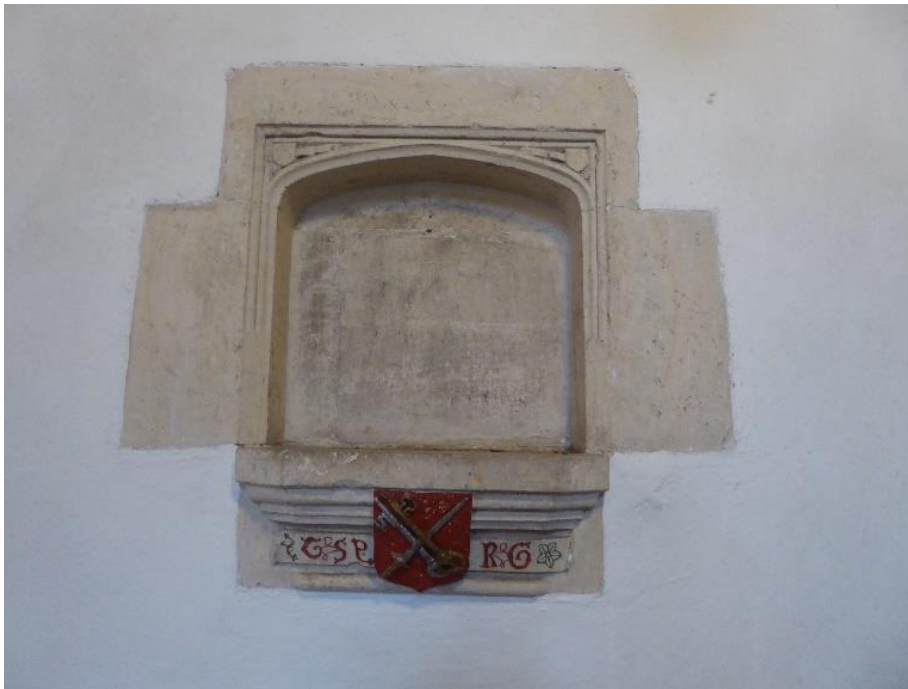
On the north wall, between the windows, is a sixteenth century niche bearing the arms of Winchester diocese (Fig 13).

*Fig 13. Niche on north wall*

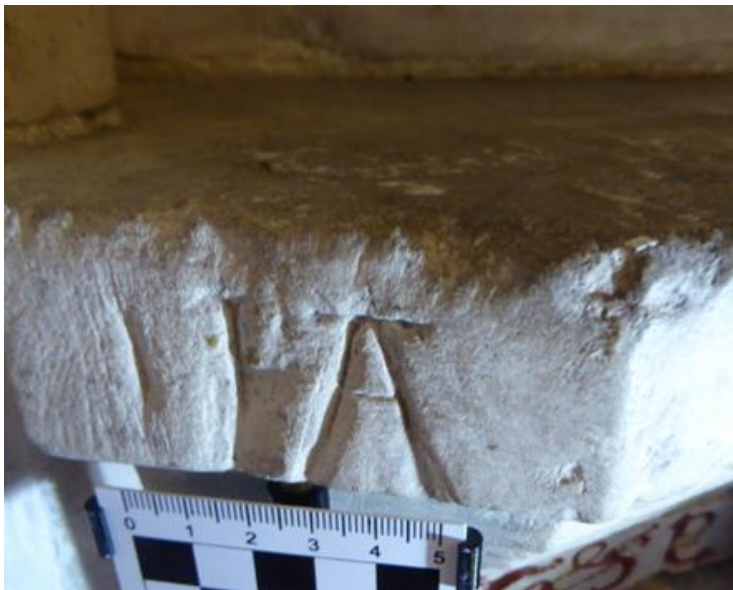
*Fig 14. North wall, niche shelf. Initials IA*

There are some initials cut into the vertical edge of the shelf. These are WI, A and another, deeply scored, IA (Fig 14).

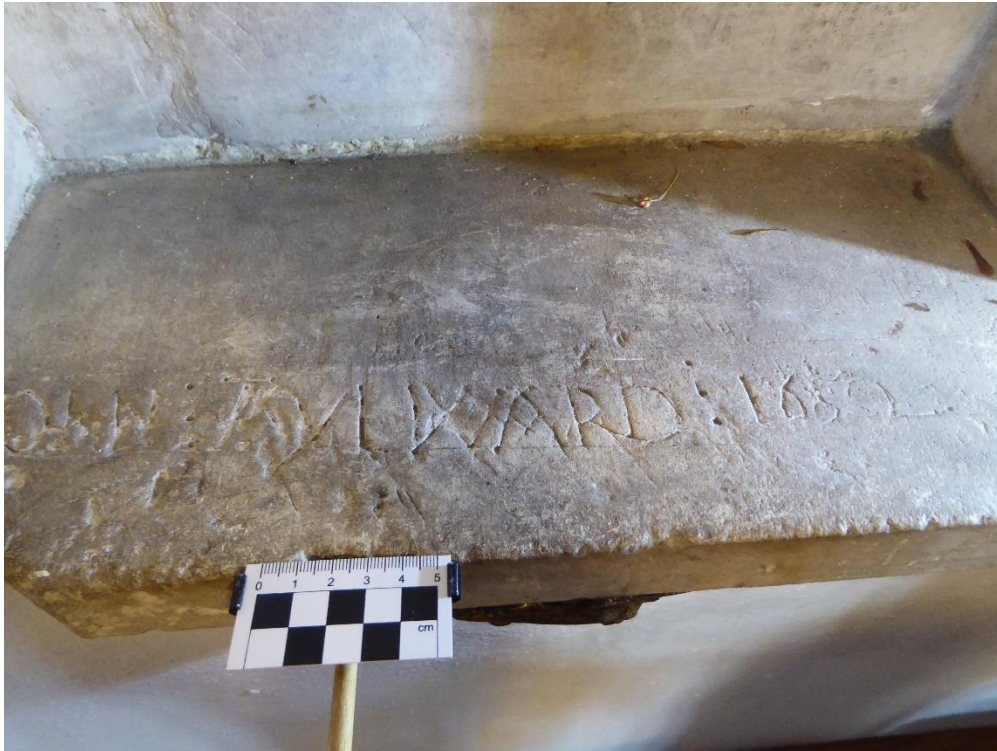
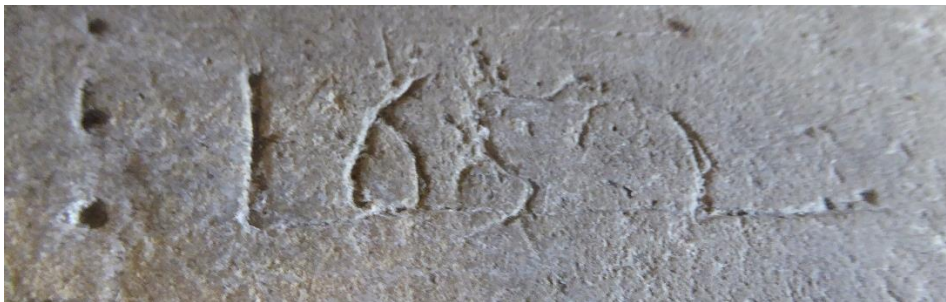
*Fig 15. North wall, niche. John Aylward 1650*

*Fig 16. North wall, niche. close up of date 1652*

On the horizontal surface of the shelf, now at a height which is hard to see from the current floor level, is a name dated to 1652, that of John Aylward (Figs 15 & 16). It would be interesting to carry out more research to see if there is any link between him and his contemporary, T Phillips. It is also tempting to wonder if John Aylward was responsible for the repetition of the initials IA on the window opposite, and on the shelf below the niche, as I also stood for the initial J.

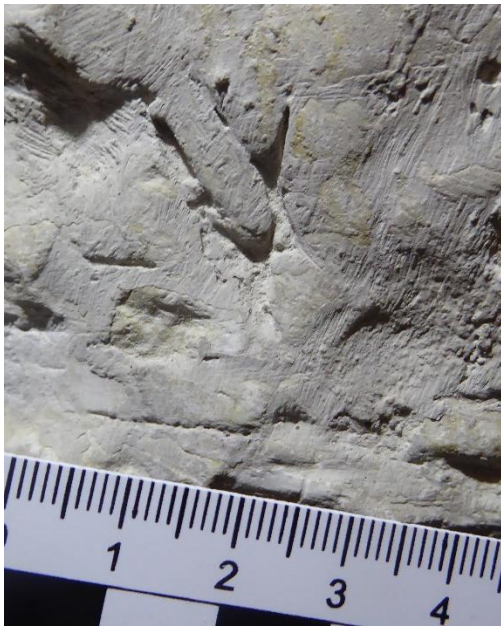
A possible apotropaic or protective symbol occurs on the east jamb of south window 2 (Fig 17). This is a small V V symbol, consisting of two intersecting Vs, which is often found around windows and doors, made to protect a building and its occupants from evil spirits. The mark originated from a symbol of devotion to the Virgin Mary,

*Fig 17. South window 1, east side. Possible VV apotropaic mark*

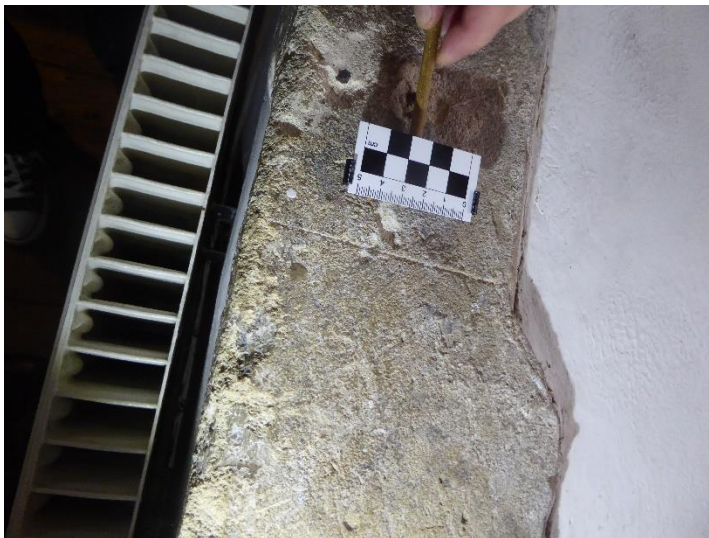
There is a mason's marking out line on the sill of north window 3 (Fig 18). No other marks made by masons were found.

*Fig 18. North window 3, sill. Mason's marking out line*

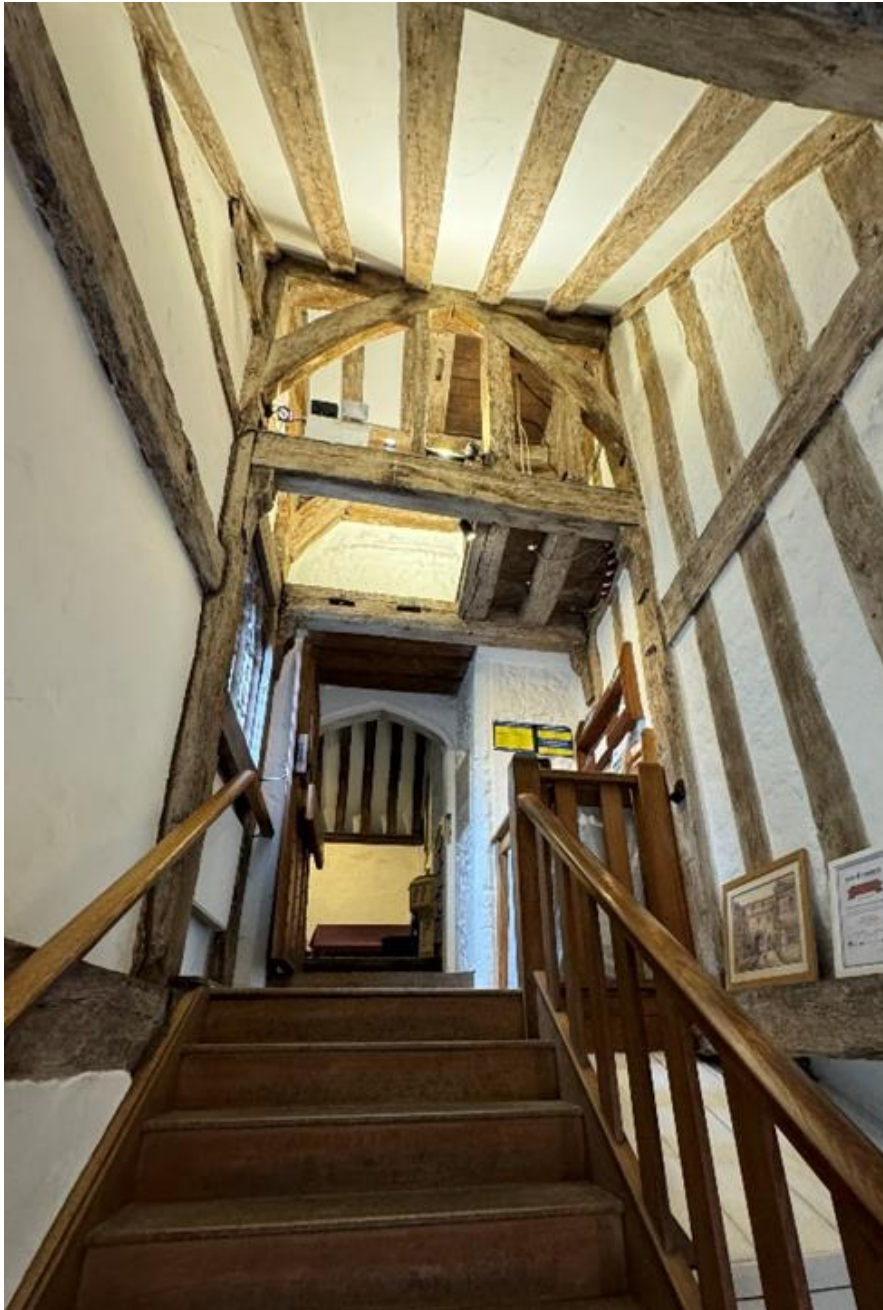
The timber framework of the entrance staircase dates to c1500 (ref: church guidebook) (Fig 19).

*Fig 19. Timber-framed entrance staircase*

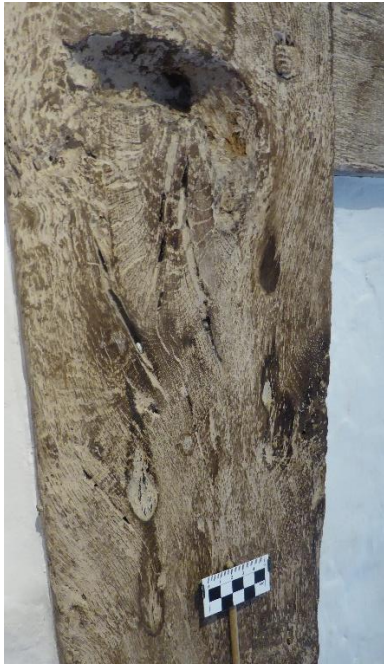
On the timber uprights at each side of the top of the stairs, are tear-shaped burn marks, which are also known as **taper burn marks** (Figs 20 & 21).

*Fig 20. Timber upright, west side of top of stairs. Taper burn marks*

These taper burn marks are thought to have been made deliberately, to protect the building, possibly against fire. Such marks are sometimes explained as being made accidentally, caused by candles placed against surfaces, but experimental archaeology by Dean and Hill (2014) show that these marks are difficult to create accidentally and are more likely to have been made deliberately. Context also aids interpretation, and here they occur in clusters, on each side of the entrance into the church, a seemingly deliberate positioning which may have been meant to protect against the ingress of evil. Such burn marks and other protective or apotropaic symbols, like the VV symbol by the south window, are usually found around building openings where evil spirits might enter.

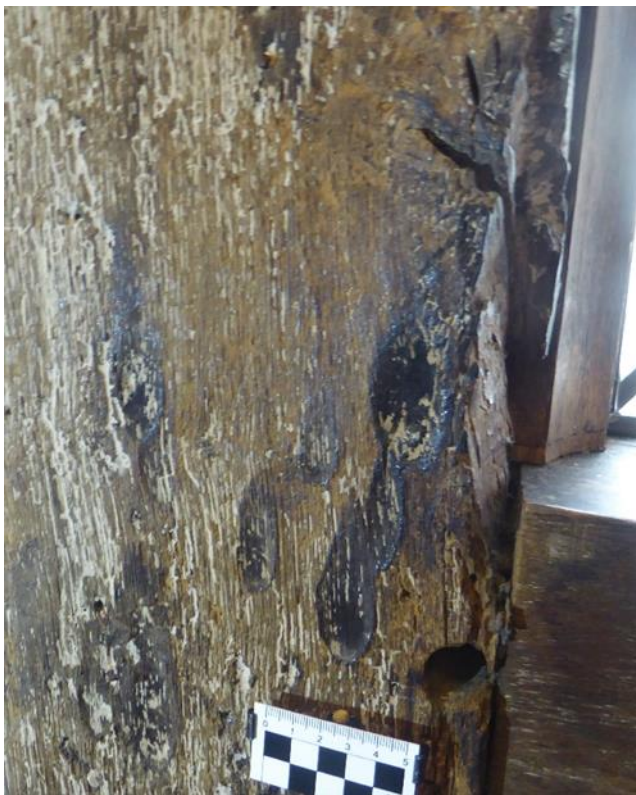
*Fig 21. Timber upright, east side of top of stairs. Taper burn marks*

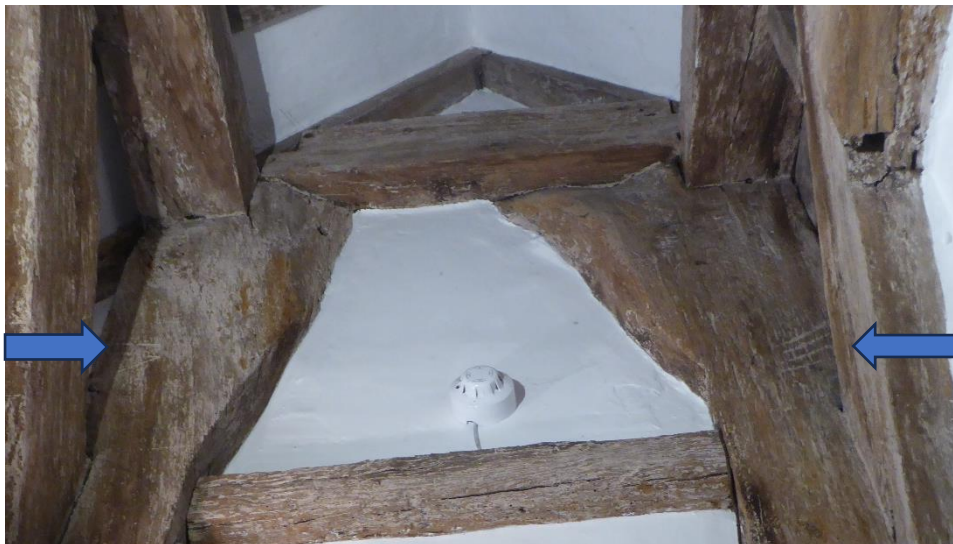
There are some carpenters' marks visible on the 16<sup>th</sup> century timber framework above the north doorway. There is a mark consisting of 4 parallel lines on the west side, and a VI shape on the east (Fig 22).

*Fig 22. Carpenters' marks above north doorway. Arrows show locations on east and west sides*

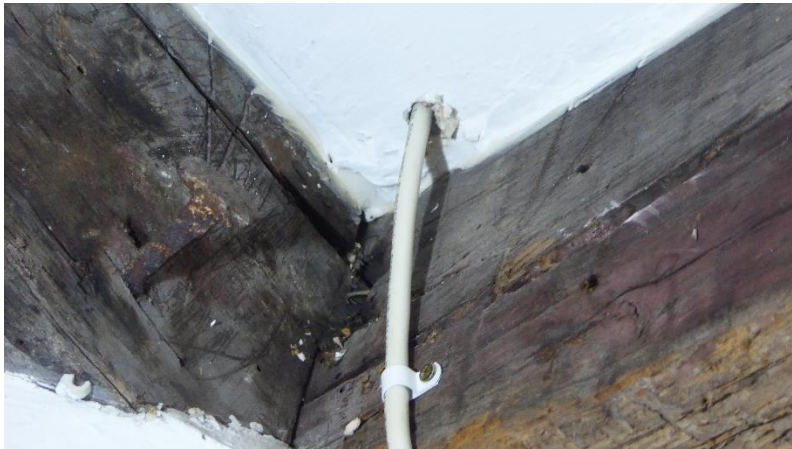
On the ground floor, in the vestry, are two matching V-shaped carpenters' marks on adjacent timber joists in the southwest corner of the ceiling (Fig 23).

*Fig 23. Carpenters' marks in vestry*

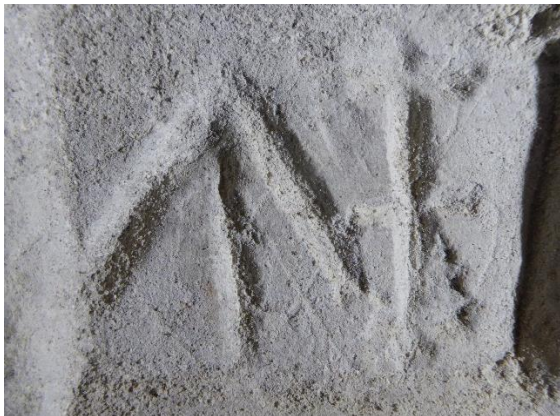
This is a carefully cut square-shaped indentation containing an upward-pointing arrow shape next to an initial I, with an additional diagonal line coming from the I (Figs 24 & 25).

*Fig 24. Undercroft, west wall. Square indentation containing graffiti arrow shape and initial I*

Similar box shapes usually contain pairs of initials, as that in Fig 3, but the arrow shape in this context is very unusual and its significance is not known.

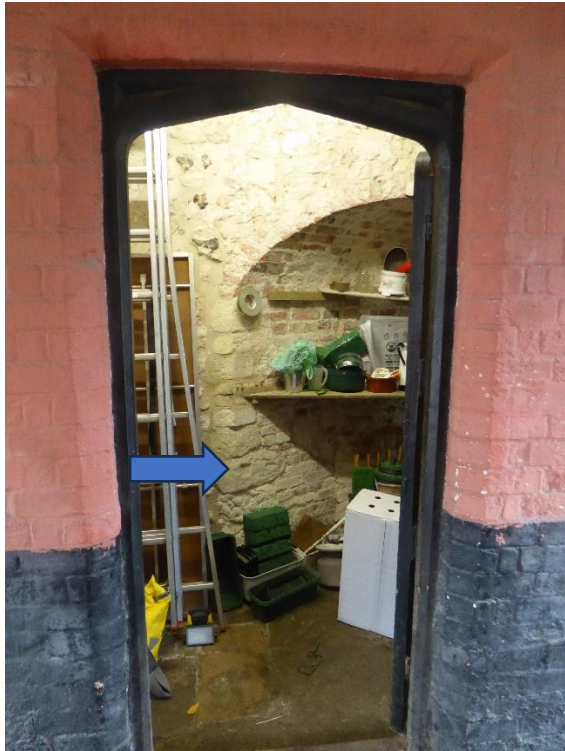
Fig 25. Undercroft. View through entrance door from street. Arrow shows location of graffiti shown as Fig 24
