THE HISTORY AND ARCHAEOLOGY OF THE HYDE BREWERY, WINCHESTER

PART ONE: THE ARCHAEOLOGICAL SURVEY

ABSTRACT

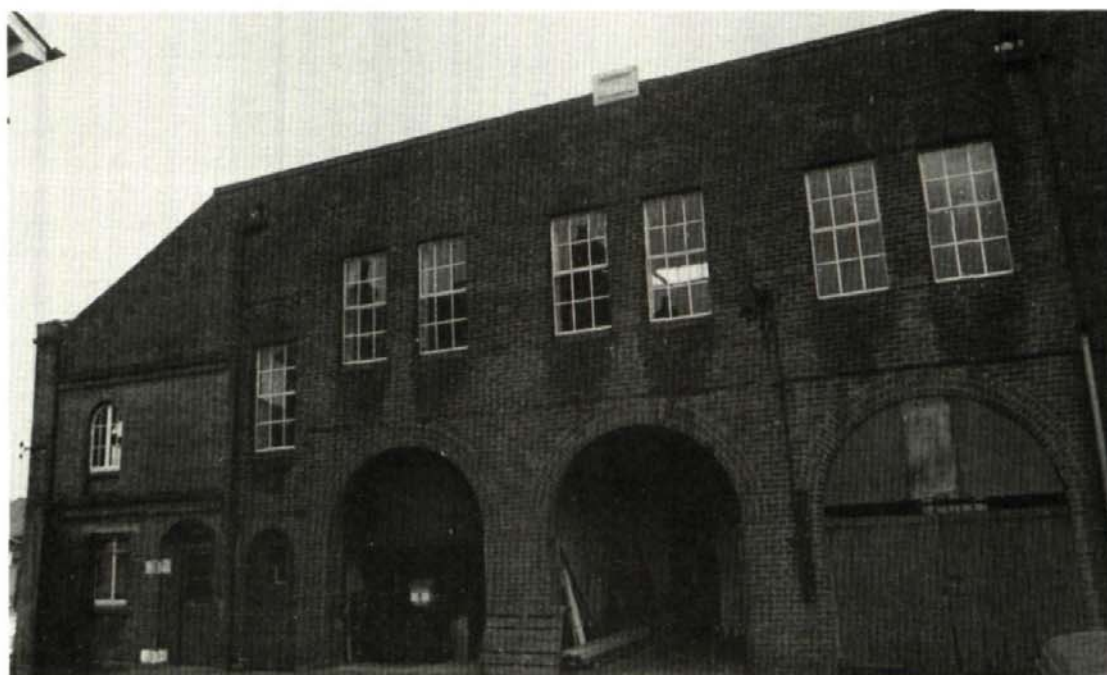
Fig 6. The side of the 1821 block (left) and the facade of the 1938 block. (Photo: author)

The facade of this building extended for 13.65m and contained a further variation on the theme of three giant arches familiar from the earlier blocks on the site (Fig 6). In this case, the arches rose to a first floor 3.81m above ground level, each arch spanning 2.93m, with semi-circular heads of three rows of brick headers. To the west of these, a door with semi-circular head led to the staircase giving access to the upper floor of the 1821 block. This stair was lit by a further window at mezzanine level. On the first floor, a pair of rectangular windows existed above each arch, each window itself below a semi-circular relieving arch of two rows of brick headers. The facade was of red brick in stretcher bond.

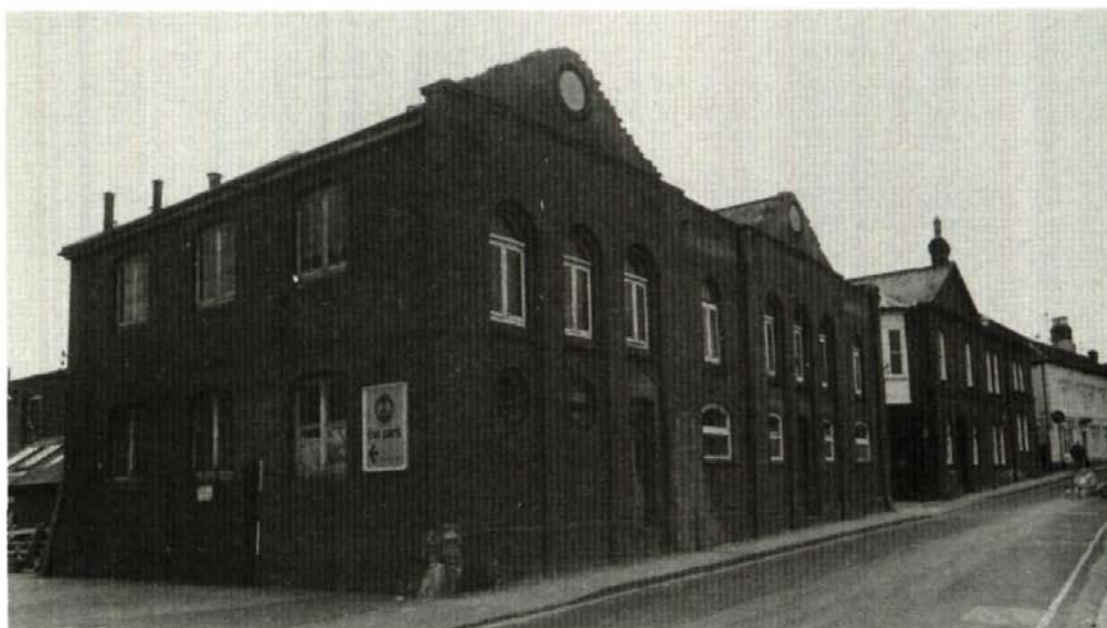
Fig 7. The 1904 block (left) and the 1821 block from Hyde Street. (Photo: author)

Adjoining the north end of the 1821 block was a further red brick building constructed in 1904. This 1904 block was clearly intended to replicate the architectural treatment of the 1821 building, being two storeys in height, and containing three bays within giant arches matching those in the centre of the facade of the 1821 block (Fig 4). The 1904 block also possessed a pediment similar in design to that of the 1821 block, including a datestone reading W. B. Co. Ltd. 1904 (Winchester Brewery Company: the then owners). The 1904 building was originally intended for storage. By the time of the survey it, too, had lost the stone coping from its pediment and cornice.

The three bays of the 1904 facade were formed by pilaster strips and giant arches of the same dimensions as those of its 1821 neighbour, and the first floor windows were closely copied from those of the earlier building, though the dimensions were slightly different: height: 1.8m, width: 1.07m. On the ground floor, however, the two designs varied. At the time of the survey, the ground floor facade of the 1904 block comprised two circular windows in the left and centre bays, and a door in the right. The brickwork surrounding the latter had been heavily repointed, and the door sill was an unusual and inconvenient 44.5cm above the road surface with no other step. The architect's plans for this building (BCP, 11.1.1904) include a third circular window rather than this door, and it seems likely the door was a later insertion, although no date can be suggested. It is thus possible that the doorway and windows at ground floor level within the giant arches of the 1821 building were also inserted at the same time, and that both buildings originally possessed only circular windows within their facade arches. In these circumstances access would presumably have been through the side door of the 1821 block and thus to the 1904. The plans of the 1904 block show no provision for external access to it. Such an arrangement, although apparently cumbersome, would have restricted access to persons within Brewery

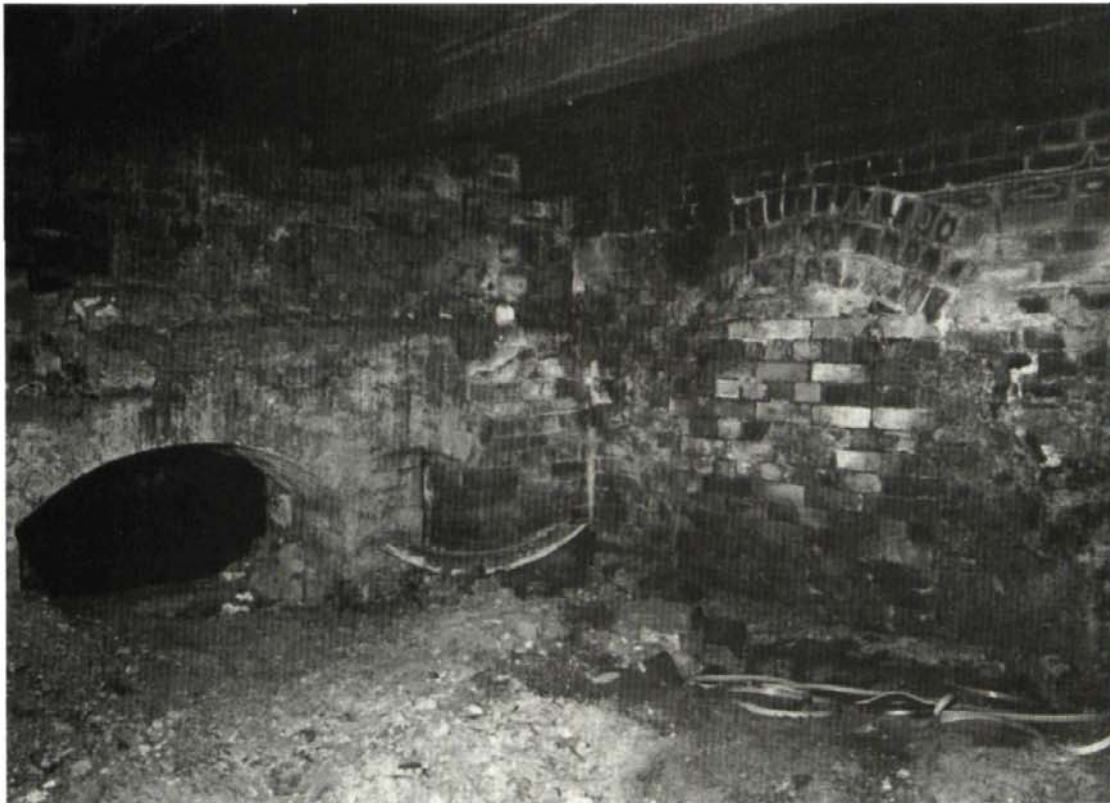
Fig 18. Cellar 6a, looking south west. (Photo: author)

By 1981, however, the top six courses of the brick blocking of the doorway had been removed, allowing access to the further cellar, here numbered 6a. Cellar 6a lay beneath the 1904 block, the wall between it and Cellar 6 corresponding to the junction of the 1821 and 1904 blocks above (BCP, 11.1.1904). The rubble infill remained in Cellar 6a to a depth of about 1.5m above the Cellar 6 floor level, so no sections could be drawn, but a number of interesting features were apparent. Cellar 6a was basically rectangular, 4.45m from east to west, and 5m north to south. The wall to Cellar 6, on average

55cm thick, was mostly faced with brick, although some stone existed above the door head. This in turn was surmounted by recessed brickwork supporting the ceiling girders. The other walls of Cellar 6a were, so far as could be established, brick, in no regular bond.

Three of the walls contained features. The south wall (to Cellar 6) contained, on either side of the door, small recesses in brick, on a level with the springing of the segmental door head from the jambs. Both recesses had segmental heads of twin rows of brick headers, that on the east being complete, that on the west being reduced to half an arch by the door pillar. On the west wall 45cm from its junction with the south wall, was a bricked in segmental arch of three rows of brick headers, 1.1m in width. The top of the arch was only some 300–320mm below the roof boards. It seems likely that this feature had been a window: the c 1890
