# Upton Grey St Mary - historical graffiti report

## Hampshire Medieval Graffiti Survey

**28<sup>th</sup> March 2022**

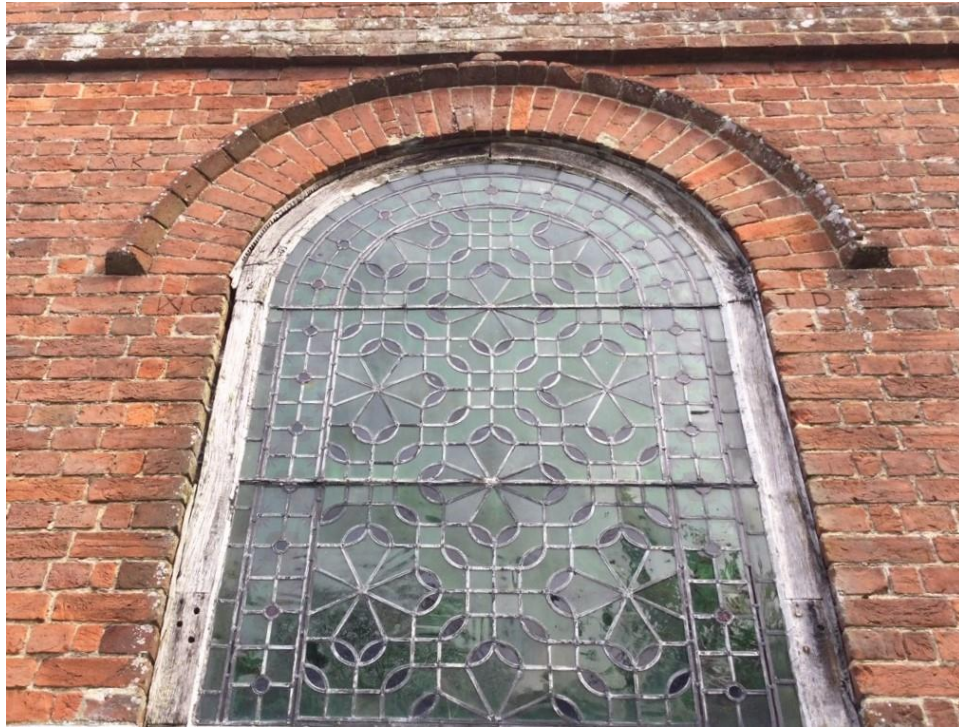
A survey of the **exterior of the church** revealed several pairs of initials carved into the brickwork of the west and north wall of the north aisle. These were carved mainly in the area around the west window (Figure 1) and going northwards to the NW corner.

*Fig 1. West wall window with initials WC and TD to either side of window. Photo KP12*

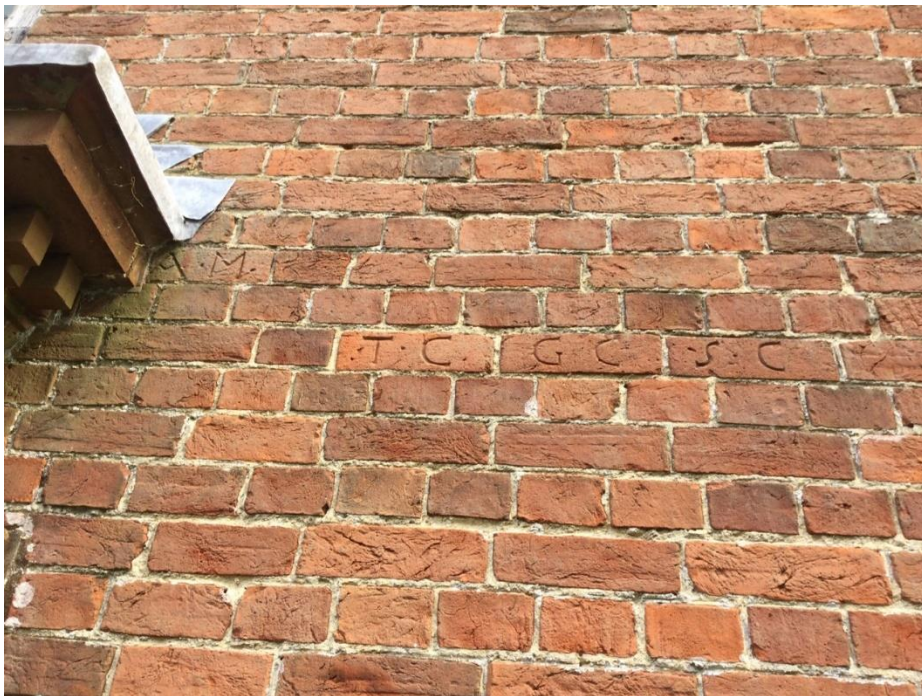
These initials have been finely cut and would make an interesting community project to try and identify who they refer to. There are no dates to tell us if they were added when the aisle was constructed in 1715 although the height of these initials suggests this was the case. Initials include a group: TC, GC, SC, possibly representing members of one family. A TL may be one of the Limbrey family and there are several others to investigate: JA, WC, TD, AK, LS, IW, EW, TT, WM and EM. (Figure 2).

*Fig 2. Exterior west wall. Initials T.C, G.C, S.C, A.M. Photo KP10*

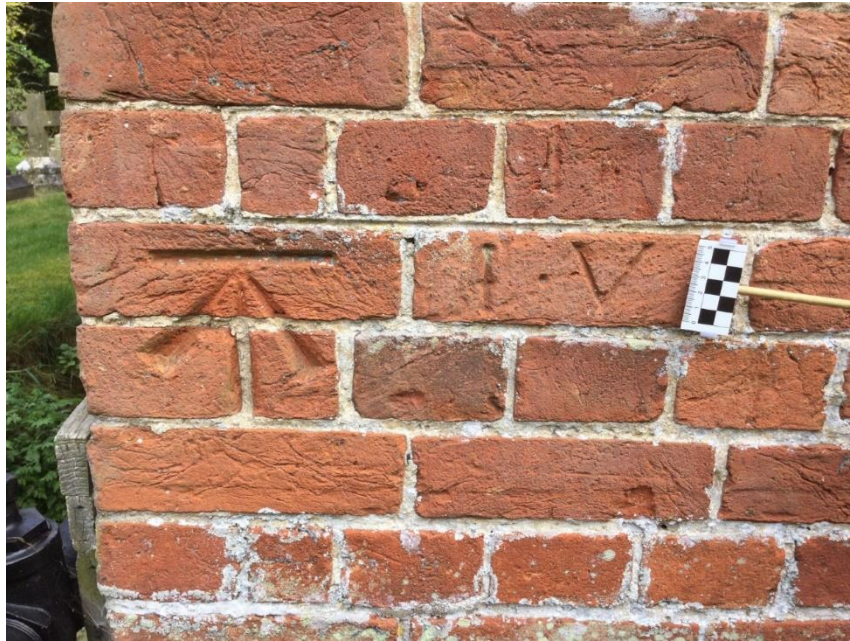
There is a well-defined cut mark benchmark towards the NW corner. (Figure 3). This is recorded on the 1897 Ordnance Survey map.

*Fig 3. External west wall. Cut mark benchmark and initials I.V. Photo KP13*

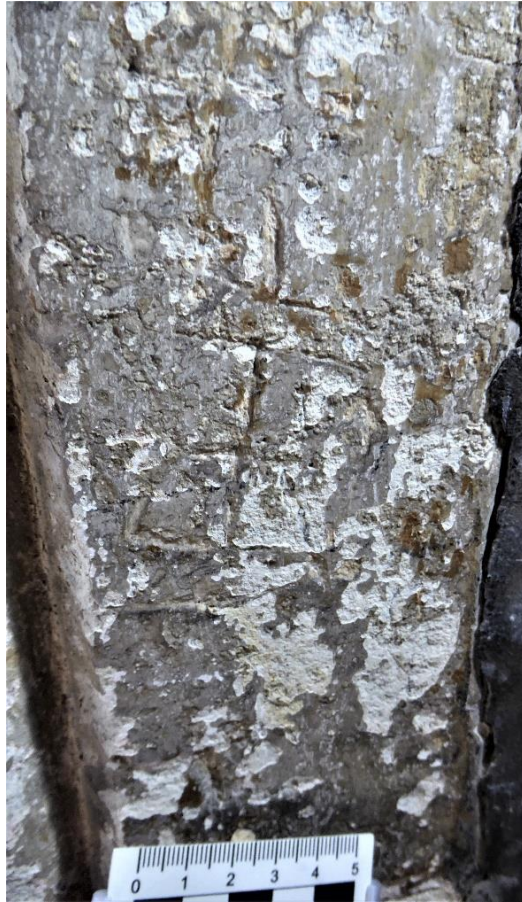
Entry to the church is through the **C13th south doorway**. There are several graffiti marks around the doorway on both the blocks and mouldings. Various crosses including a calvary cross (Figure 4) and possible baptismal crosses (Figure 5) are in evidence. Although these are much degraded it is possible to make out the 8 points of the baptismal crosses. It is also possible to see that some of the graffiti is overlain by later inscriptions. On the east side is a pair of initials WA. (Figure 6).

*Fig 4. South doorway west side. Calvary cross with other crosses. Photo KW42*

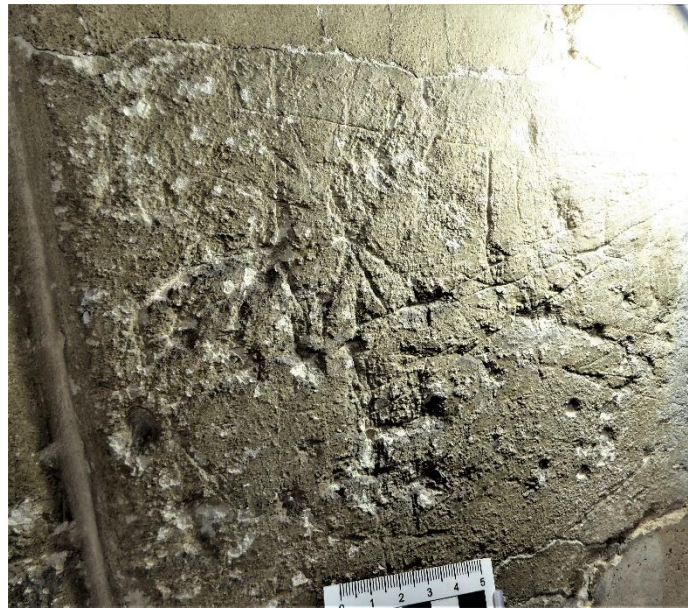
*Fig 5. South doorway east side. Degraded baptismal crosses and other degraded marks. Photo KW38*

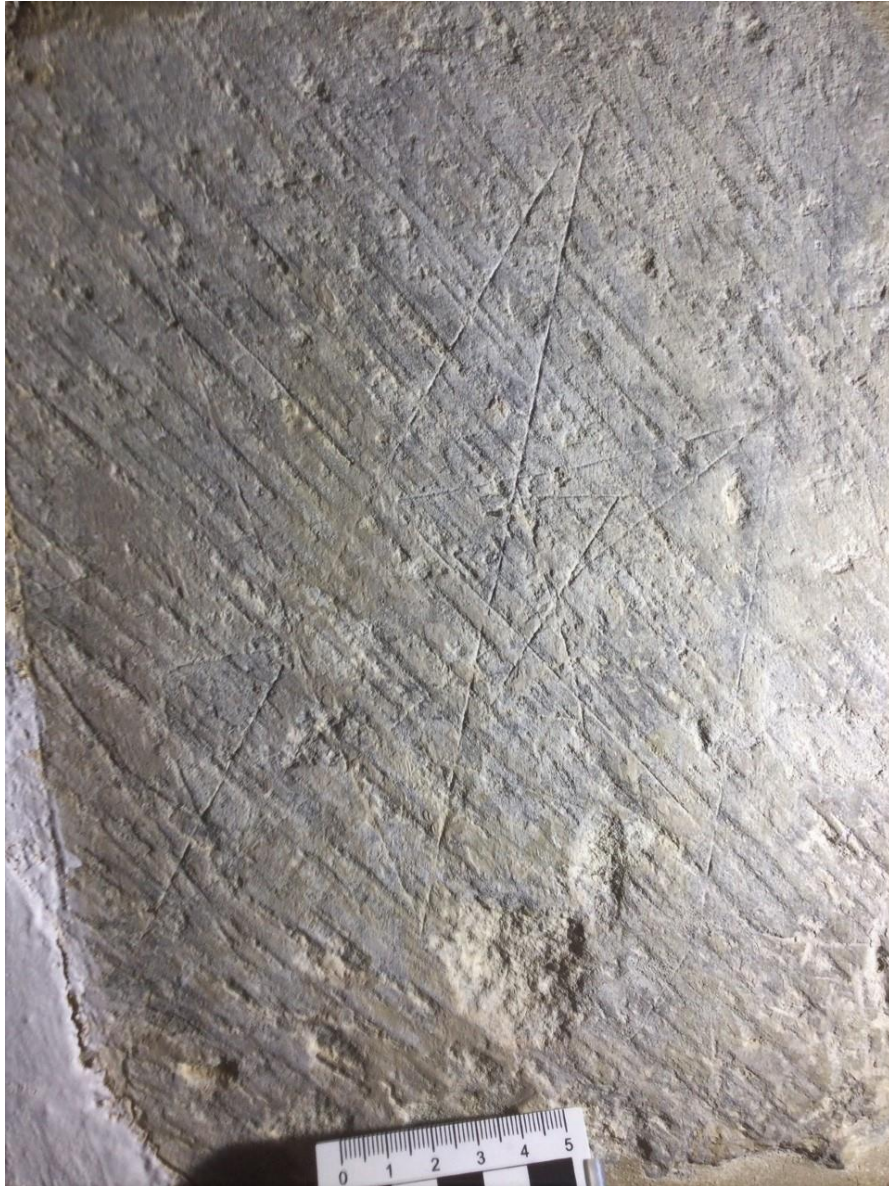
Passing through the **south door to the inner door jambs and surrounds** there are two areas of graffiti of particular interest. There is a large pentagram and butterfly shape on a block on the inner west side. (Figure 8). On the east side are two grids, one with a cross beneath it. (Figures 9 /10).

*Fig 8. South doorway inner jamb. Pentagram with butterfly mark. Photo KP25*

The pentangle was a powerful religious symbol in medieval times. In this instance because of the position of the marks at the threshold of a doorway, they may have been made to protect the entrance to the church against evil spirits – (James Wright Triskele Heritage 2021).

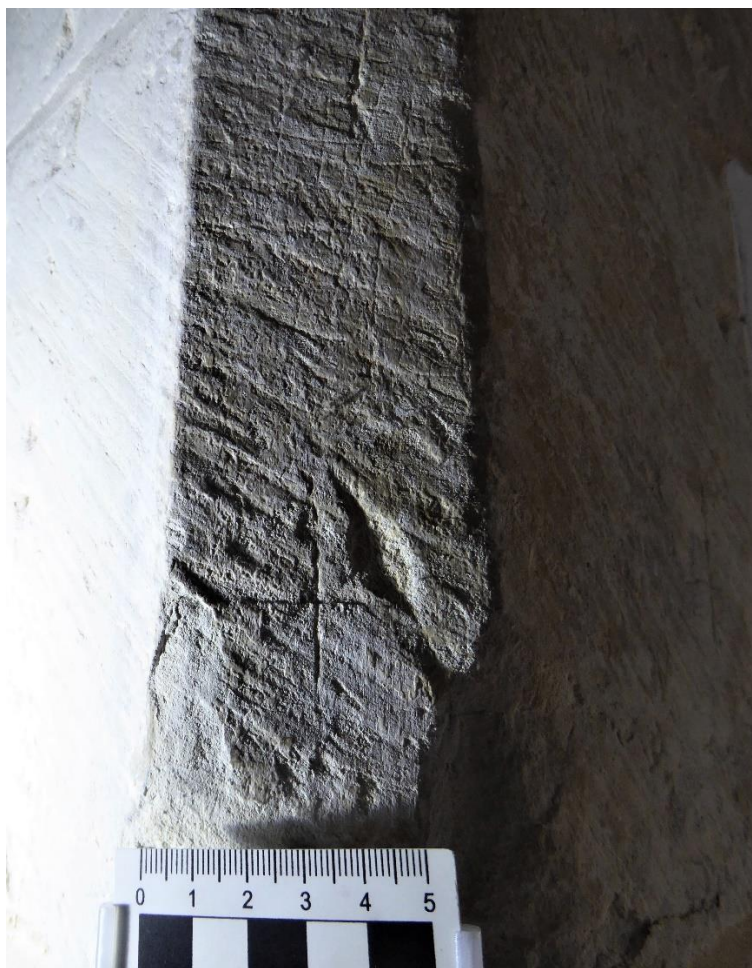
*Fig 9. South doorway inner jamb chamfer facing nave. Grid with cross below and to LH side.  
Photo KW59*

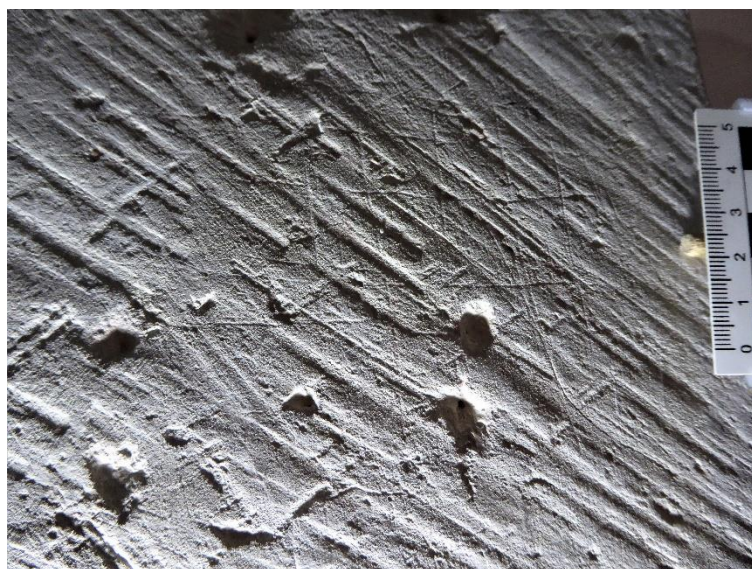
*Fig 10 South doorway inner jamb chamfer facing nave. Grid. Photo KW60*

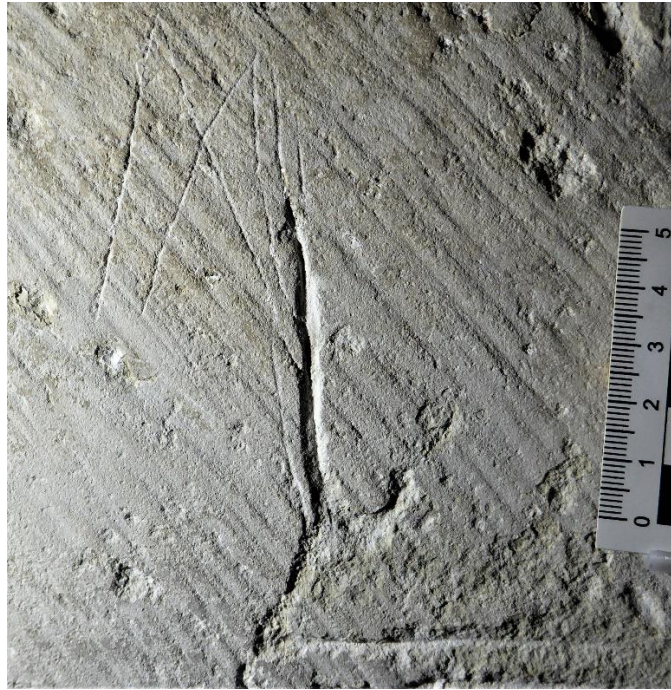
A conjoined inverted VV symbol can be seen on the south wall on the central pier to the old south arcade. (Figure 11). Such symbols are thought to derive from Marian marks, originally made as devotional symbols for the Virgin Mary, but having a more protective or apotropaic function in post-Reformation times. The chancel arch south side has a finely cut cross (Figure 12) mirrored on the chancel arch north side (Figure 13), both are facing west.

*Fig 11. South wall central pier to old south arcade. Inverted VV symbol. Photo KW67*

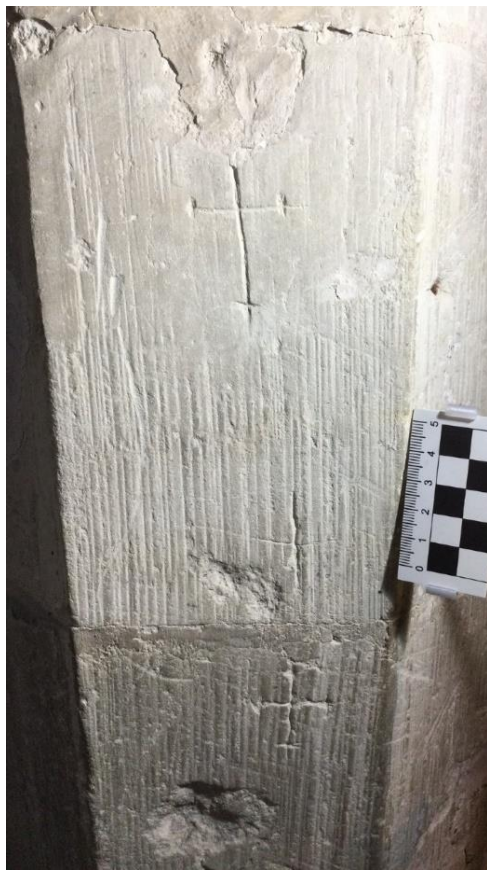
*Fig 12. Chancel arch south side. Cross. Photo KP34*

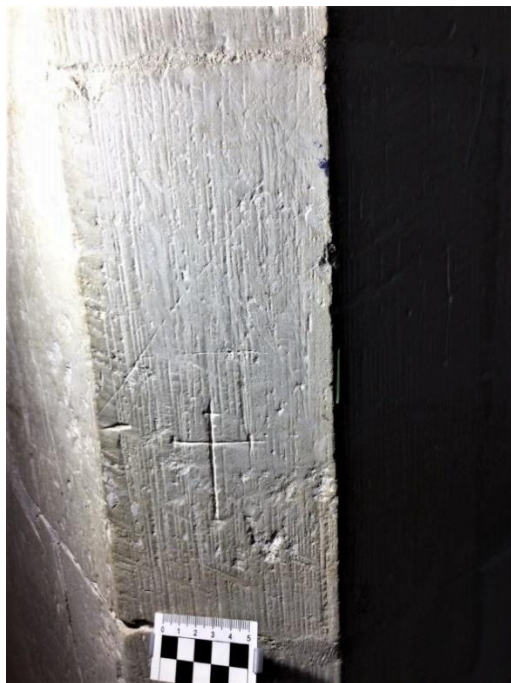
*Fig 13. Chancel arch north side. Cross. Photo KP31*

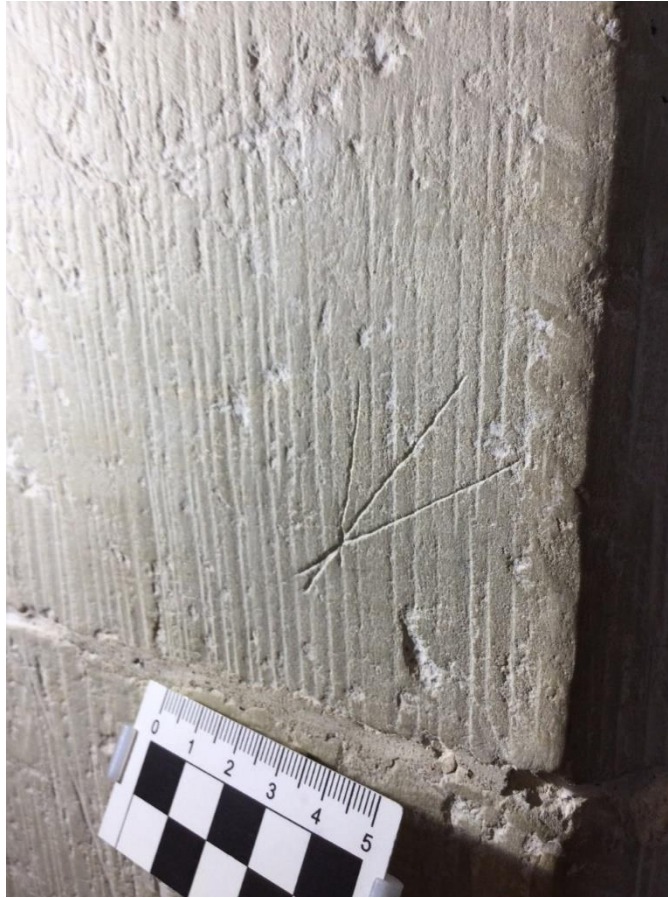
On the south side of the chancel arch is a neatly cut mason's mark (Figure 14).

*Fig 14. South side of chancel arch. Mason's mark. Photo KP33*

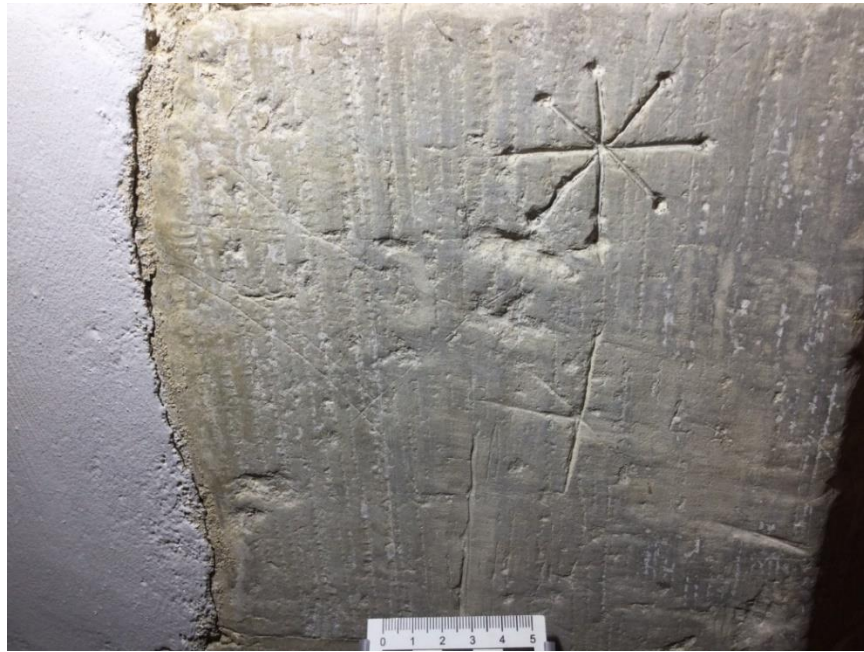
**The chancel doorway** west side has a finely cut baptismal cross with other less well-defined baptismal crosses below. (Figure 15). The chancel doorway east side has a pair of inverted VV marks. (Figure 16).

*Fig 15. Chancel doorway west side. Baptismal cross. Photo KP49*

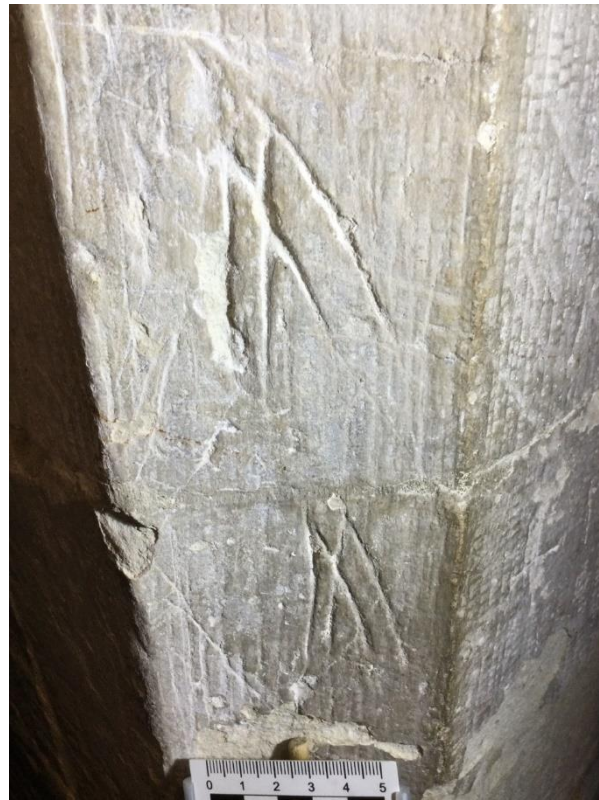
*Fig 16. Chancel doorway east side. Inverted VV's. Photo KP53*

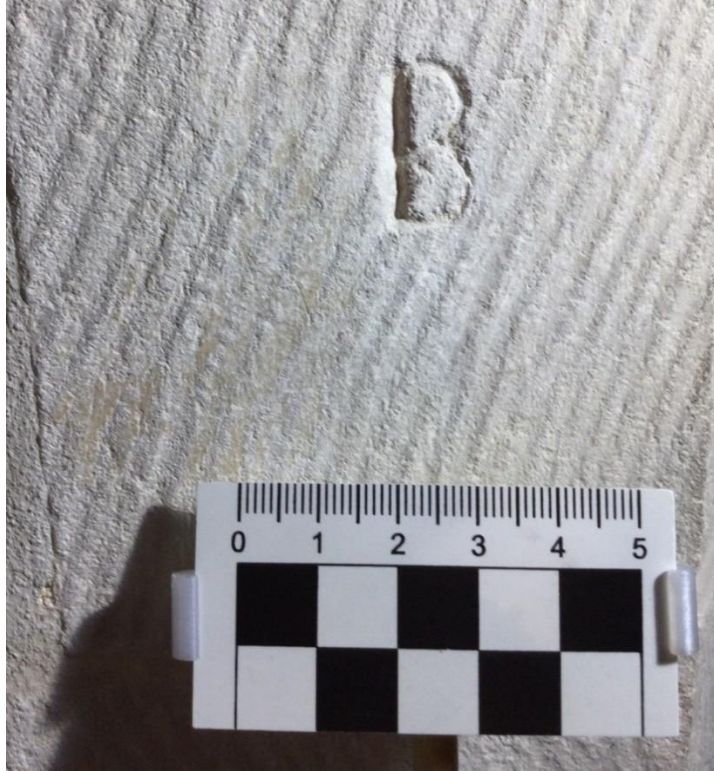
The sanctuary window has a finely cut initial B (Figure 17).

*Fig 17. Sanctuary window ledge. Initial B. Photo KP61*

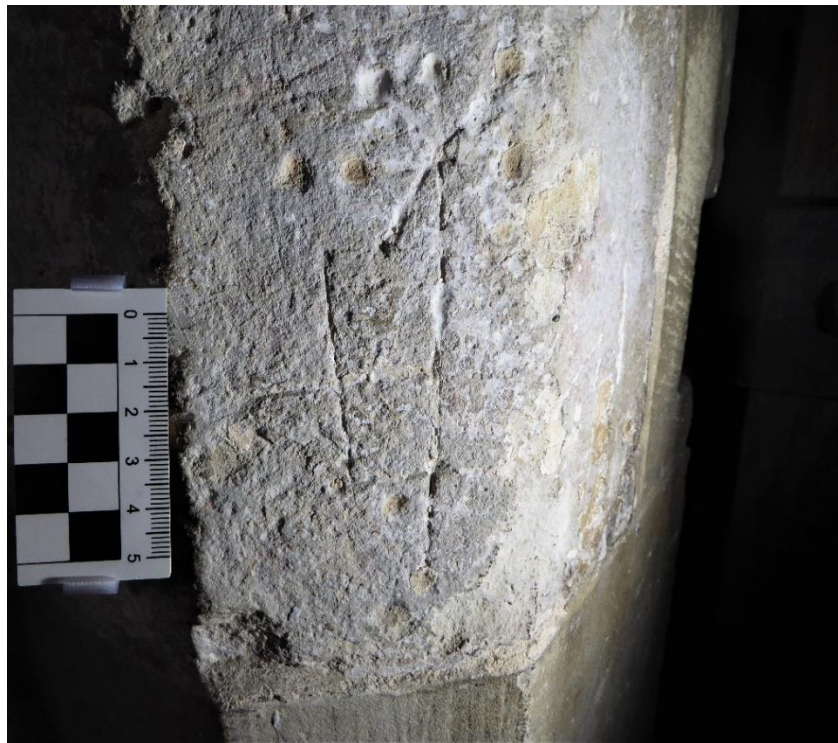
Inside the vestry porch the C14th south doorway into the chancel has a cluster of crosses of different types including a simple vertical cross, a baptismal cross and what could be a Byzantine cross (Figure 18).

*Fig 18. Chancel doorway within vestry porch east side. Crosses. Photo KW4.*

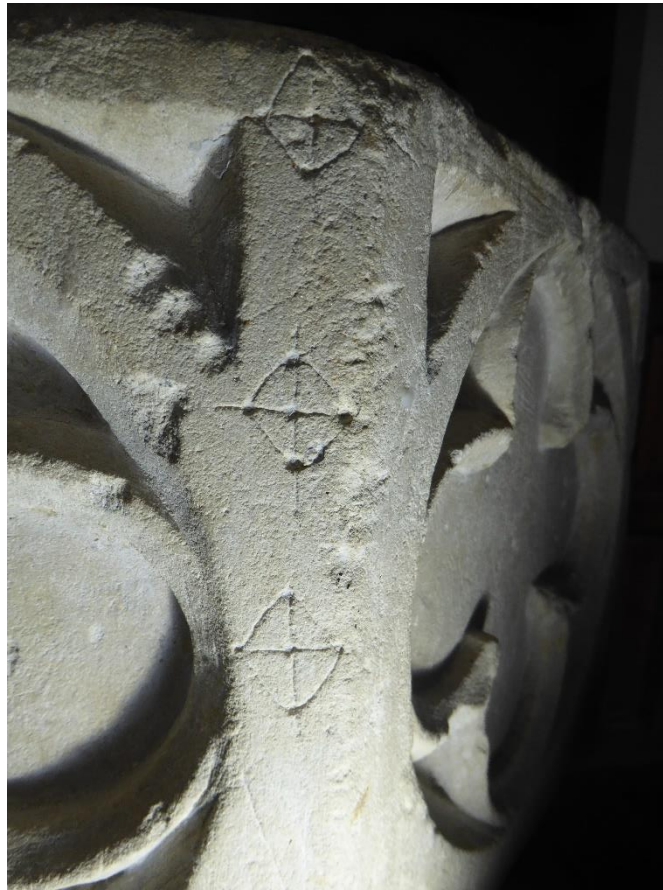
**The font** quatrefoil faces are covered in lines crisscrossing the stone. Between the S and SE faces are 3 crosses. Each cross is enclosed and they sit one above the other facing the south doorway. (Figure 19).

*Fig 19. Font between SE and S faces. Crosses. Photo KW82*

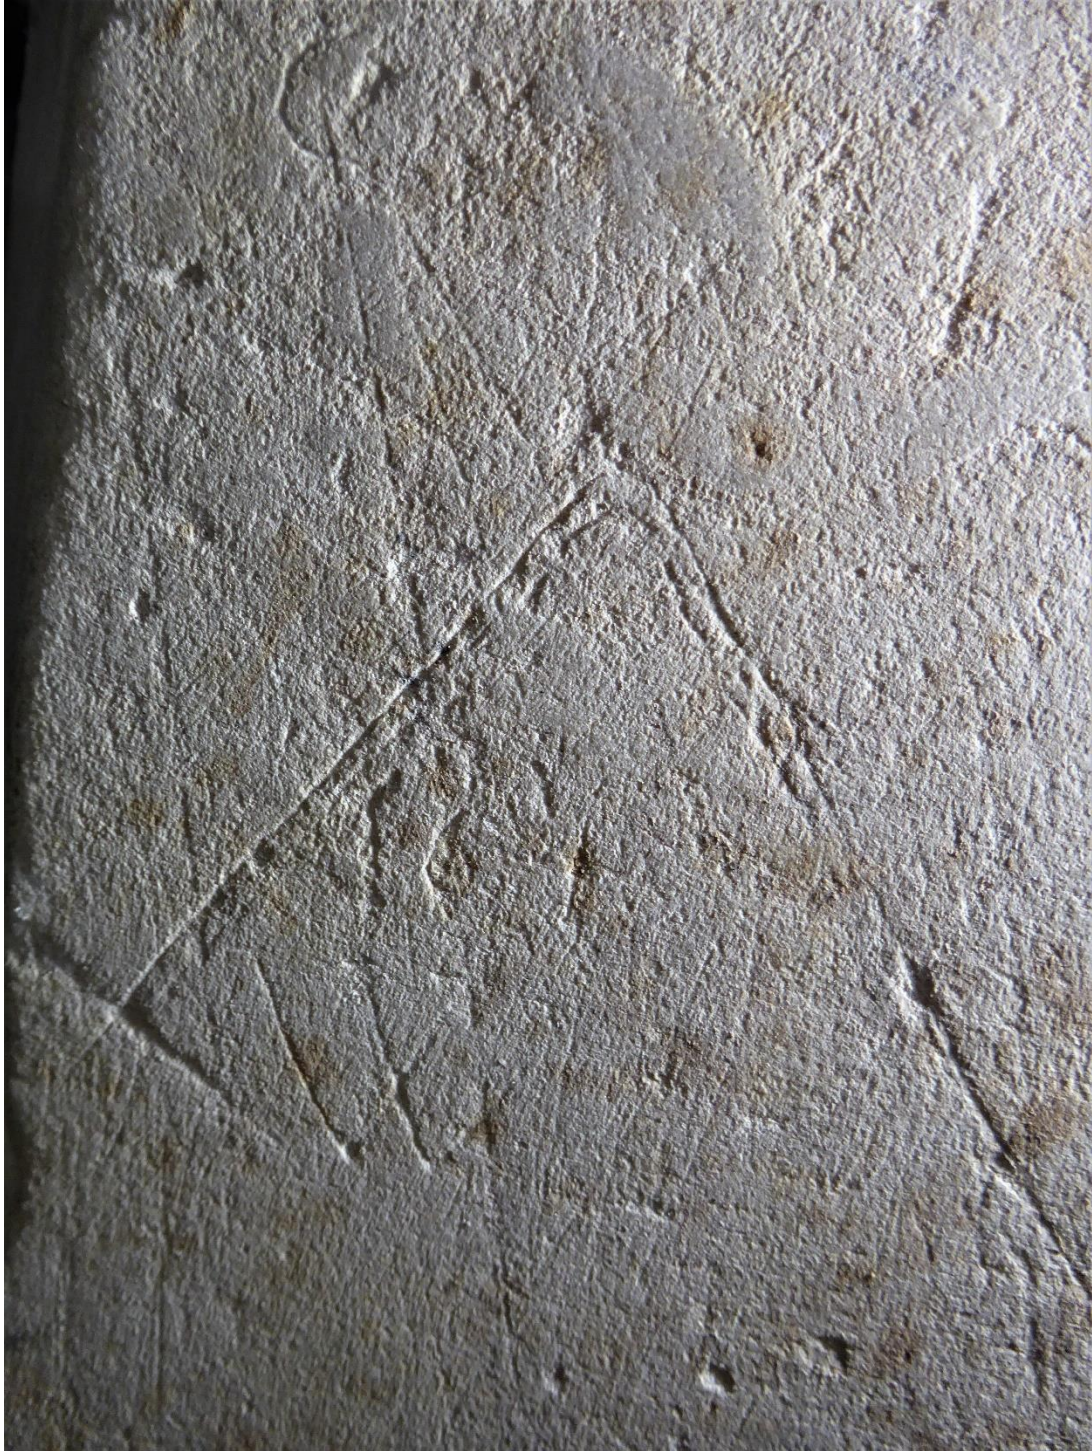
On the west-facing font stem is a pair of initials W I and a date 16\_1. These are canopied by a large, inverted V. Above and left is a small circle with 3 radiating lines coming from it which seem to underlie, thus pre-dating, the inscription below. (Figure 20). There are no other pre C20th dates found in St Mary's. The gap between the 6 and the 1 might represent a zero. Instead of bothering to carve a 0, a space was left, so the date could possibly read 1601.

*Fig 20. Font west side of stem. Initials WI and date 16\_1. Photo KW73*

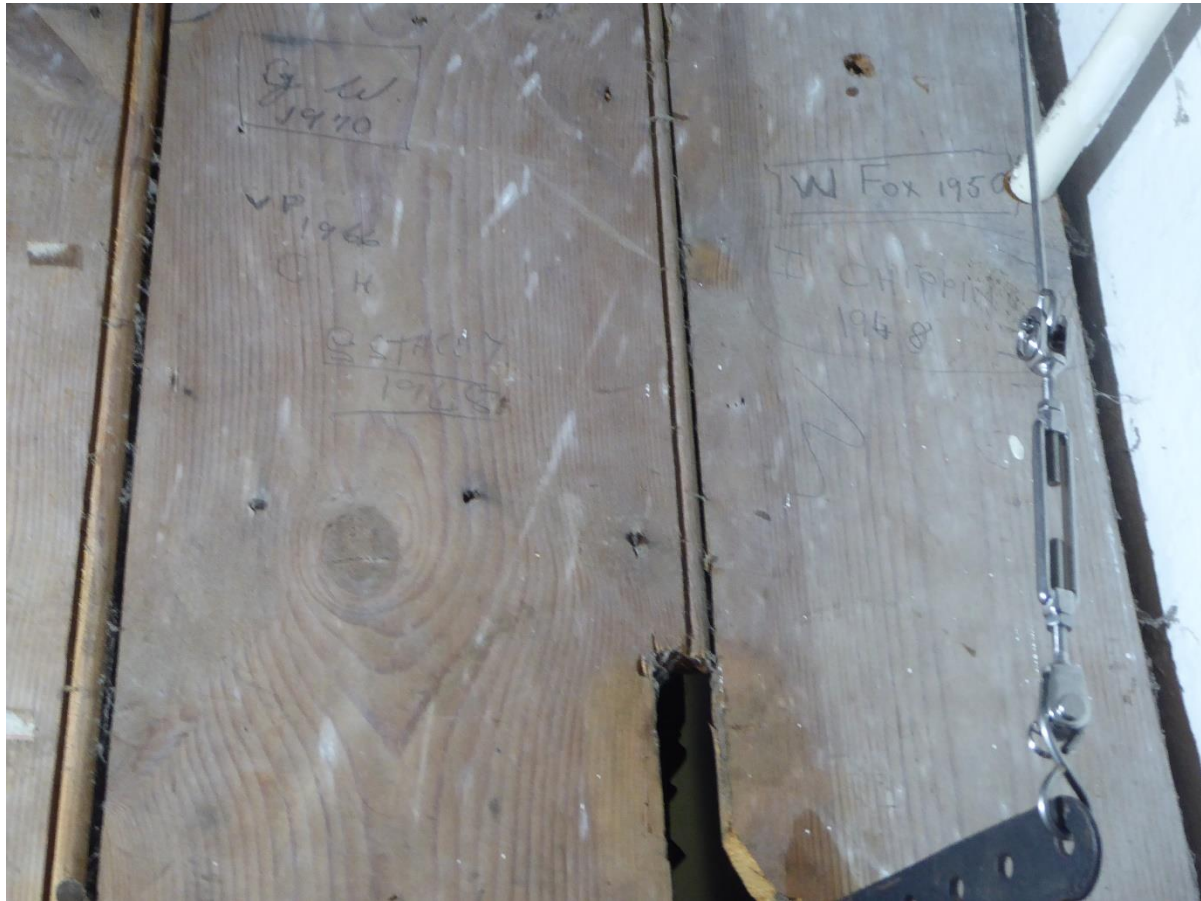
**The bell tower**, in particular the ringing chamber, is rich in C20th graffiti including names, initials and dates, written in pencil on the clock's wooden casing. These include N.Brasing, D.Childs 1936, F.Sims 1939, W.W 1936, Keith Lewis Corder, GW 1970, VP 1966, S.Stacey 1945, W.Fox 1950, I.Chipping 1948. (Figure 21).

*Fig 21 Bell ringing chamber clock cupboard. Initials, names and dates. Photo KW27*
