St John the Baptist church

New Alresford

Historical graffiti survey report

Date of survey: 29th November 2024

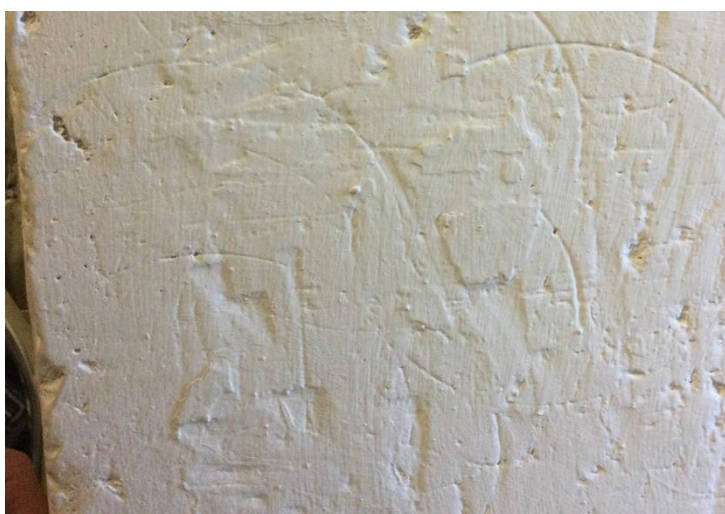
Fig 1 Ringing chamber. North window, west jamb. Intersecting circles

The main piece of graffiti found in the tower was on the west jamb of the north window in the ringing chamber. This consisted of at least five intersecting compass-drawn circles, now almost obscured by many layers of paint and limewash (Fig 1). Such compass-drawn marks are thought to have had a protective, or apotropaic function, to prevent

the ingress of evil spirits, and are often found on building openings such as fireplaces, doors and, like here, windows.

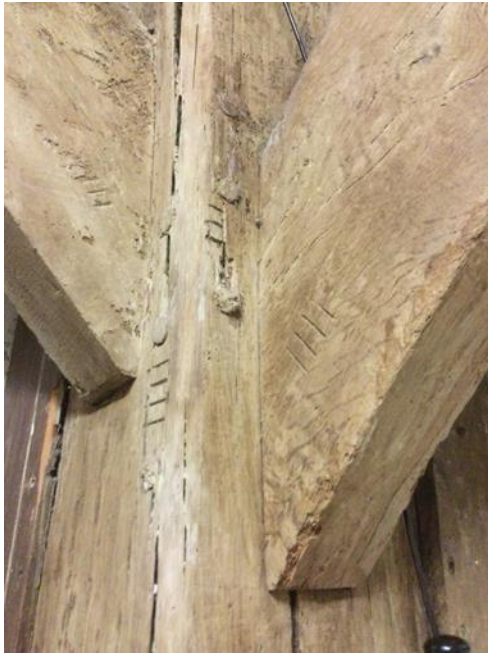
Fig 2. Carpenters' marks on post and braces in NE corner

Although not graffiti as such, the survey also recorded the fine examples of carpenters' marks which are on the exposed main timbers in the ringing chamber. Timber buildings were first constructed off site, in a framing yard where the carpenters could assemble the wall-frames and roof trusses by laying them out flat on the ground and pegging them together temporarily. Then they would mark up and number the frames and trusses before dismantling them for transport to the construction site. The numbers ensured that the right tenons went into the right mortises for an accurate fit. They were always positioned next to a joint with the same number in Roman numerals marking both joining timbers. The marks used on the joints between the upright posts and the braces in each corner of the chamber are of 3 and 4 lines. Four is

always denoted by IIII to avoid any confusion with six, VI. The structure in the NE corner has marks on all 4 surfaces. (Fig 2) Sometimes, as here in the chamber, one side of the building will have a plain set of numbers while the matching ones on the other side will be distinguished by an extra diagonal line to avoid any confusion. Here, the braces in the SE and SW corners have an extra line or "tag" added, giving the end mark the appearance of a Y (Fig 3).

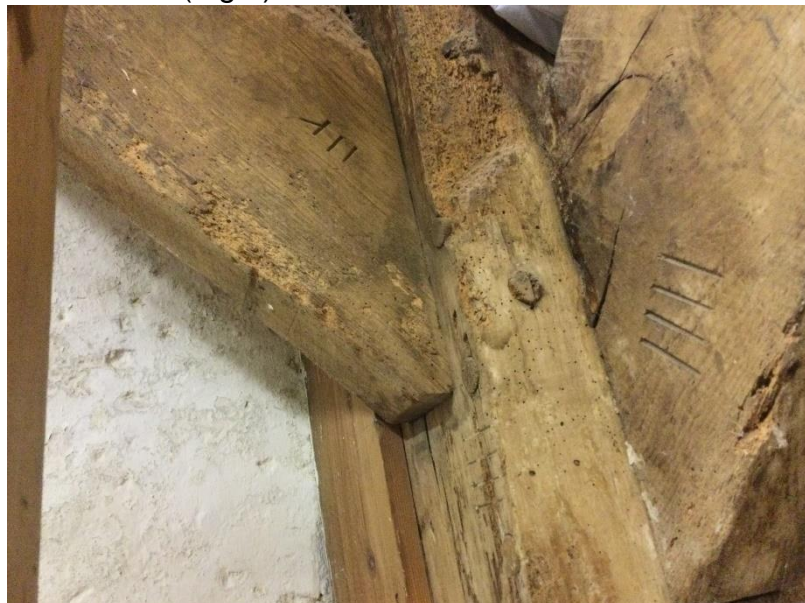
Fig 3. Carpenters' marks, one with additional tag in SW corner

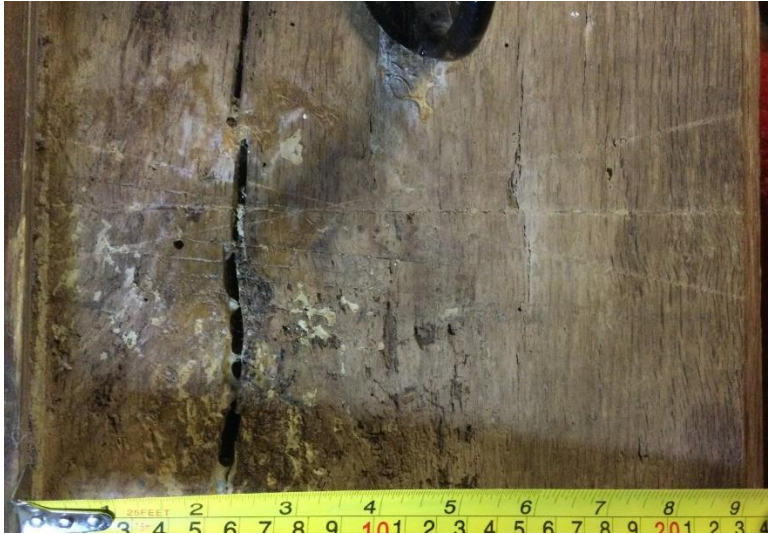
In addition to these marks are some more unusual marks. In each corner, on the surface of the upright post which faces into the chamber, is a mark consisting of 3

intersecting lines, forming a flattened cross shape (Fig 4).

Fig 4. Incised mark on post in NE corner, facing into chamber

These marks are not associated with a joint, and their function is uncertain, but their symmetry and similar appearance on each corner post suggests that they were made at the same time and with a specific purpose. It is therefore possible that they are apotropaic and were perhaps made soon after the timber structure was built, with the memory of the recent catastrophic fires still fresh and were an attempt to seek protection against similar disastrous occurrences to the church.

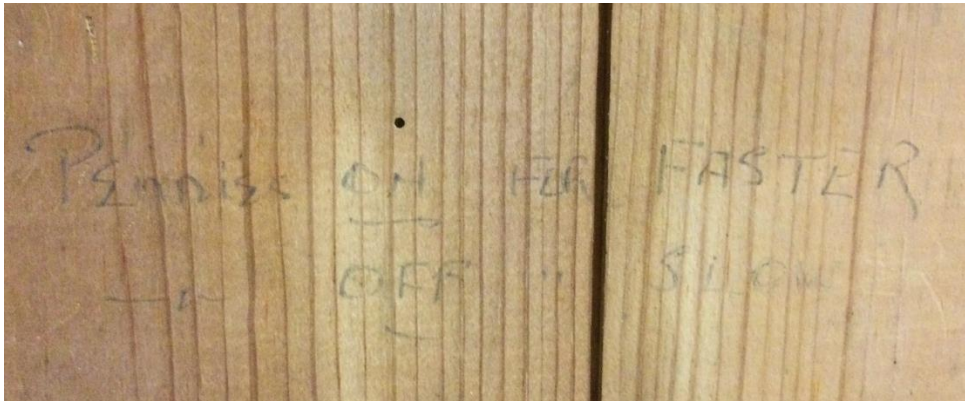
Also of interest are the instructions to use pennies on the pendulum to slow down and speed up the clock, (Fig 6). This use of old pennies continues and the best-known parallel is the Great Clock associated with Big Ben at the Palace of Westminster. There, pre-decimal pennies are used to regulate the clock mechanism, and adding one

penny causes the clock to gain two-fifths of a second in 24 hours.

Fig 6. Bell chamber, Clock case. Pennies ON for faster, OFF for slower

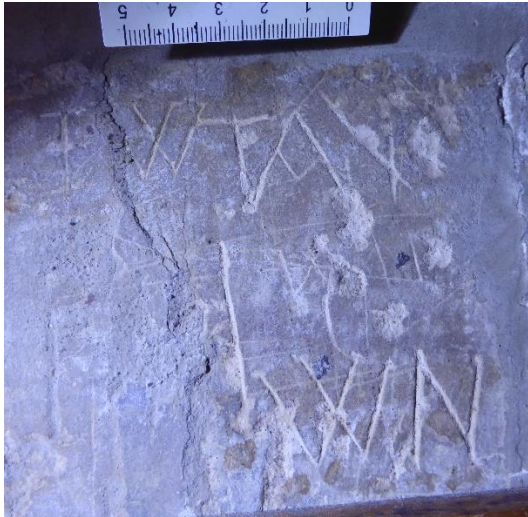
tower (Fig 8). The pilaster here has pairs of initials, crosses and the date 1708 incised into it. The form of lettering of the initials is typical of 18th century, for example W is shown as intersecting Vs. These pairs of initials include IW, IM, WN, CL and TA (Fig 9). The form of the number eight in the date 1708 is also of interest, being an English variant of the numeral, with a flattened horizontal top (Fig 10).

Fig 9. West face of pilaster, Initials including IW, TA and WN

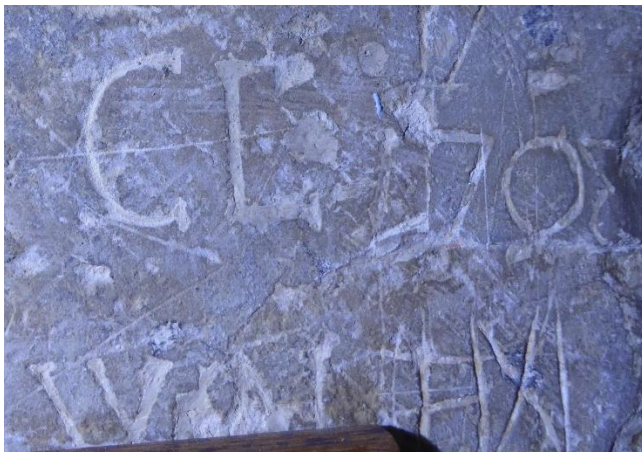
Fig 10. West face of pilaster. Initials and 1708

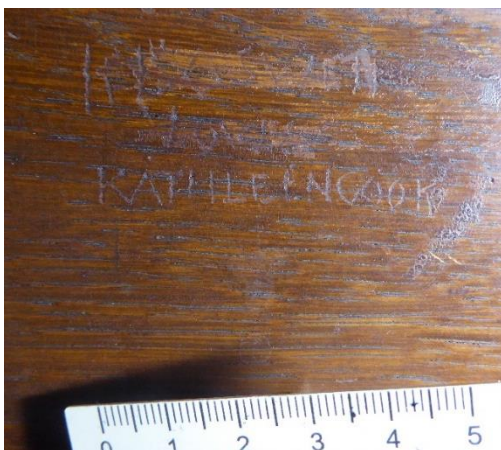
aisle. There is a some on the re-located panelling on the south wall of the passage leading to the old vestry. The graffiti has been scratched into the top of this panelling, so was obviously made when the panelling was in this position as it would have been too high to reach in its original location. The most legible of this graffiti reads "R Boswell loves Kathleen Cook" (Fig 11).

Fig 11. Modern graffiti on south aisle panelling.

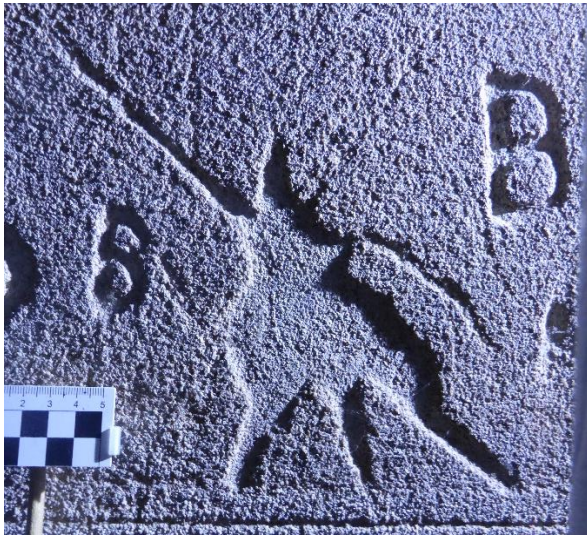
There is a group of deeply carved graffiti on the wall to the north of the old vestry, partly obscured by pipework. This consists of initials DB and BM on each side of an unidentifiable shape (Fig 12). There are also abraded names written in pencil and blue ink, and part of a date, 1921.

Fig 12. Wall to north of old vestry. Initials and shape

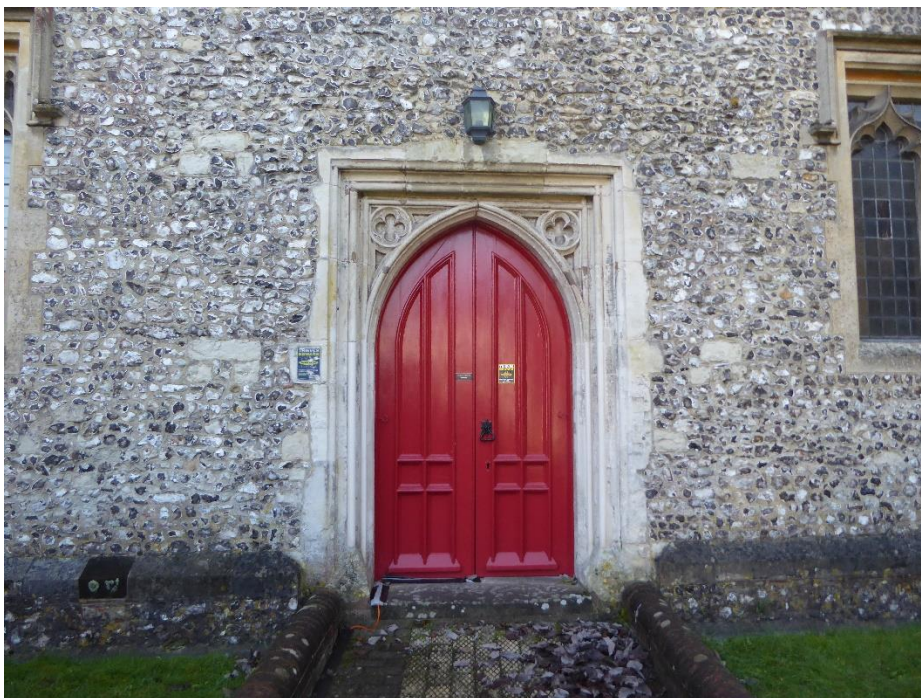
Fig 13. North doorway

There is an interesting group of graffiti around the exterior of the blocked north doorway in the north aisle (Fig 13). This consists of dates, which are all from the early 18th century, and sets of initials, some boxed (Figs 14 and 15).

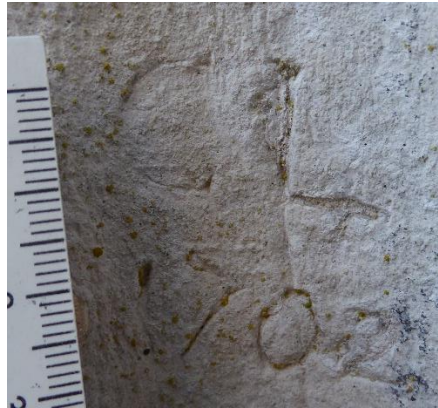
Fig 15. East side of north doorway. CL 1702

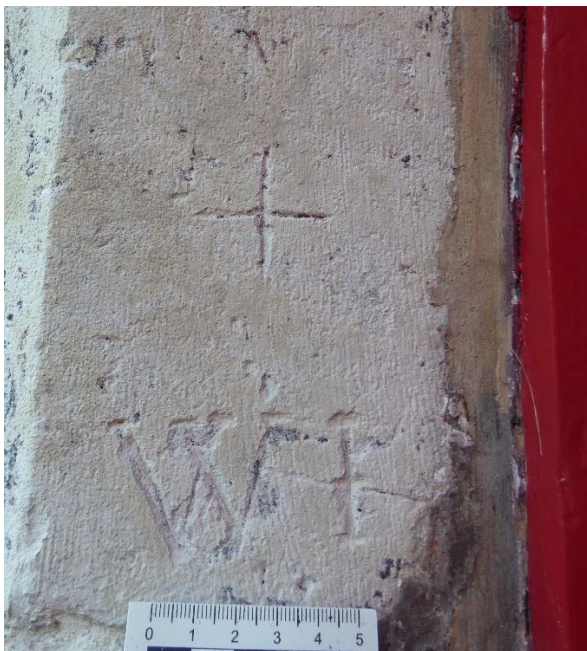
Fig 16. East jamb of north doorway. WI and cross

more elaborate box shape, containing the (very worn) initials WH, with a triangular roof-like top surmounted by a cross (Fig 17). Such forms are well known in Hampshire churches, and there is a good parallel at Romsey Abbey. It is thought that some of these more elaborate sets of initials may represent memorials to people who could not afford an expensive monument or tomb within the church, (Champion, 2018). The graffiti around the doorway also includes crosses, left as symbols of personal devotion (Fig 16).

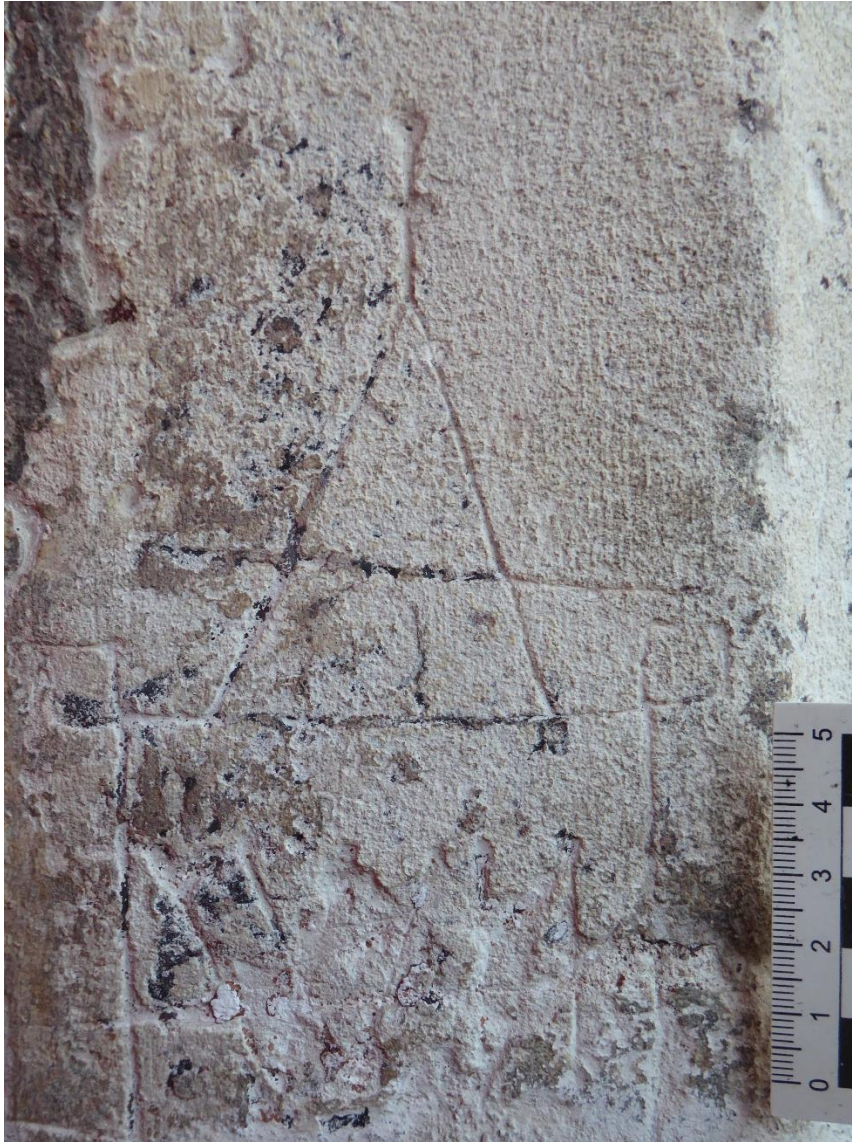
The weathering of the stone means that sometimes only the incised outline of the box remains, the initials inside having worn away. On the west side of the door is a

Fig 17. West jamb of north doorway. Elaborate boxed initials

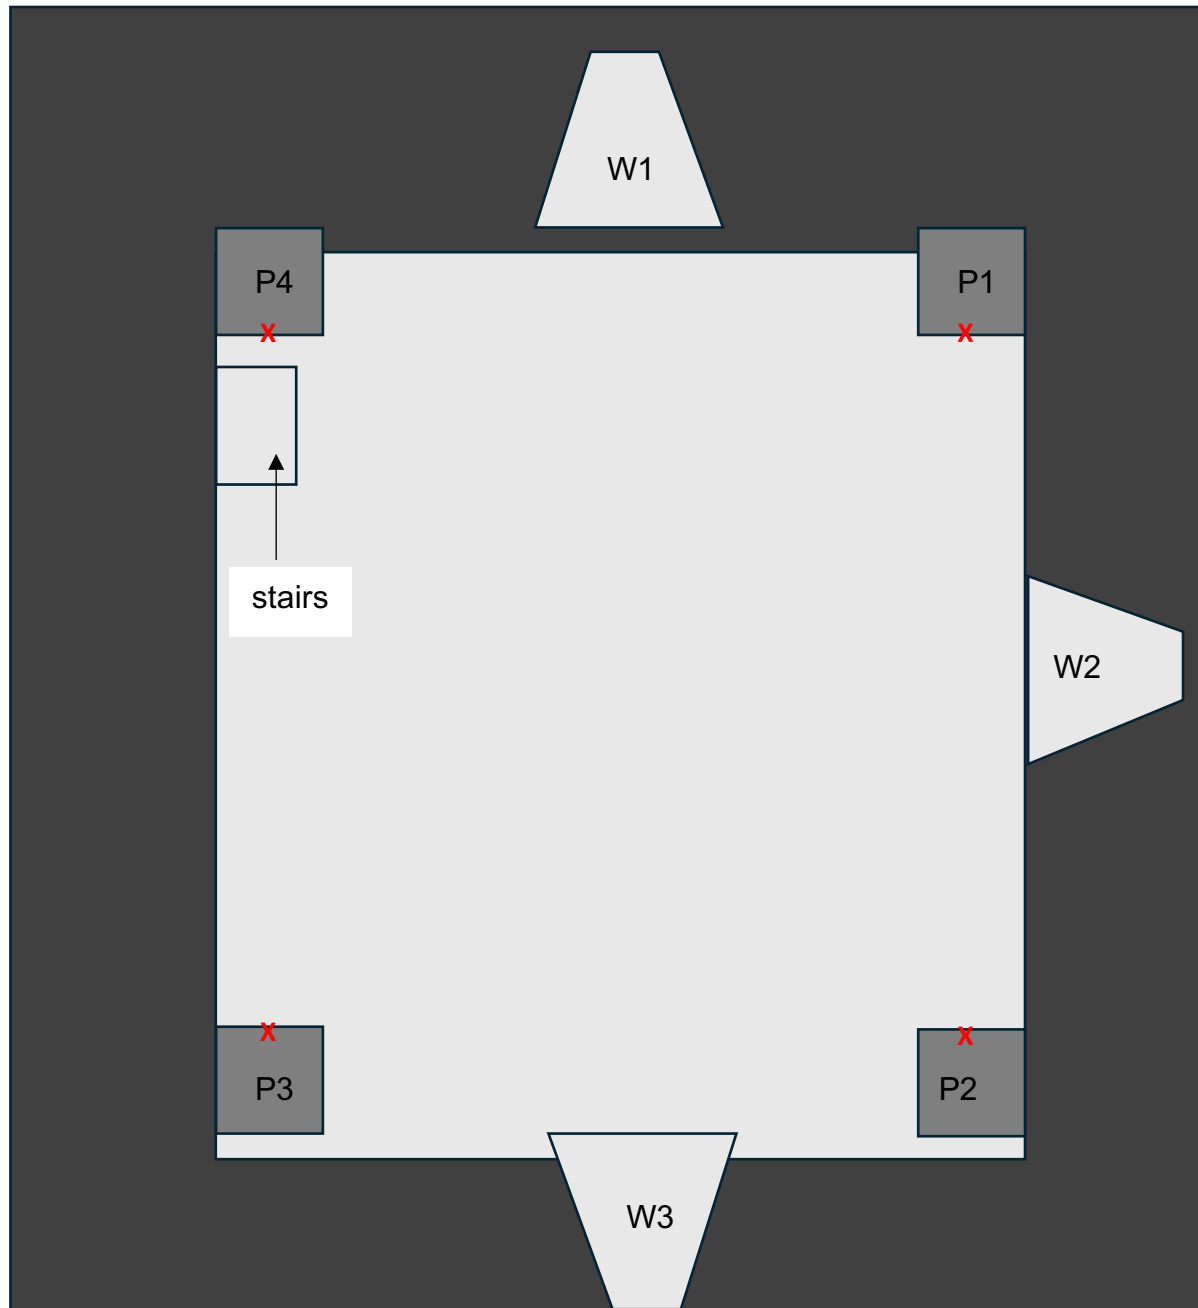
St. John the Baptist Church
West Street, New Alresford
Plan of Ringing chamber
29 November 2024
P= post W = window
X = cross-shaped marks
