A JETTIED HOUSE AT WICKHAM, HAMPSHIRE

By ELIZABETH LEWIS

The interest of this timber-framed house lies first in the details of construction which suggest that it was built with an open hall, the jetty carrying a gallery at the front; and secondly in its interior decorative scheme which includes wall paintings and an unusual painted wooden ceiling.

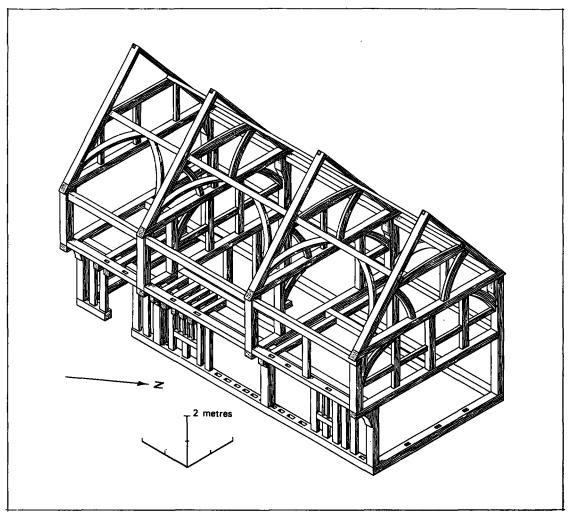
Fig. 1. Curio Shop, Wickham. Conjectural reconstruction of the first phase of construction. Drawing: Nigel Fradgley.

The roof trusses have diminished principals clasping side purlins (Fig. 1). There are two curved queen struts and a central strut between tie beam and collar, except on the end south truss where there are straight queen struts. All are closed trusses, at least to the collar. The roof has been retiled this century and the rafters renewed.

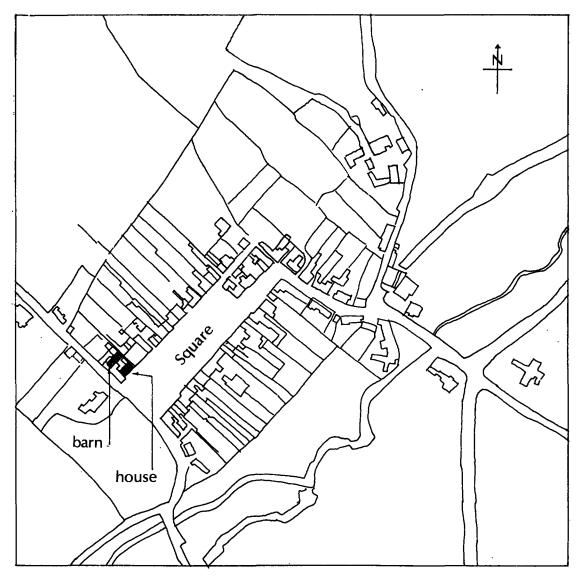
Fig. 2a. Curio Shop, Wickham. Site plan.

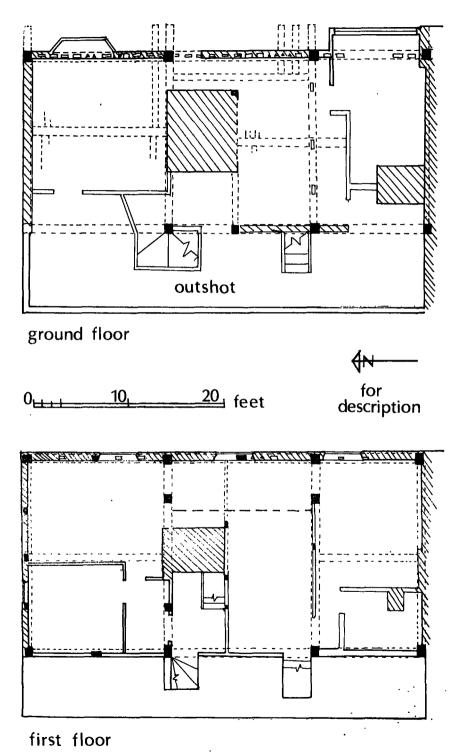
Fig. 2b. Curio Shop, Wickham. General plan of house.

bay, and this supported a bressummer beam making an additional chimney bay (Fig. 2.b).

the existing spine beam would have to be shortened, or a new one would be needed. But the surviving evidence at the Curio Shop seems to indicate different circumstances altogether. Here the spine beam appeared to be a new one, and at its insertion the whole plan of the two south bays was reorganised so as to increase the length of the middle bay to compensate for the loss of space caused by the

introduction of the chimney. The partition to the service bay was opened by removing the studs, and a new partition was introduced, reducing the service bay by four feet. These alterations rather suggest that the hall had previously been open, leaving plenty of scope for radical rebuilding when a new floor was inserted. The jetty, however, was an original feature, although its co-existence with an open

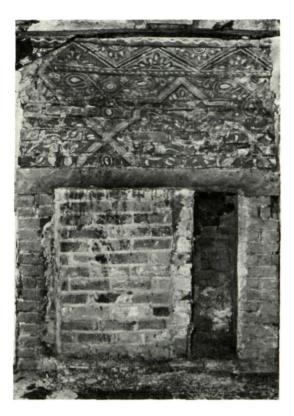
Fig. 4. Curio Shop, Wickham. Fireplace on first floor, with painted decoration.

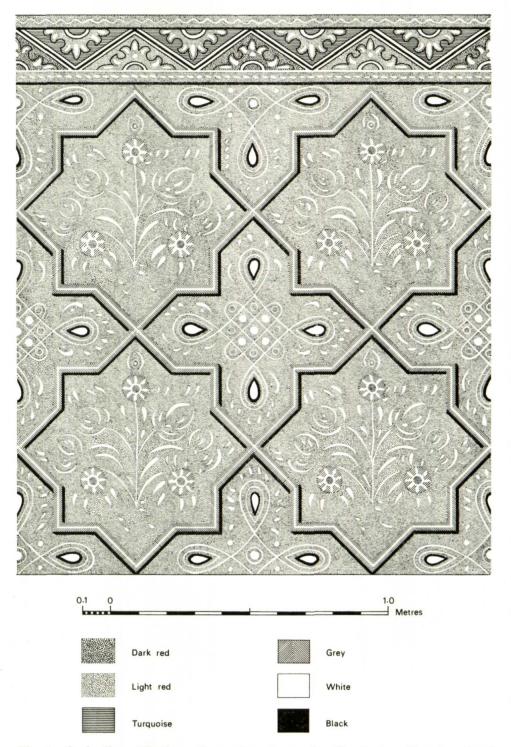
Fig. 5. Curio Shop, Wickham. Decorative scheme of wall paintings. Drawing: Nigel Fradgley.

The painted decoration covers the walls of the first floor of the north bay, and the ceiling of the room below, though there is no reason to assume that the two schemes are exactly contemporary. The scheme on the first floor can be dated to after the insertion of the brick chimney. Here the painting covers the whole of the wall surface from floor to plate, on both the timber framing and on the wattle and daub infill panels. Its condition was fragmentary in some parts of the room, and a wooden partition had been inserted at a later date, dividing the room into two. No painting survives on the front wall where all the infill panels had been replaced. At a later date attempts had been made to cover the paintings with black paint and plaster. During alterations in early 1977, the fireplace was uncovered, and the design could be traced over the bricks of the fireplace, over the wooden fireplace lintel, and over a plaster filling linking the beam to the chimney breast. Here the paintwork was particularly fresh (Fig. 4) and a reconstruction could be made of the scheme, including the frieze which ran round the top of the walls (Fig. 5).

The ground of the painting is a deep red, and over this the design is painted in white and blue-grey pigment. The design is of interlacing geometrical figures, a pointed cross and an eight-sided pointed star. Within the cross is a four-looped knot with embellishments, and within the star is a spray of leaves and daisies, in grey, white and orange repeated in each star. A slight suggestion of relief is provided in the dark shading. The frieze above has a zigzag pattern with half daisies or marguerites in each triangle, alternately in orange and blue-grey and heightened with a dark brown wash. This motif is of Renaissance ancestry, and was noted by Francis Reader (1936) to occur in two dated contexts, at Fittleworth Manor in Hampshire and at Vernon House, Farnham. The painting at Fittleworth Manor bears the date 1580, while the Vernon House painting includes the arms of Robert Horne, Bishop of Winchester (1561-80). In both cases, as at Wickham, the

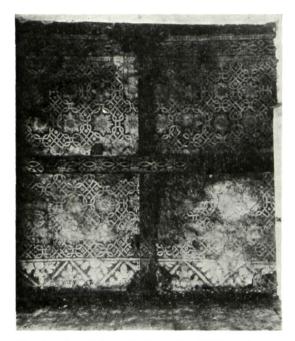
Fig. 6. Angel Inn, Basingstoke. Wall paintings. Photograph: Hampshire County Museum Service. PWCM 12983.

motif is used in an architectural context, as a framing or skirting element, or as part of the entablature. The strapwork panels enclosing flowers are a common device in Elizabethan and Jacobean wall painting, and the strong resemblance to woven damask is probably deliberate. In Hampshire few wall paintings have been recorded, but there was a similar scheme at the Angel Inn in Basingstoke, now demolished (Fig. 6). Here the walls were banded by a painted frieze at the top, mid rail and bases of the walls, and the frieze at the base used the repeated zigzag and daisy motif found at Wickham and Fittleworth and at Hambledon, where fragments of this same motif have been found recently in studwork at Hole Farm. The intermediate spaces are covered in a densely-patterned strapwork design of which the elements are octagons surrounding daisies of several different designs, and an interlacing four-looped knot such as we see at Wickham.

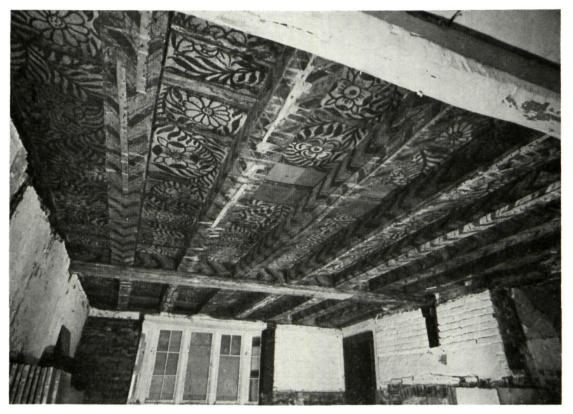
Fig. 7. Curio Shop, Wickham. The painted ceiling. Photograph: Royal Commission on Historical Monuments. PWCM 10780.

Perhaps the most remarkable feature of the Wickham house is the painted ceiling in the parlour (Figs. 7, 8). This was almost perfectly preserved except for two missing planks. The painting is on the joists, wall plate, part of the spine beam (much is obscured by later paint) and the underside of the floor boards. Where the joists are seated on the jetty beam, the spaces between are filled with patches of plaster decorated with arabesques, and in two places holes in the joists have been plugged with linen cloth and painted over.

The painting is in black on a white ground. A continuous chevron pattern with a double outline covers the joists and the side of the spine beam. Traces survive on the underside of the spine beam, which has been scraped. The spaces between the joists on the underside of the boards are filled with a running leaf scroll design, apparently willow, which encloses fruits and flowers. These include various

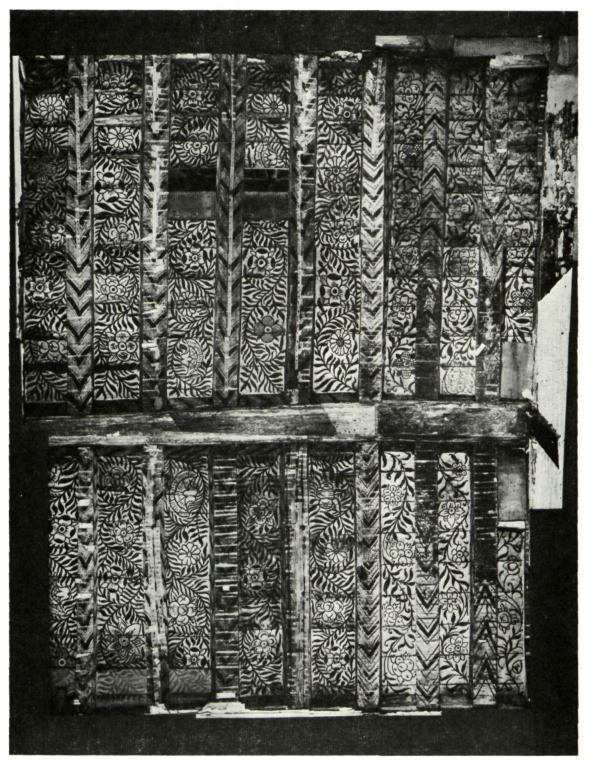
Fig. 8. Curio Shop, Wickham. Photo collage of the painted ceiling. Photograph: Royal Commission on Historical Monuments. PWCM 10781.

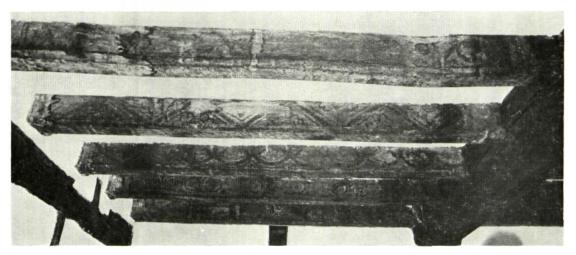
Fig. 9. Old Farm, East Harting. Painted joists. Photograph: M. Rutter. PWCM 13761.

list of known examples is given below, but it is worth mentioning specifically two Sussex examples, one at Elsted and the other close by at West Harting (Fig. 9). They are both in ground-floor rooms, on ceilings that have carpentry details compatible with a late sixteenthcentury date. In the Elsted house the joists are chamfered and this is emphasised by the painting of a black line along the chamfer. Both ceilings use arabesques to finish off awkward spaces. The West Harting paintings are remarkable in the use of different designs on each joist. The marguerite/zigzag pattern we have seen in several wall paintings. There are also running scroll patterns, a leaf or cloudburst device, and circles or daisies. The most complete example of a painting like the Wickham one is that at the Bursary at Trinity

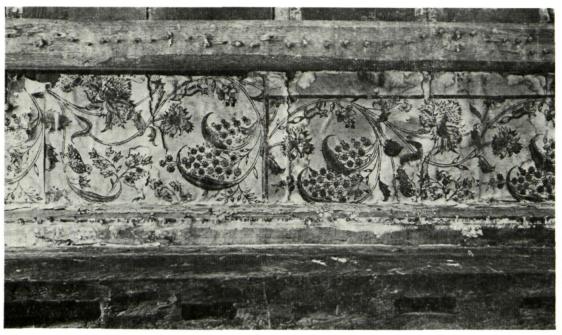
Fig. 10. Park Cottage, Swanmore. Eighteenth-century wallpaper between joists. Photograph: John Bosworth. PWCM 12482.

There is one curious late variation on the painted ceiling at Park Cottage, Swanmore, about five miles from Wickham. Here the hall of a house rebuilt in the seventeenth century has been decorated with pasted on strips of hand-blocked wallpaper which were found applied to both the joists and the underside of the boards. There are three layers, the earliest dating from about 1690 and the latest, datable by the customs stamp, after 1712. The design is of a running scroll pattern of leaves and flowers with birds and foxes (Fig. 10). It seems that locally, at least, the fashion for cheap decorative ceilings lasted for some time.
