EXCAVATIONS AT OTTERBOURNE OLD CHURCH, HAMPSHIRE

By DAVID A HINTON

ABSTRACT

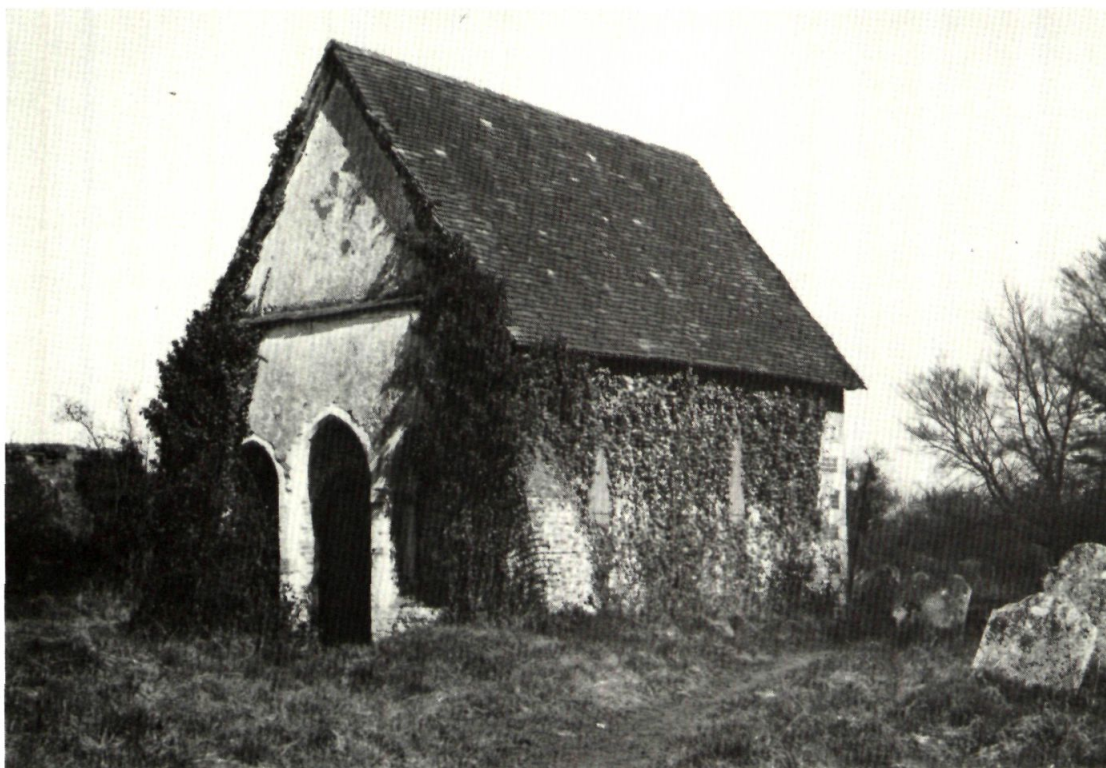
Fig 2. Otterbourne, the chancel from the south-west in 1945. This photograph shows the niches flanking the chancel arch leading from the nave demolished in or immediately after 1839. *Photo: Hampshire Field Club and Archaeological Society, negative housed National Monuments Record, Royal Commission on Historical Monuments for England.*

of the Royal Commission on Historical Monuments and of Winchester City Museum (Fig 2). It was built of flints with dressed stone quoins, laid roughly side-alternate, but of irregular size – and surprisingly unweathered. The structure had been patched with brick at the west end and the south-east corner, and the south-west and south-east corners had been buttressed. The photographs show an east window which had been much damaged, but may have been of two lights with quatrefoil head (cf. Charlton-on-Otmoor, c. 1240: Parker 1877, 128). The north and south walls each had two single-light lancet windows. The roof was of three bays, with arch-braced collars, two rows of purlins and two tiers of wind-braces, perhaps fifteenth-century; a tie-beam had been inserted. The most interesting feature was at the west end, where the chancel arch was flanked by arched niches with attached columns in the angles and roll

The west wall of the chancel had been much disturbed by in-filling (Figs 2, 5 and 6). Furthermore, diagonal brick buttresses over what had been the north-east and south-east corners of the nave obscured the junction of the chancel and nave. As a result, it was not possible to be certain of relationships without completely dismantling what survived.

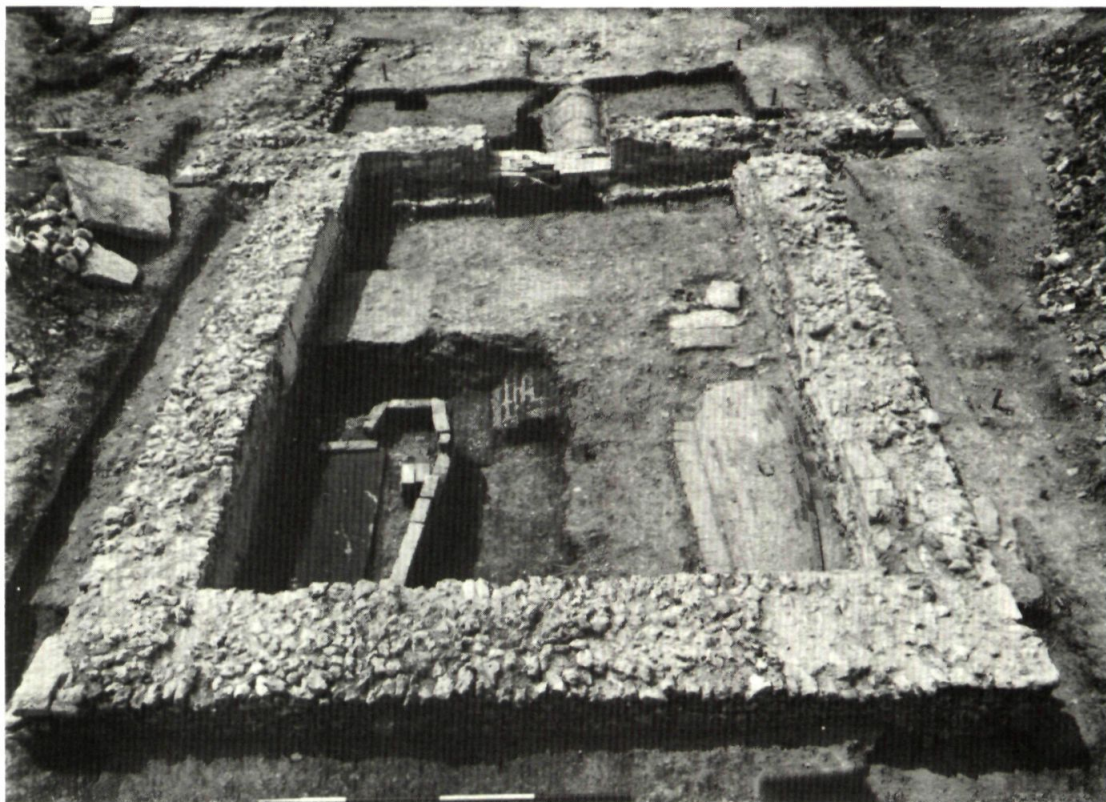
Fig 5. The chancel at the end of the 1984 season, showing how various inter-cut vaults had completely destroyed the medieval floors.

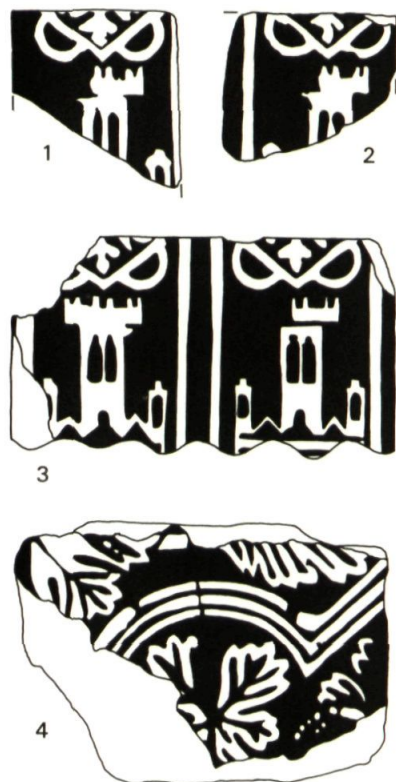
Fig 9. Floor-tiles. 1–3, Norton 1983, design 2 = 16.4 (upper part only shown here); 4, design 1 = 16.2. Scale 1:3

completed by 1404, where only four designs occur (Norton 1983, 87–88). At Otterbourne, examples of all six designs used in the college were found – and no other decorated tiles. (As all have been published recently, only two designs are reproduced here (Fig 9). It might therefore be assumed that this was indeed the full range made by William Tyclere, but Dr Christopher Norton is inclined to attribute counter-relief tiles, such as were found in Winchester in the Broadway, to him, and also some larger tiles found in the area (Norton 1983, group 18, page 90). At the college, purchases of Flemish tiles, which would have been plain, are recorded and survive in some numbers. None of these were found at Otterbourne, nor had any tiles been scored and broken for use in borders.

Norton has pointed out that flaws in the patterns of the Otterbourne-made tiles suggest that the stamps from which they were produced were already old and worn (1983, 88). Certainly those found in the excavation had the faults noticed at Winchester: part of the battlement of the right-hand tower is missing (Norton 1983 fig 5, 2 = 16.4; here Fig 9, 1–3) and there are breaks in the oak-leaf design (Norton 1983 fig 5, 1 = 16.2; here Fig 9, 4). Norton has pointed out that there are examples of the former in Winchester which have complete battlements and that the condition of the oak-leaf design seems to have become worse between its use in 1395–96 in the college, and its pre-1404 use in the cathedral. The Otterbourne church example of the latter seems to have all but one of the faults – the central line on the right side is not broken through, though the crack was beginning to appear. This suggests that the stamps did indeed get worse during their use at Otterbourne. Other tile designs were too incomplete or worn for similar signs of damage to be identifiable.
