ARCHAEOLOGICAL EXCAVATIONS AT THE 'WINE PRESS', BEAULIEU ABBEY, 1987-1989

by K J BARTON, R B BURNS and DAVID ALLEN

A ruined L-shaped building in the grounds of Beaulieu Abbey, known as the 'Wine Press' was excavated over three summer seasons. At the north end a complex sequence was revealed indicating a wet industrial process, initially with stone tanks and a channelled stream. It is suggested that the process was fulling, or the finishing of woollen cloth by shrinking and felting. Documentary evidence exists for fulling at Beaulieu from the mid-13th century. The other section of the building was a large hall, with an undercroft. Post-Dissolution, all parts of the site saw some demolition, and agricultural and industrial use.

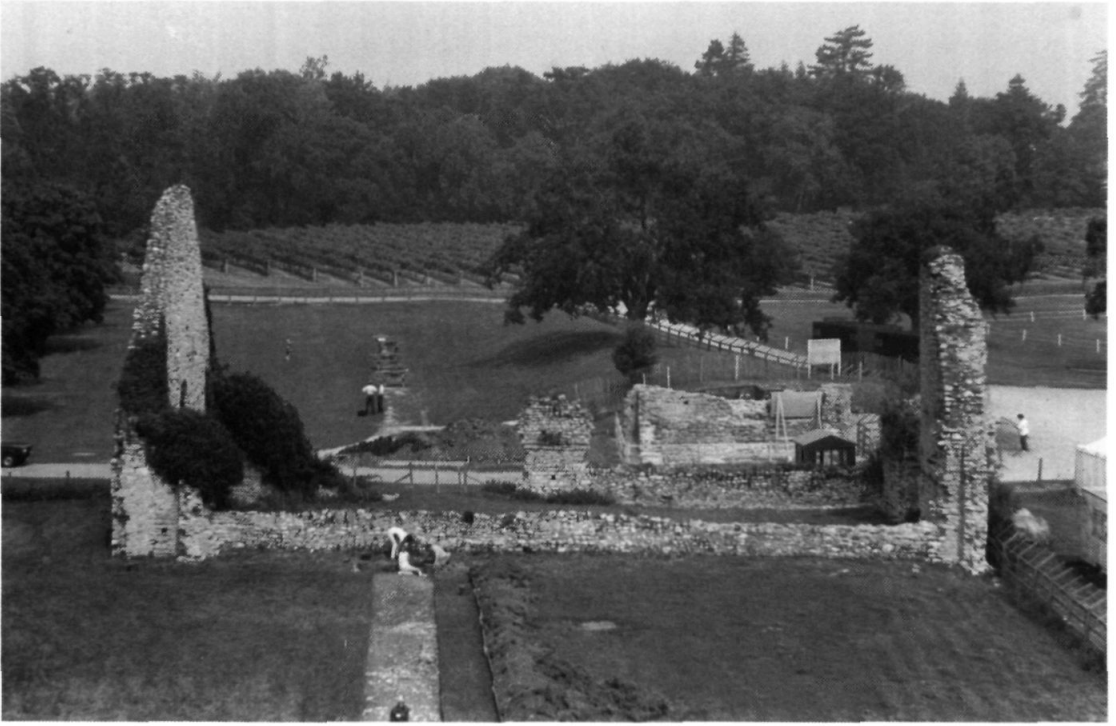
Fig 3. View of the 'Wine Press' site from the south during the 1988 excavations.

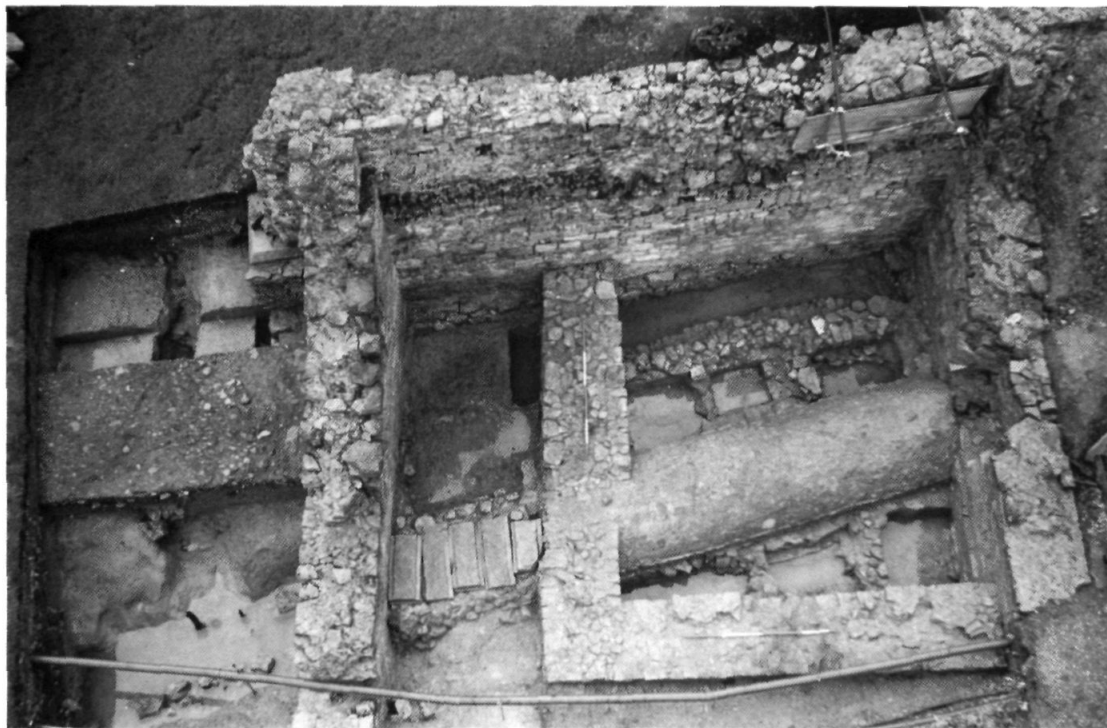
Fig 10. Aerial view of the 'Wet End' of the Annexe during 1987. The L shaped internal wall, arched and capped drain, and 6 rectangular 'vats' are exposed.

Excavation of all the deposits within the tank exposed a number of stone-built structures (Figs 8 & 10). These clearly preceded the walls of the 'tank' in date, but apparently continued in use after its construction. They consisted of six rectangular foundations or 'vats' (19), the smallest *c.* 1 m × 0.60 m × 0.40 m deep, three to each side of the central drain. These vats had slab stone floors which sloped towards the drain. They would have been capable of holding water, but holes in the side walls of the central drain would have allowed them to be emptied. Between the north wall and the vats was a long 'trough' (24), measuring 4.50 m × 1 m but of unknown depth. Its fill consisted of fine yellow clay (16).

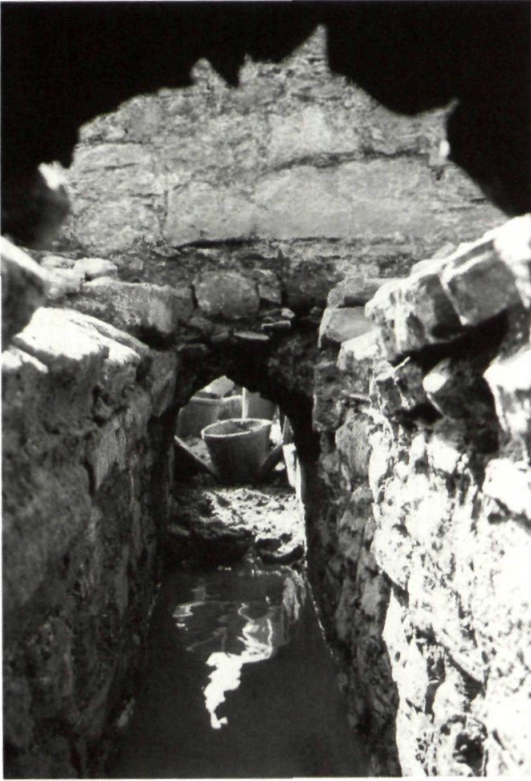
Fig 11. View west along the channel of the Annexe, from inside the arched drain. The capping slabs have been removed.

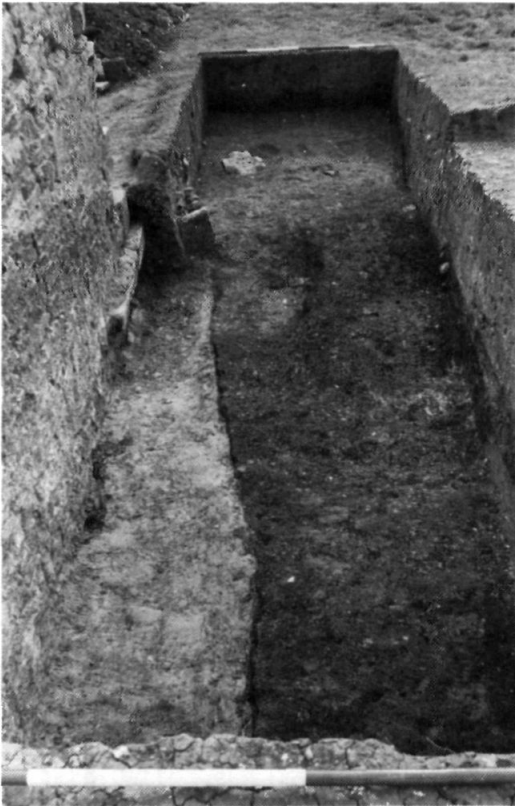
Fig 14. View west of the Aqueduct Bank under excavation. The clay-filled foundation trench is clearly visible, running at a different angle to that of the north wall of the Annexe.

The north wall was constructed in a foundation trench (73), the line of which diverged from it at an angle of 6 degrees. The possible reasons for this and the likely sequence are discussed below (p. 139). The wall itself was well built, and its north face of even surface, presumably because the width of the trench allowed good access. The trench was filled with stiff green clay (74), possibly for waterproofing. It was not fully excavated due to wet weather and difficult conditions (Fig 14).

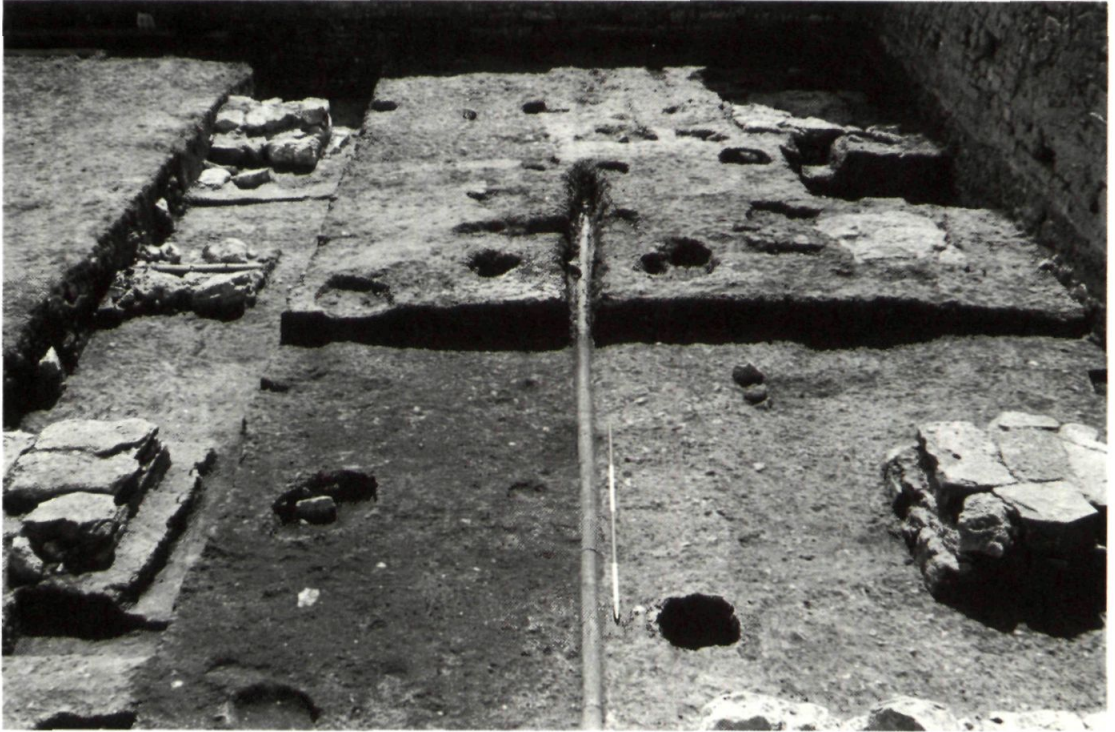
Fig 19. View south of the western end of the Range, showing the rows of three post-bases, and extensive later intrusions cut into the floor.

pipes (112) which led through the south wall and out into the Donkey Field. Some of these post-holes and the areas of hard-standing represented evidence for make-shift structures utilising the ruined walls (Fig 19).
