## A GEOLOGICAL REVIEW OF SOME HAMPSHIRE ANGLO-SAXON CHURCHES

By JOHN F. POTTER

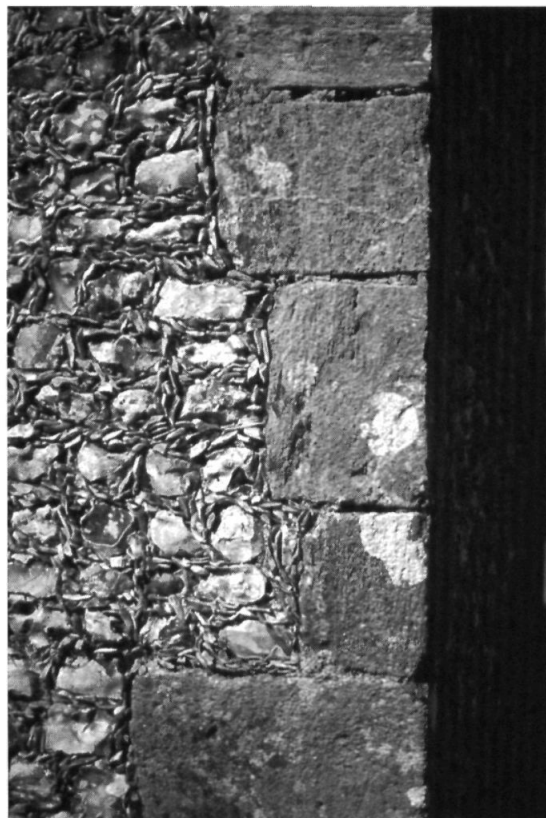
Fig. 2 Stones 6. to 10. inclusive in the SE. chancel quoin at St Nicholas, Boarhunt. A low setting sun lights the stones obliquely so that the orientation of the bedding in the uppermost four stones can be read as BVFR, BVFR, BVFR, BH. Stone 6. is also orientated BH but cannot be read without a magnifying lens. The S. chancel wall has been redressed with a knapped flint and flint chip finish which is typical of 18th century workmanship.

16. BH
15. Orientation uncertain
14. BVFR
13. BVFL
12. BVFR
11. BVFL
10. BH
7. – 9. BVFR
6. BH
5. BVFR
4. BVFL
3. BVFR with bench mark
1. – 2. BH

Stones 6. to 10. of the SE. chancel quoin are illustrated in Fig. 2.

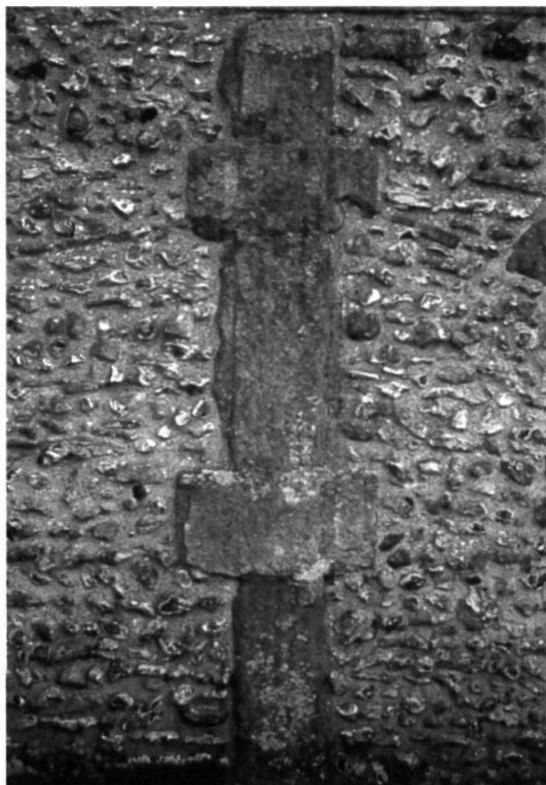
Fig. 3 The remnant pilaster strip on the N. nave wall of St Mary, Breamore in which a number of the stones exhibit cut backs: these are described in the text. Stones 1. and 3. are orientated BVFB. The pilaster is 290 mm. wide.

The partial pilaster strip on the N. nave wall was figured by Fletcher and Jackson (1945) and Green and Green (1951). The same pilaster was selected by Brown (1903, 88) to be illustrative of cut back 'flat slabs' ('short' stones), to meet in his belief, 'a stop for plaster'. Brown failed to note that the cut back stones also included a 'long' stone in the long and short style of the pilaster, and that on one of the two 'short' stones the 'cut back' was but a minor incision in the stone; the working of the stone probably being only decorative (Potter 2006). The Upper Greensand stones, however, exhibit Anglo-Saxon workmanship (Fig. 3):

5. 'Long' stone, cut back, E. side, orientation uncertain
4. 'Short' stone, cut back both sides, orientation uncertain
3. 'Long' stone, cut back both sides, BVFB
2. 'Short' stone, incipient cut back, W. side, orientation uncertain, cement covered
1. 'Long' stone, not cut back, determines the cut back width of higher stones, BVFB Pedestal, orientation uncertain

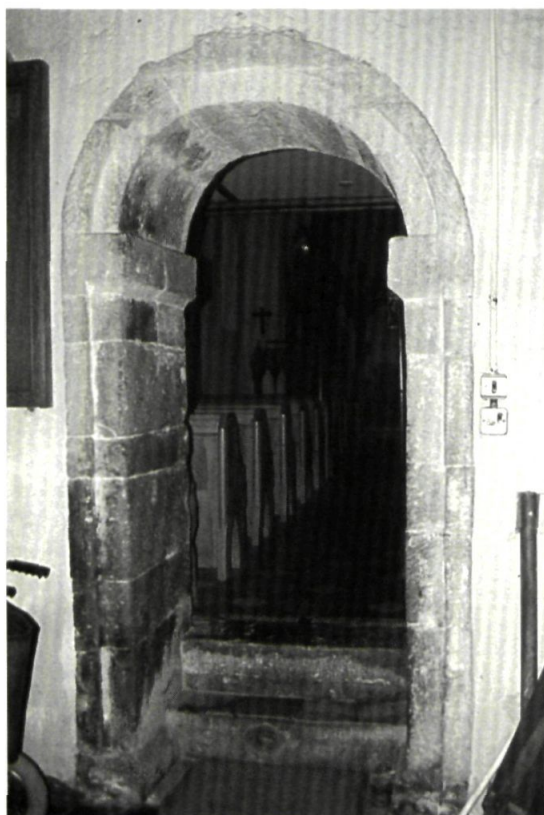
Fig. 4 The W. nave doorway of St Swithun, Headbourne Worthy, here viewed from the porch (from the W.), exhibits jamb stones placed 'Escomb fashion'. These Quarr Stone blocks are also orientated with their bedding either BVFIA (generally the 'long' through stones) or BH. The mutilated, but famous, rood occurs above this doorway.

The walls of Headbourne Worthy church are principally of quarried flints with occasional specific use of rocks such as Quarr Stone and later Caen Stone and Lower Chalk. Quarr Stone is used in both the Anglo-Saxon pilaster strips and quoins, but additionally in the font bowl, and in the nave W. doorway (Fig. 4), which is set 'Escomb fashion' and with the stone orientations BVFIA and BH. Nisbett (1894, 314) observed that some of the Quarr Stone blocks at this church were 'placed in an upright position', this now being recognised more than a century later as an Anglo-Saxon tradition. The jamb stones of the W. doorway illustrate this tradition further, being set only BVFIA and BH.

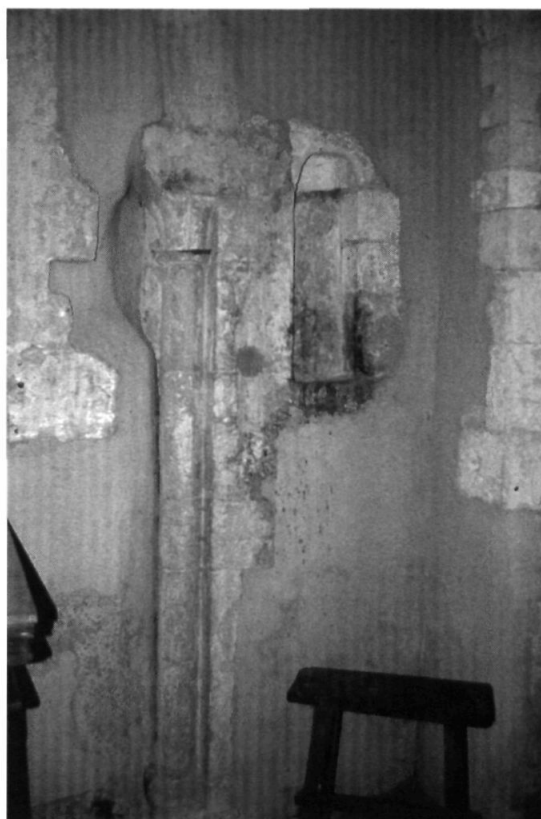
Fig. 5 Although the chancel arch of All Saints, Little Somborne was modified in the 12th century and subsequently blocked, it seems probable that the arch jambs and pilasters, carved together from individual blocks of Quarr Stone, represent traces of the original Anglo-Saxon structure. The S. jamb, shown here, has its stones set BVFIA in Anglo-Saxon style.

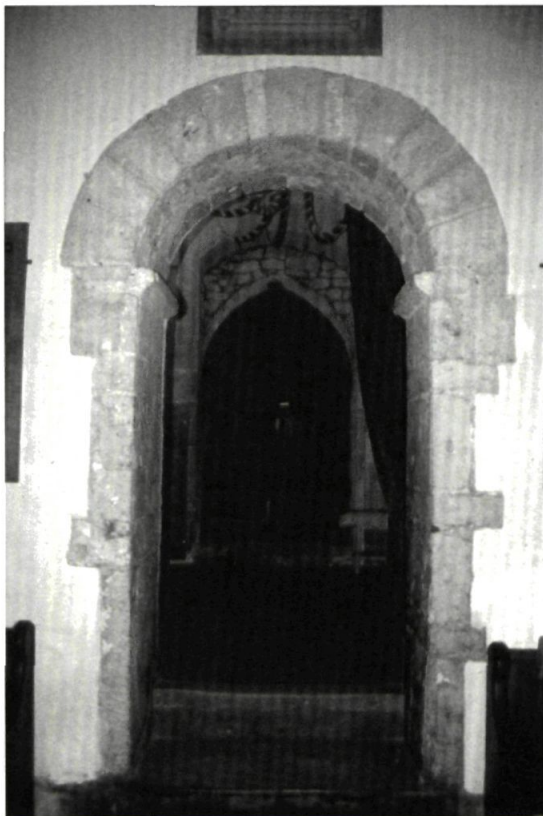
Fig. 8 The west nave doorway (tower arch) of St George, Arreton, viewed from the nave. The jambs built of Quar Stone are placed in 'Escomb style', with the longer upright stones inserted with their bedding planes facing into the arch (BVFLA) in Anglo-Saxon style.

All stones are of Quarr Stone, with the repair completed in more orthodox Bembridge Limestone. Each stone is a through stone with the exception of positions 1, 3, and 7 in the N. jamb where two stones complete the width of

the jamb. The jambs are set 'Escomb fashion' and the arch, on its W. face, consists of 12 well-constructed voussoirs.
