THE WATERMEADOWS AT THE ITCHEN VALLEY COUNTRY PARK NEAR EASTLEIGH, HAMPSHIRE

By HADRIAN COOK and KEVIN YOUNG

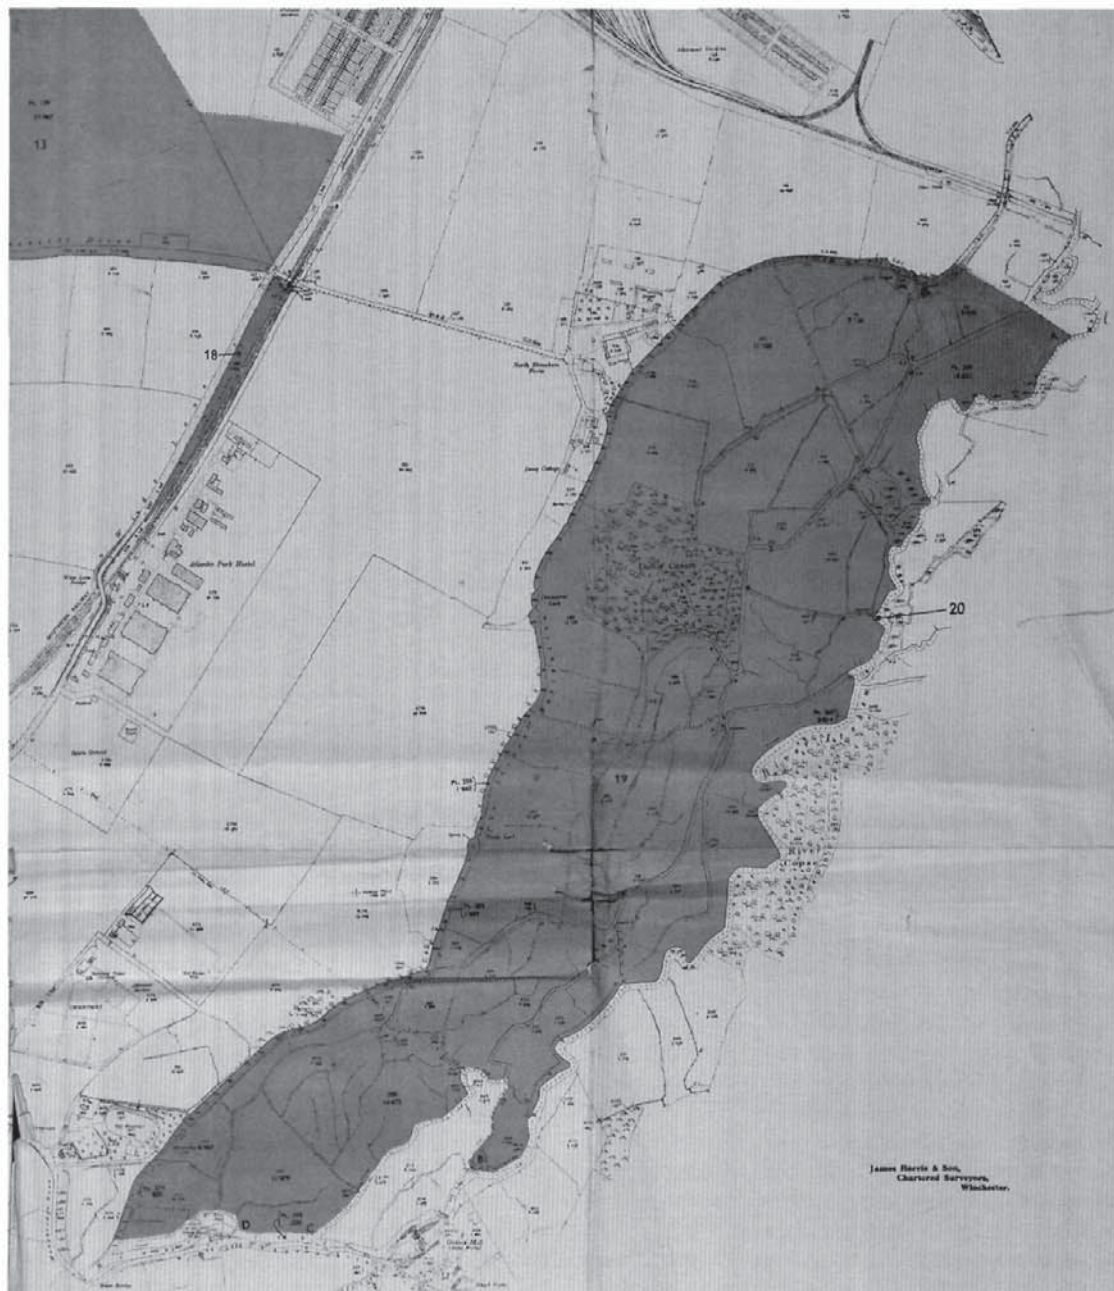
Fig. 3 Deed of sale document for North Stoneham Farm from 1953. ©Hampshire Public Records Office

One elderly local resident recalls hay crops being taken off in the 1940s and 1950s, although there is no evidence for irrigation continuing into the twentieth century. A mid-twentieth century document (Fig. 3) is the 'Particulars and conditions of sale of the freehold agricultural estate known as the North Stoneham estate extending to about 1357 acres' from 1953 (Hampshire Record Office, 159M88/1128). This describes the Estate's 'Lot 19' as 'a valuable block of water meadows', while Lot 20 is 'Valuable Fishing rights in the River Itchen'. The area involved is comparable to IVCP, less most of the river banks on the eastern side.

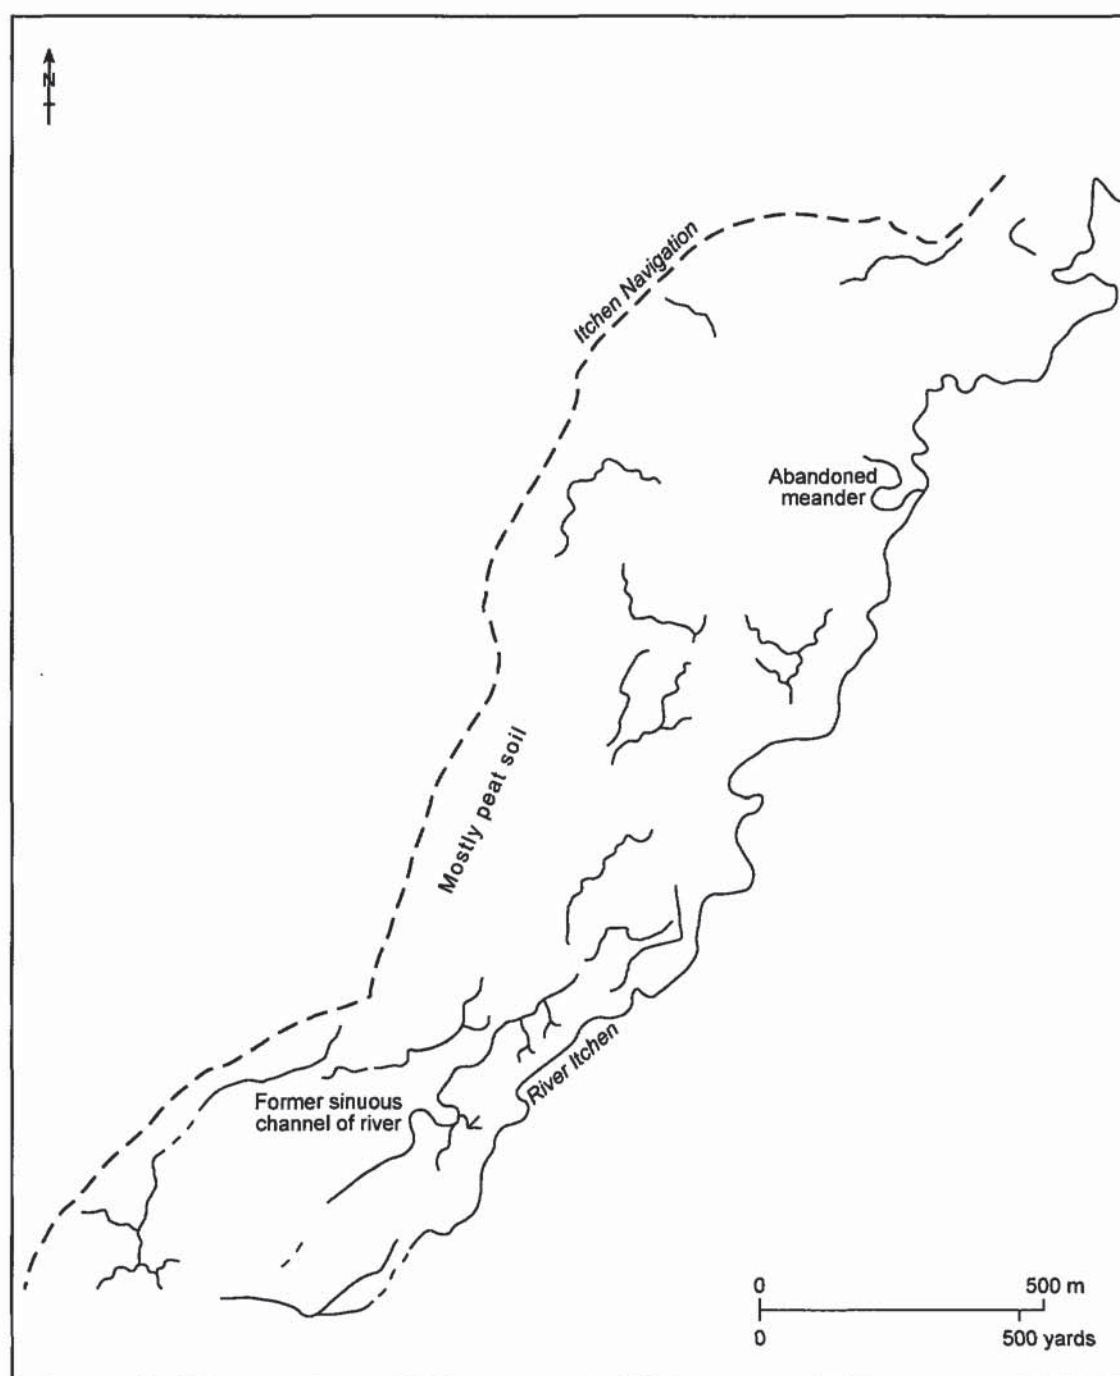
Fig. 5 Sinuous channel elements in the landscape at the Itchen Valley Country Park, identifiable from ground survey, modern mapping and air photography.

To the north of this stretch, around SU 46251700, is a clear abandoned meander feature that is incorporated in a main carrier inlet to the system (Fig. 5). The River Itchen at IVCP may thus be in a transitional state between anastomosed and multiple-channel. This complex floodplain geometry is the basis for the layout of the watermeadows. Cook (2008) has reviewed the possible causes of switches between a single meandering channel to multiple forms for Wessex alluvial valleys and suggests multiple channels may arise from increased soil erosion and channel sediment loading since pre-historic times, although a tendency to multiple channel may also be inherited from the late Pleistocene. Then true braided rivers associated with valley-fill gravels, are likely to have dominated the valleys (Gibbard & Lewin, undated). However, the modern interplay between meandering and multiple channel geometries reflects adaptations in channel form relating to Holocene climatic, hydrological, soil vegetation and human factors. A lower valley environment is vulnerable to up-catchment changes in

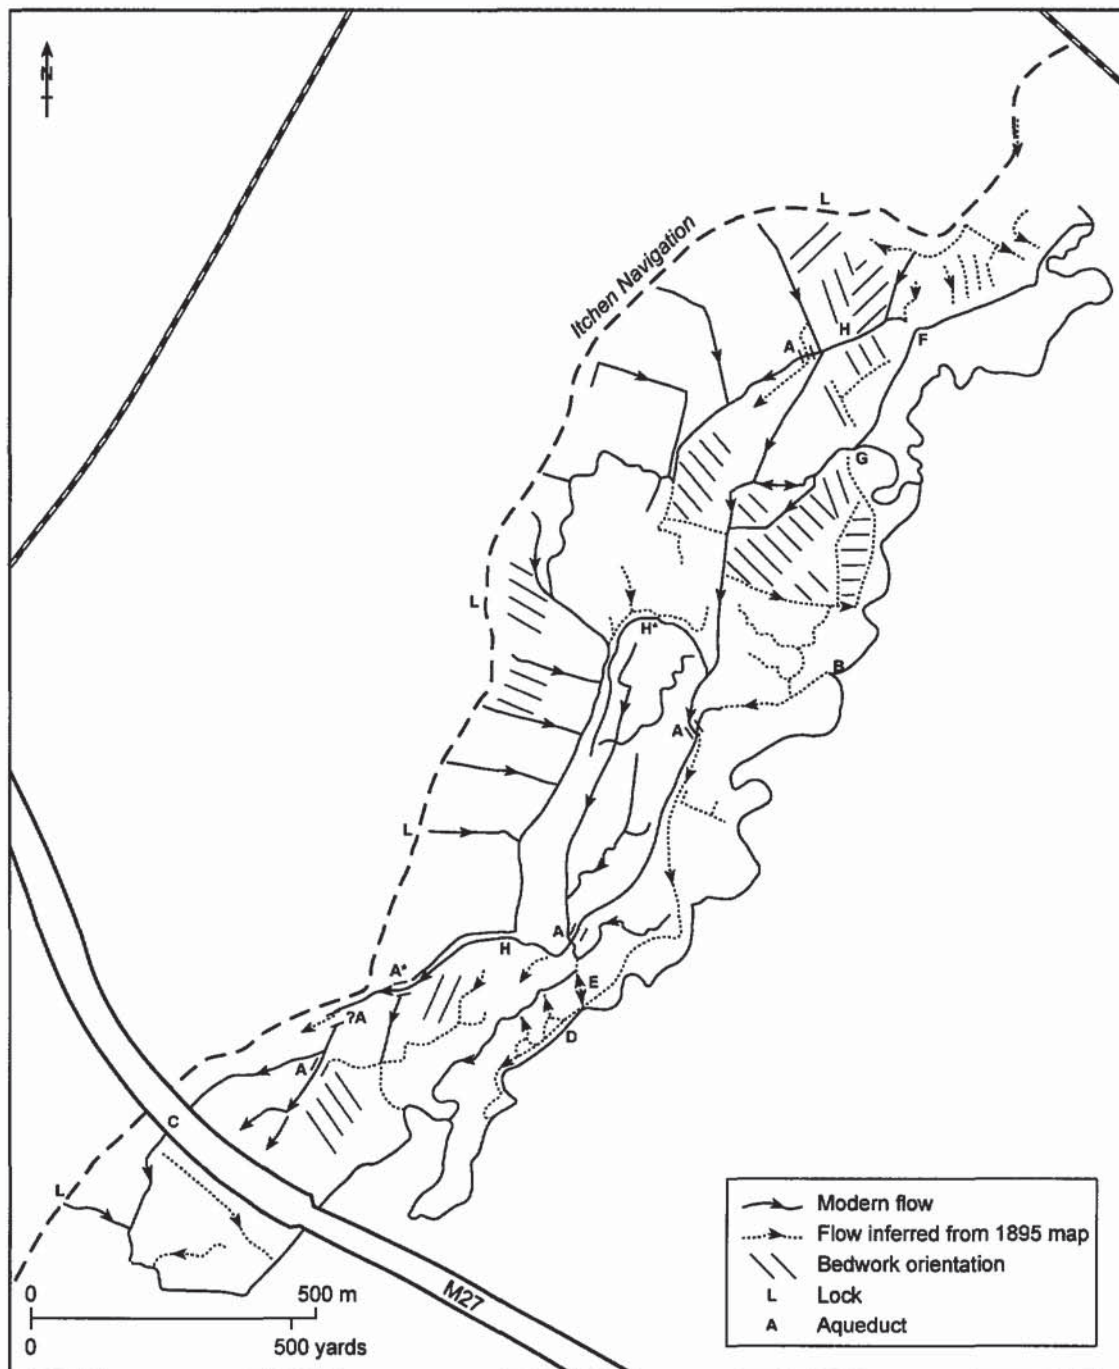
Fig. 6 Speculative reconstruction of watering arrangements at Itchen Valley Country Park watermeadows. See text and the figure key for explanations.

Figure 6 shows a tentative reconstruction of the system. The modern channels showing direction of flow are differentiated from those re-constructed or interpreted from late nineteenth century mapping (at a scale of 1:2,500). Only the orientation of clear bedworks is shown from ground evidence and from that of the 1:5,000 aerial photograph. While most of the eastern and southern meadows are directly supplied from the River, the meadows on the

These arise near the Fish House (indicated on the 1:2,500 map) entering the meadows via a sluice at point F on Figure 6 (SU 46301730). The meandering stretch of the river south of point F appears narrower on the 1896 map, suggesting adjustment to water taken off for the meadows. There was a second main carriage leading off the river at point G (SU 46211708), this remains the major, and sometimes problematic, supply. A third carrier supplies the meadows from point B (SU 46191669). These carriers fed approximately 70% of the system; originally involving aqueducts (marked 'A') that conveyed water as far as the SW corner of the Park beyond the modern M27 (point C). A* is illustrated in Figure 7; although in other instances it is less than clear whether a

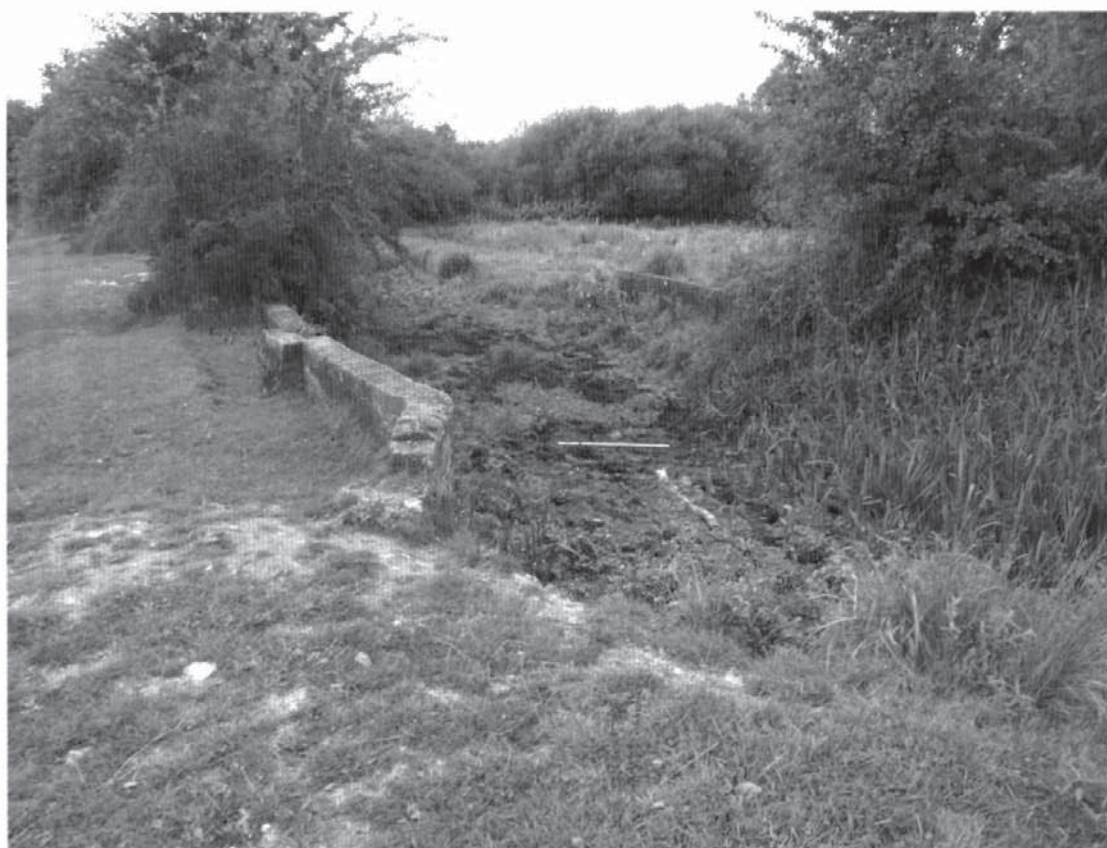
Fig. 7 Aqueduct structure and hatch housing (photo H. Cook)

Figures 7 to 11 show respectively: Intact aqueduct and hatch housing (A* in Fig. 6) at SU 45431613, the hatch pool complex (northernmost 'H' in Fig. 6) at SU 46151724, a bridge and hatch housing at SU 45771656, a hatch structure (H* in Fig. 6) at SU 45821674 and concrete hatch housing (probably for a

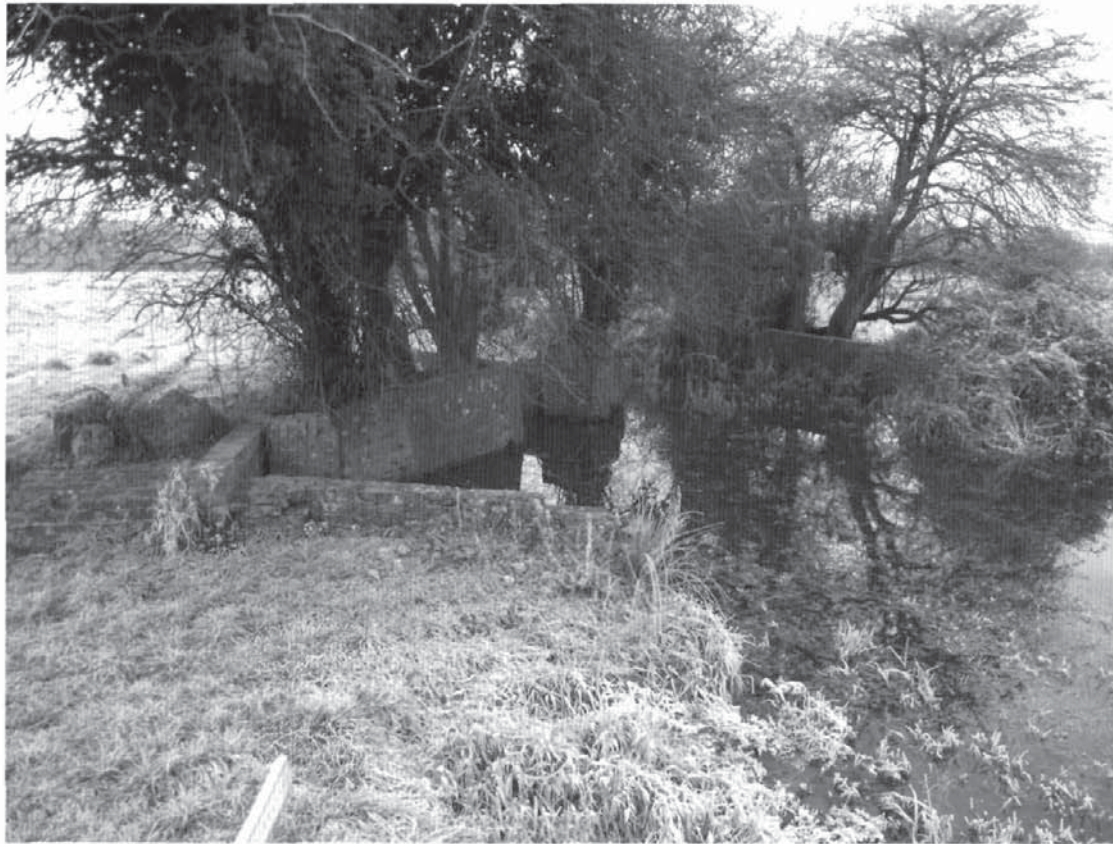
Fig. 8 Hatch pool complex (photo H. Cook)

Main hatches, such as those marked H (see also Figs 8, 9 & 10) would have provided main controls for secondary carriers (now

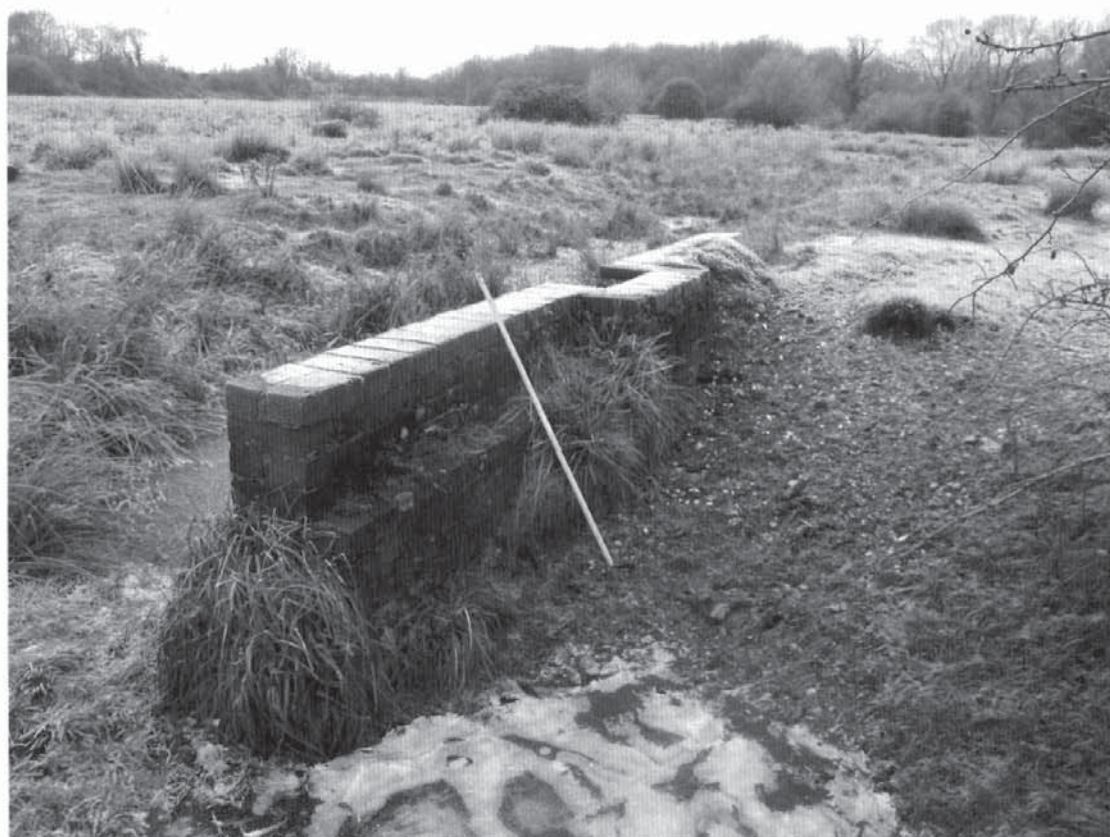
Fig. 9 Hatch in bridge (photo H. Cook)

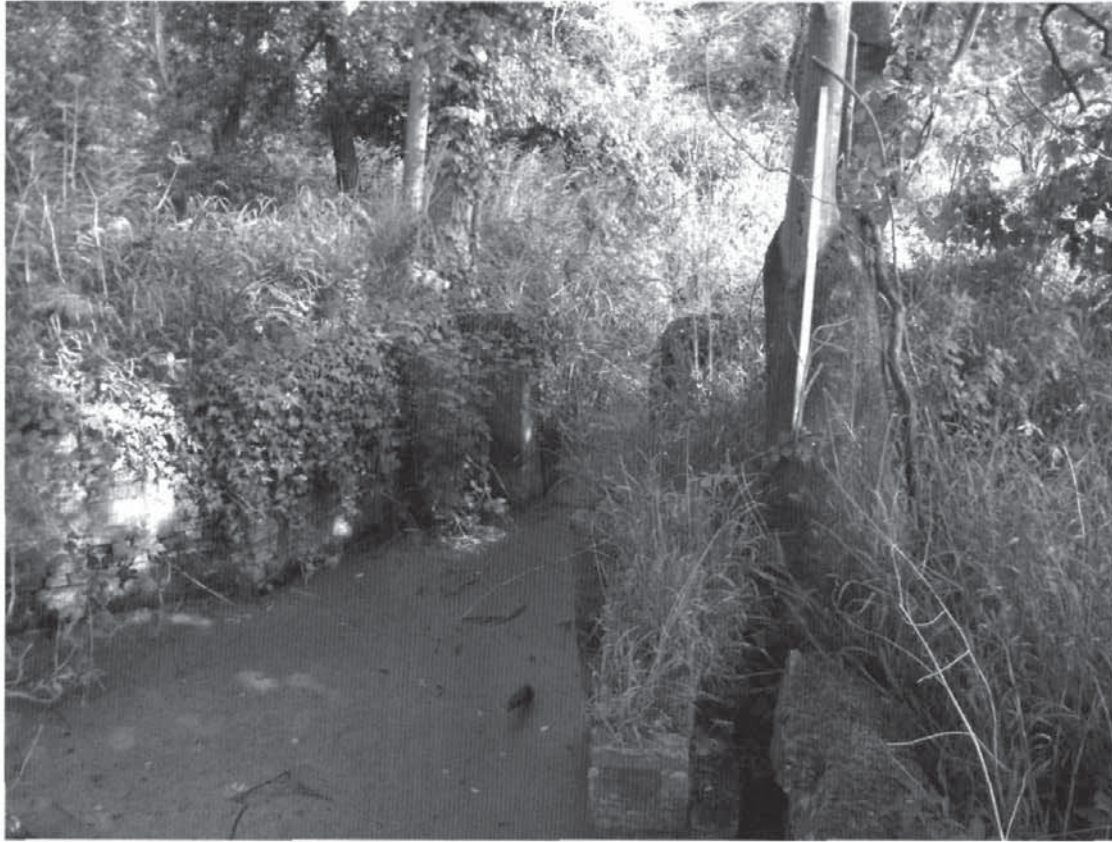
Fig. 10 Hatch structures in woodland (photo H. Cook)

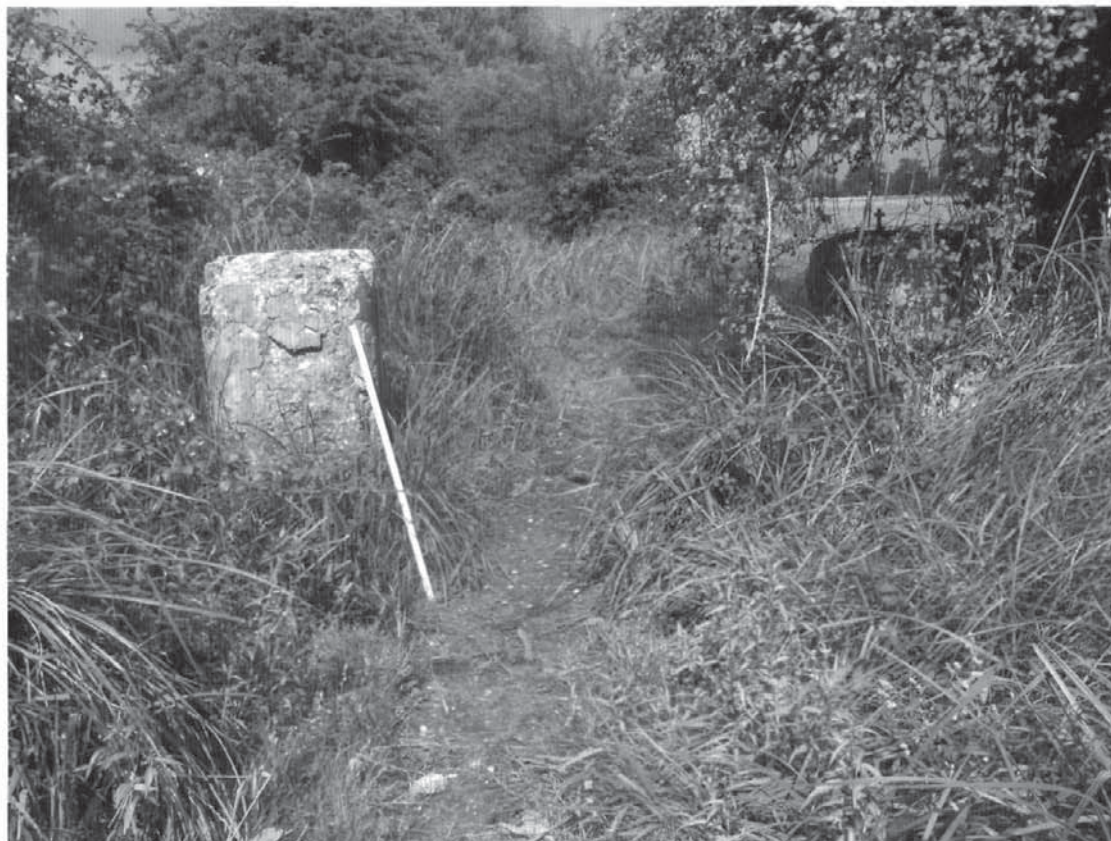
Fig. 11 Concrete (double) hatch structure

double hatch) ('E' in Fig. 6) at SU 45741612. Figure 12 shows extracts from the 1:2,500 Ordnance Survey, some of which relate to the photographs.
