**BASING HOUSE
HAMPSHIRE
EXCAVATIONS
1978 -1991**

Hampshire Field Club & Archaeological Society: Monograph 10

Basing House
Hampshire: Excavations 1978 -1991

By David Allen & Sue Anderson

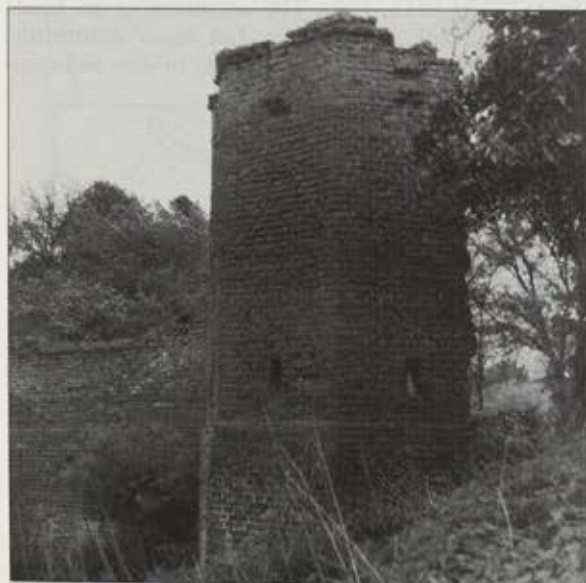
Fig 16 'The Turret', once part of the curtain wall, now isolated on the north bank of the dry canal.

battlements. It is composed of red brickwork in English bond, with a blue diaper pattern above a high plinth. Another short section of wall is attached to the west side of Turret Cottage. The tower, and its attendant walls once formed part of the outer circuit of Basing House (shown as a dashed line on Fig 9). Large sections of this wall have disappeared with the passage of time, but the surviving fragments and occasional glimpses of foundations show what a substantial structure it was. (For a description of the curtain wall in the Walled Garden, see p21.)

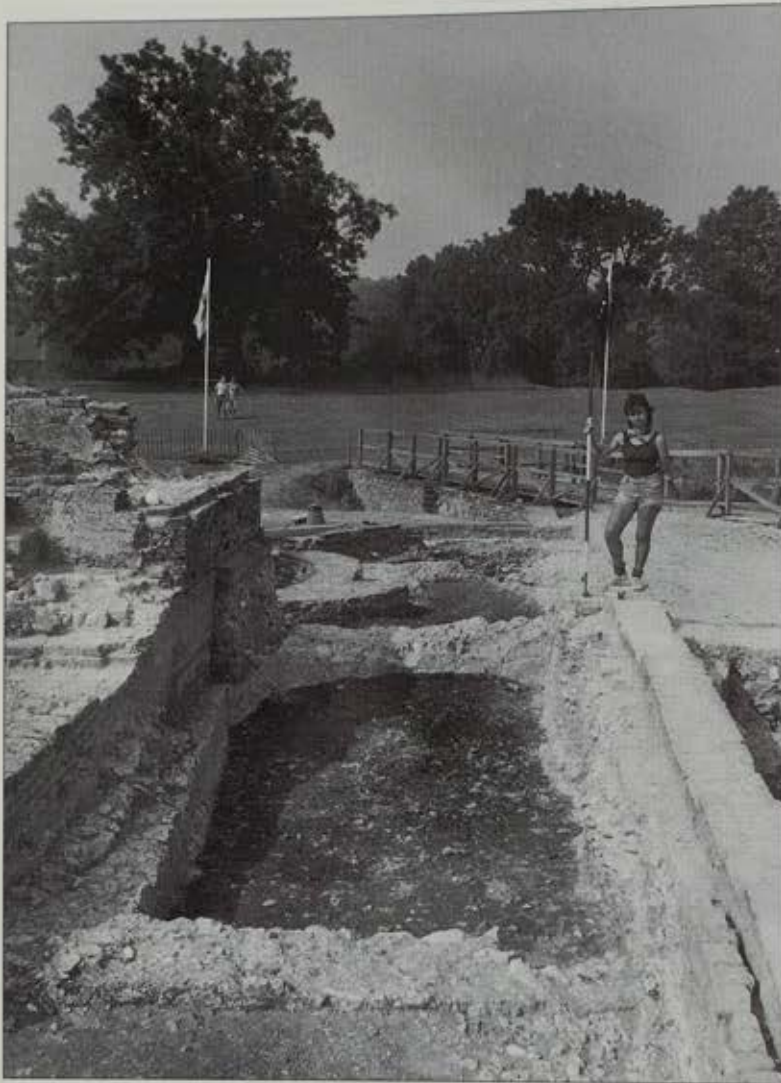
Fig 29 The Phase II chalk building viewed from the south after removal of the floor.

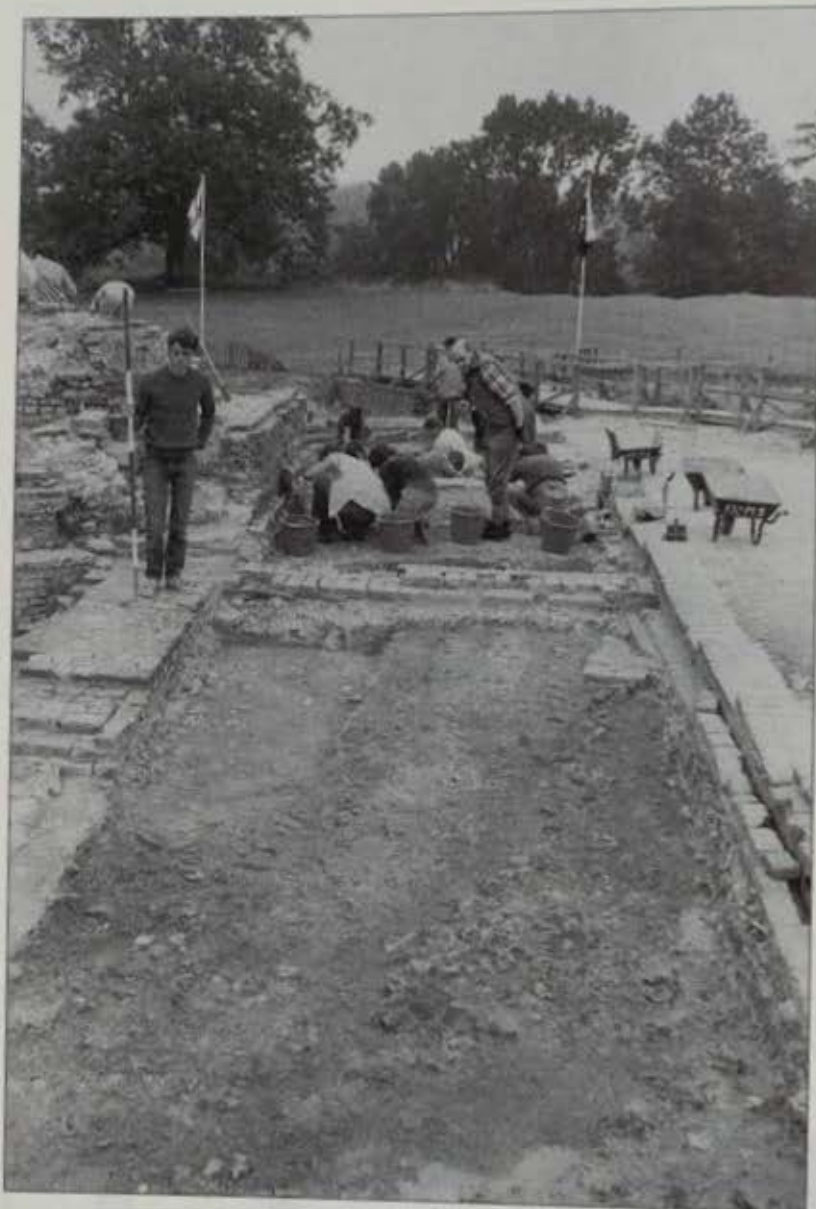
Fig 33 The Phase IV west gatehouse viewed from the south.

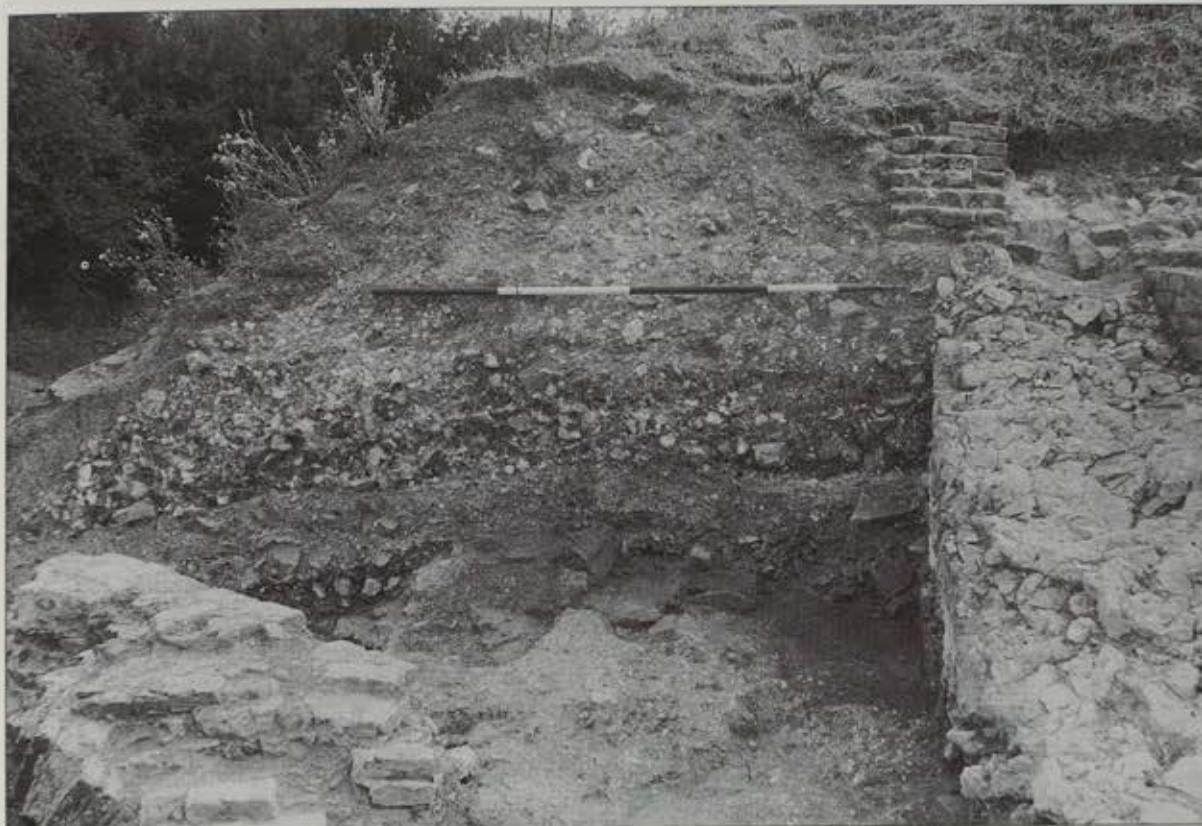
Fig 40 View of the Ringwork Terminal East showing the tips of subsoil 955 (the 0.7m deposits below the ranging pole) which may represent Civil War period strengthening.

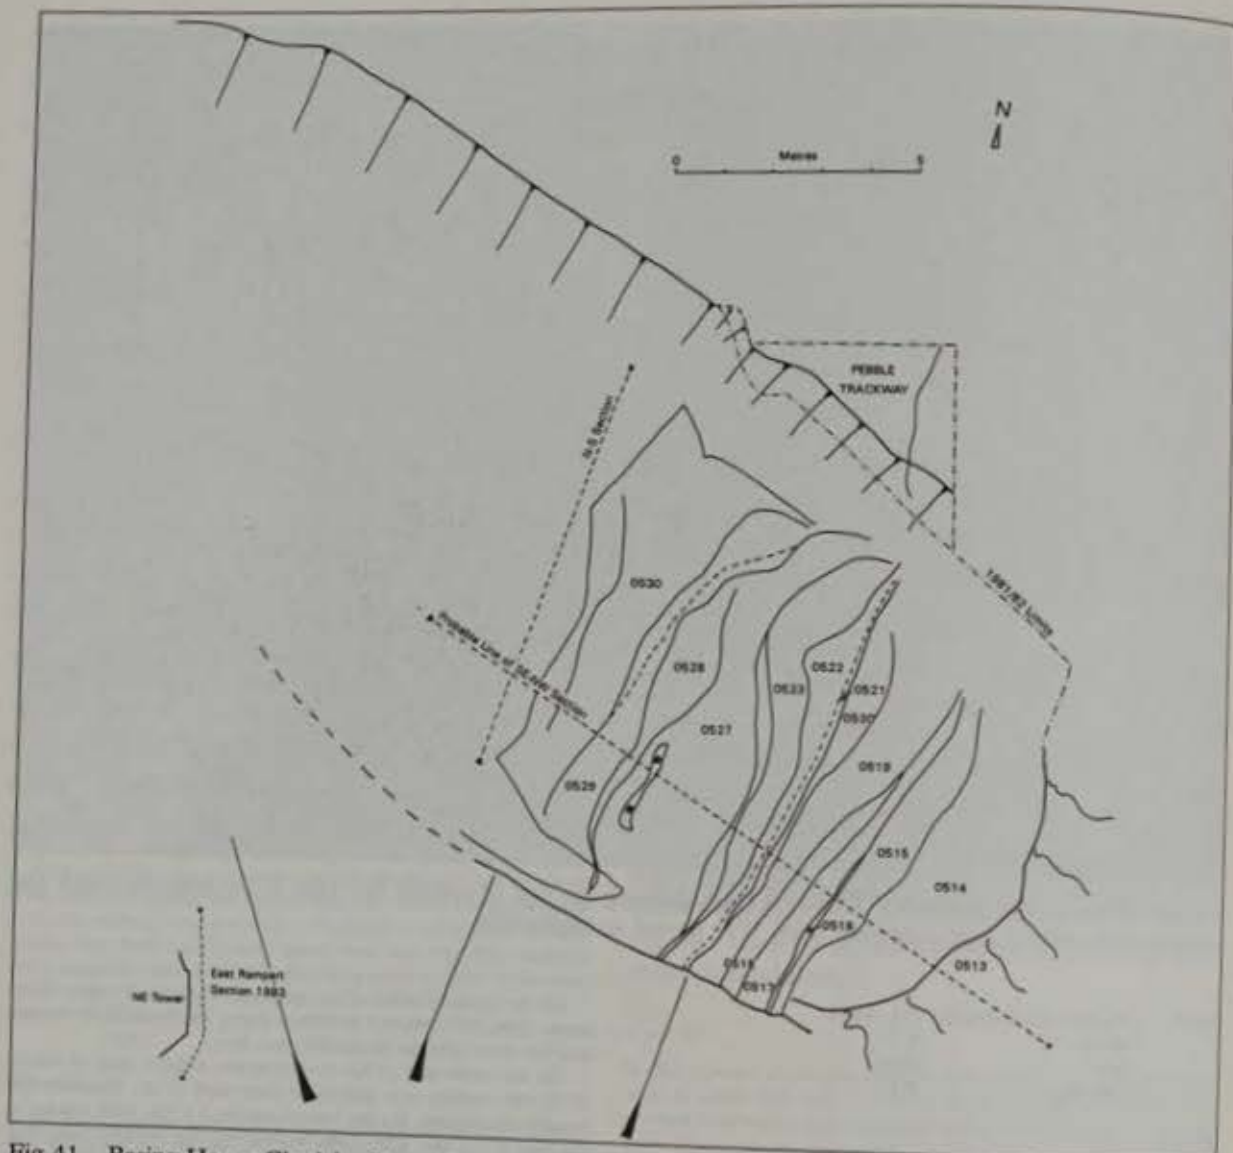
Fig 41 Basing House Citadel – Plan of East Ditch Excavation showing tip lines and relationship to Gatehouse.

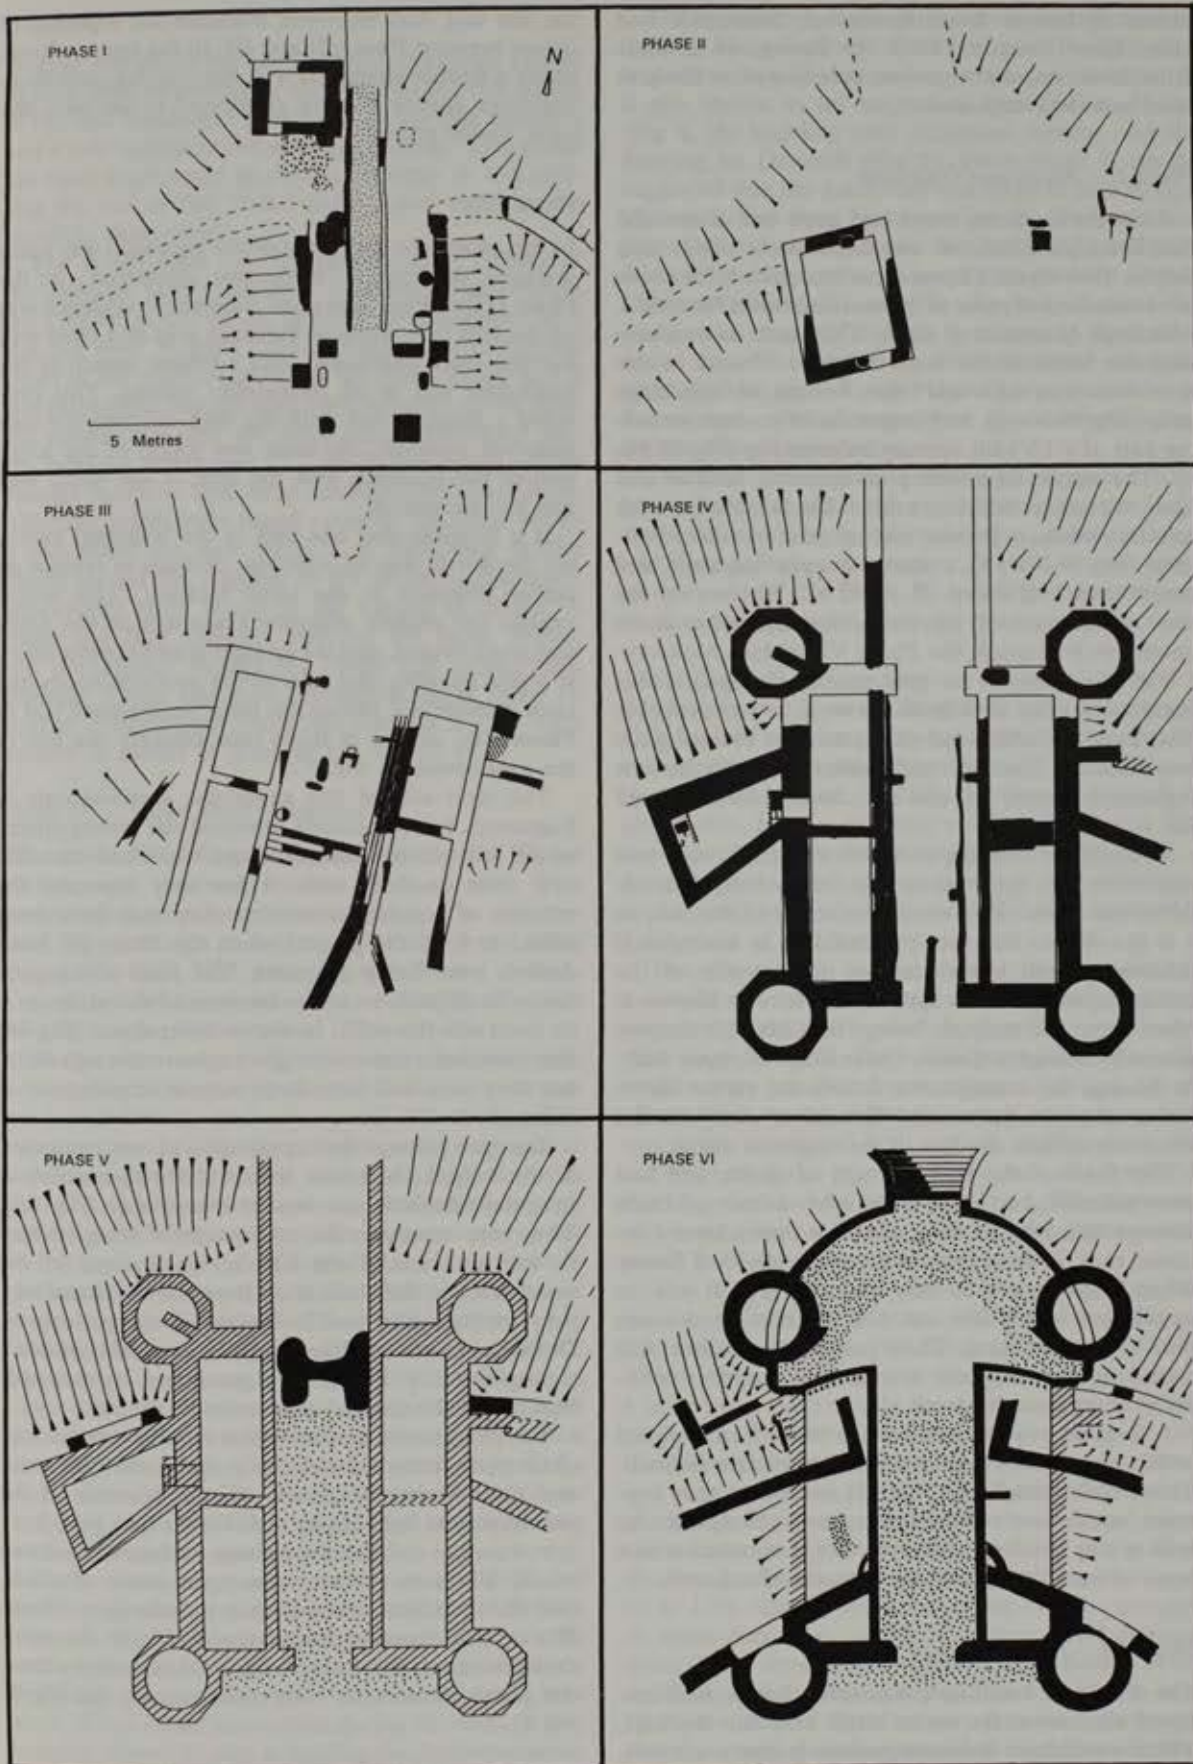
Fig 43 Citadel Gatehouse Interpretative Sequence.

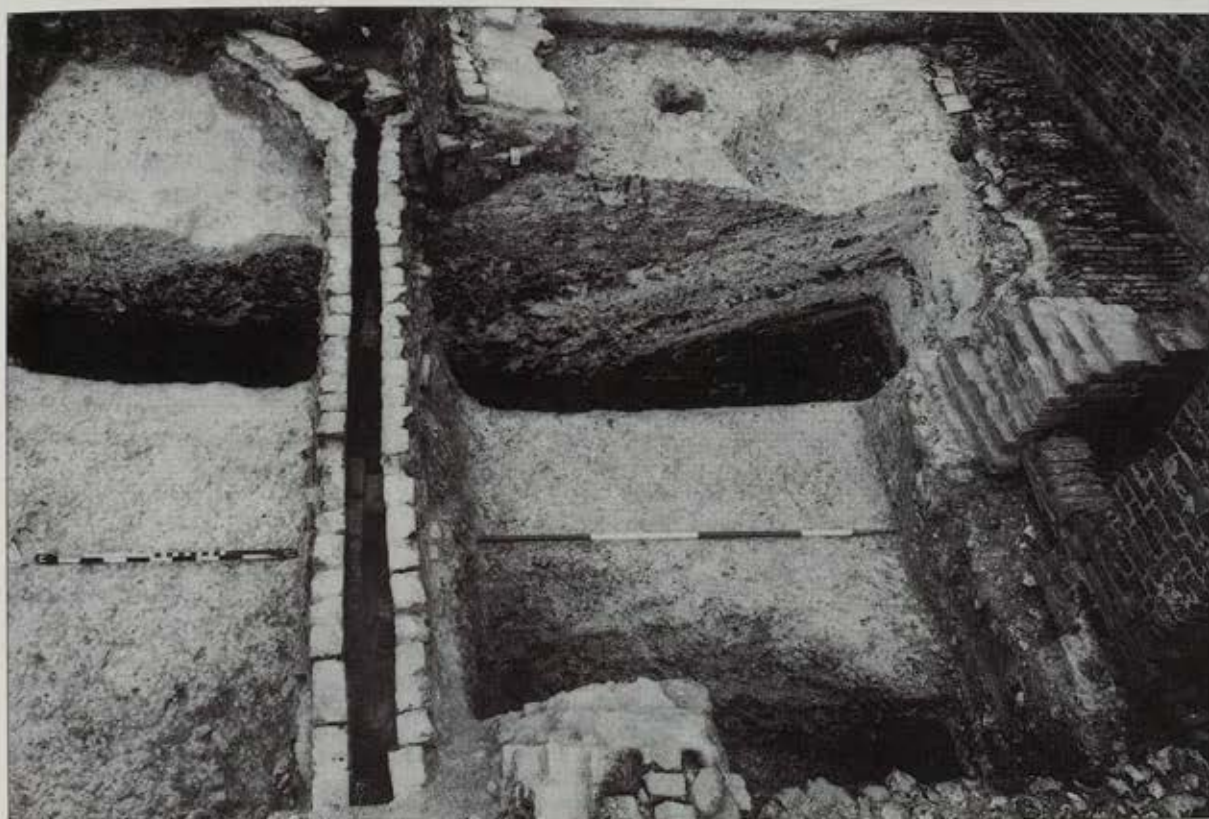
Fig 64 The Citadel Kitchen Area viewed from the north-east. A 3m length of boundary wall has been removed, but the Tudor drain remains in situ. The angled layers of the ringwork bank can be seen in the cross-section.

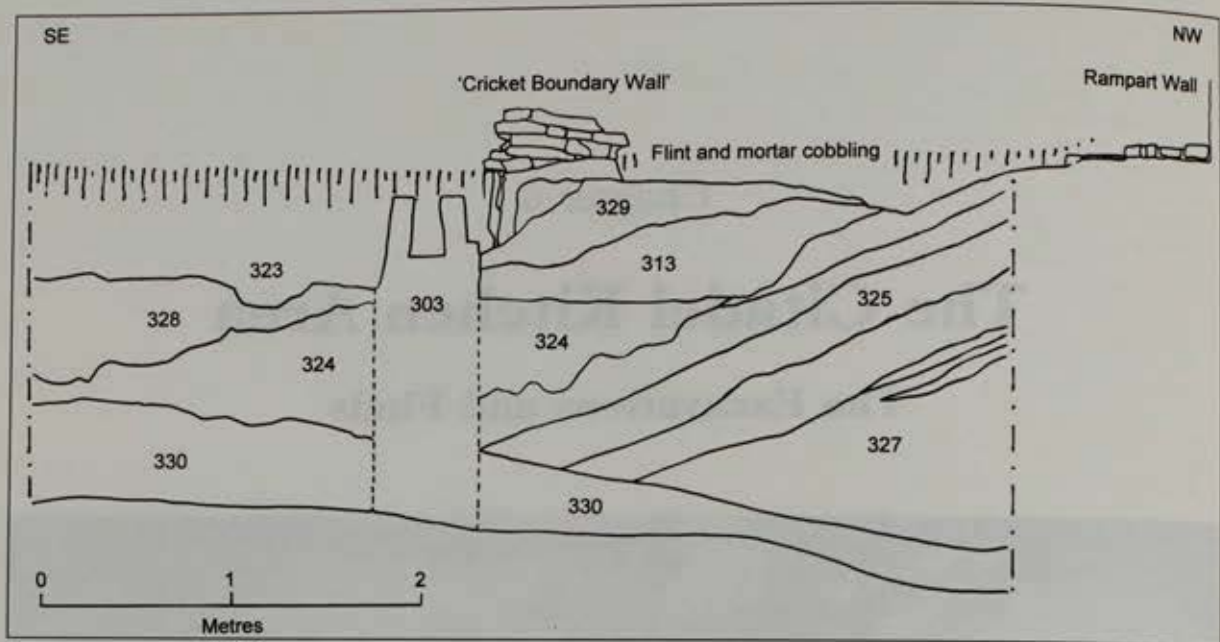
Fig 65 Basing House Citadel Kitchen Area 1980. Diagrammatic section showing the relationship of the medieval ringwork bank (325, 327) to the underlying brown clay (330) and the later features.

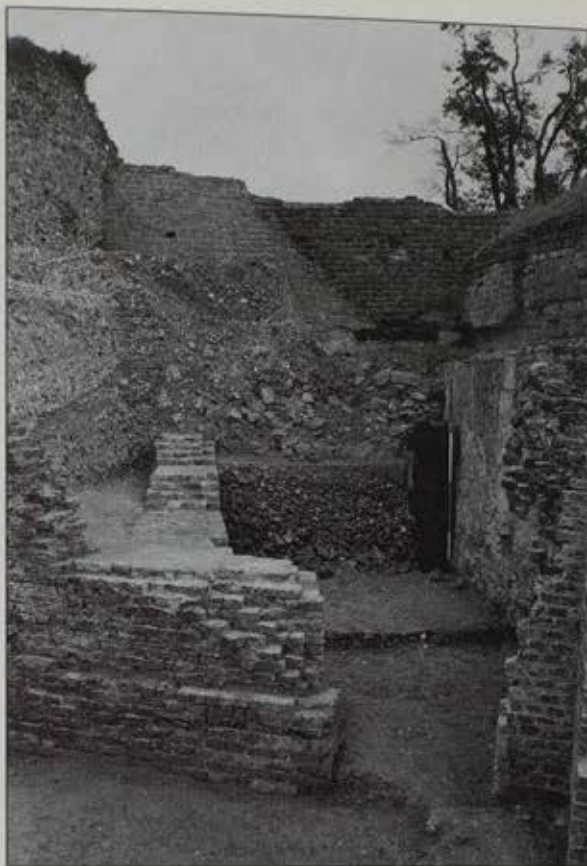
Fig 75 View from the interior showing the successive narrowing of the west end of the Postern Gate passage.
