# SELBORNE PRIORY

## Excavations 1953–1971

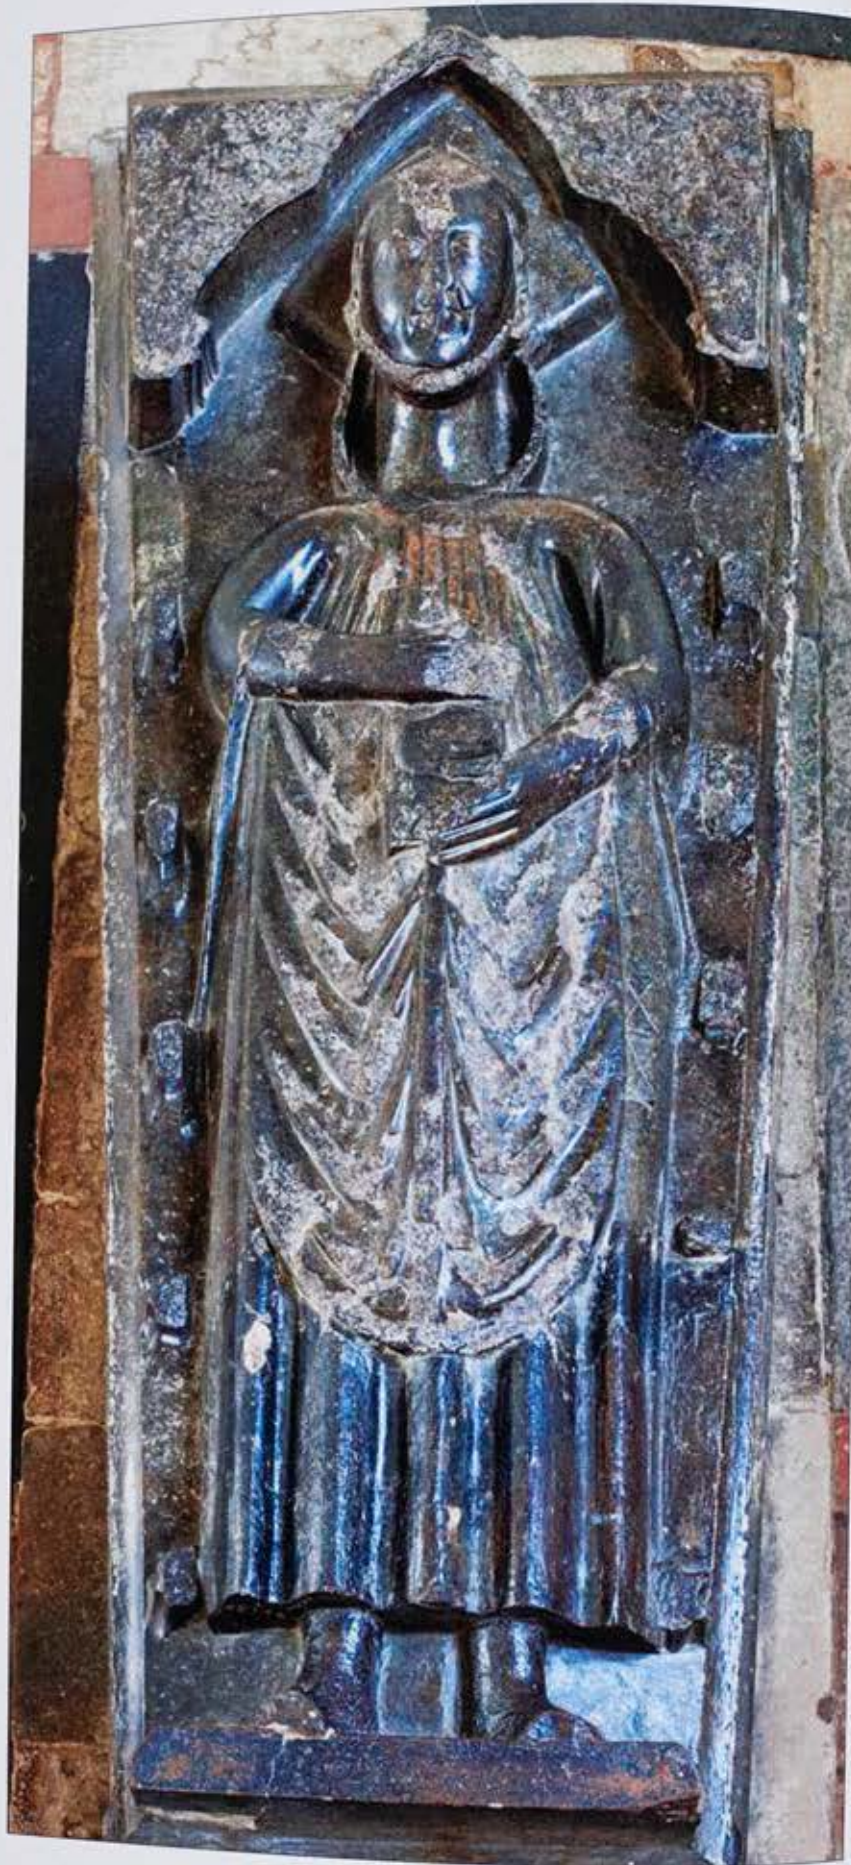
Bishop of Winchester  
either Geoffrey de Lucy 1189-1204  
or Peter des Roches 1205-1238  
founder of Selborne Priory in 1233  
Effigy in Winchester Cathedral  
(John Crook)

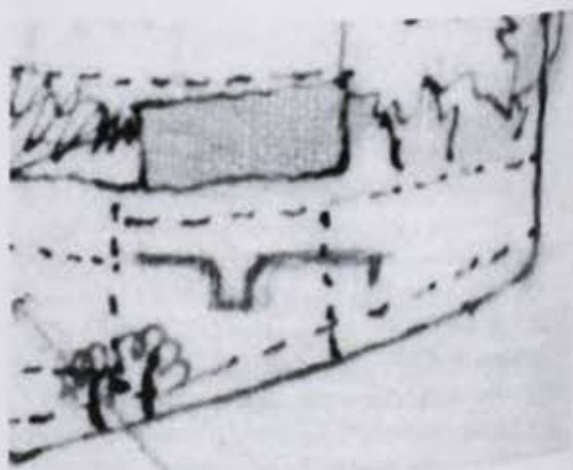
Figs 3.9, 3.10 Details of buttress, barn and field from RT Gunther's 1905 sketch of Bowdler Sharpe's 1901 excavations (Magdalen P233/2/MS2/1)

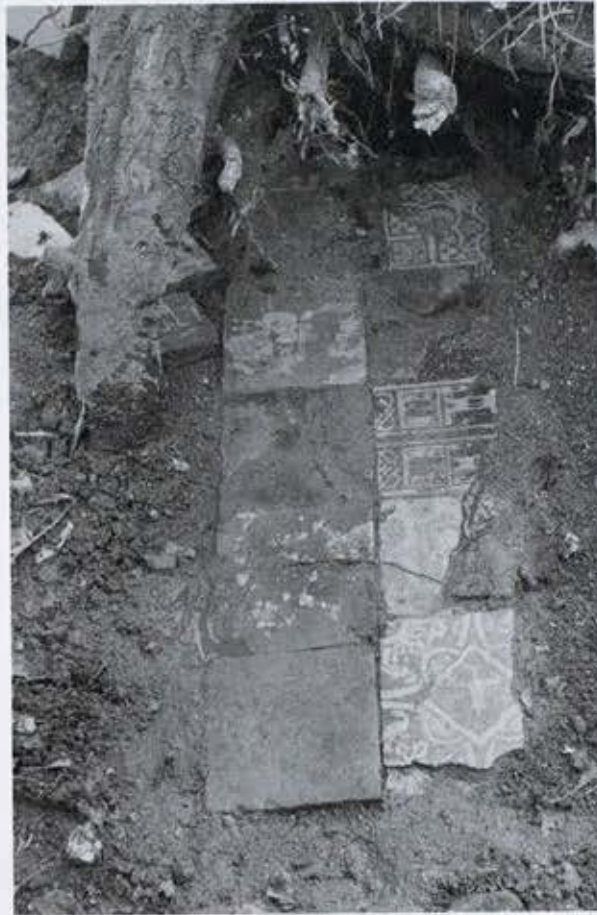
Fig 3.11 South transept: floor tiles *in situ*, 1963

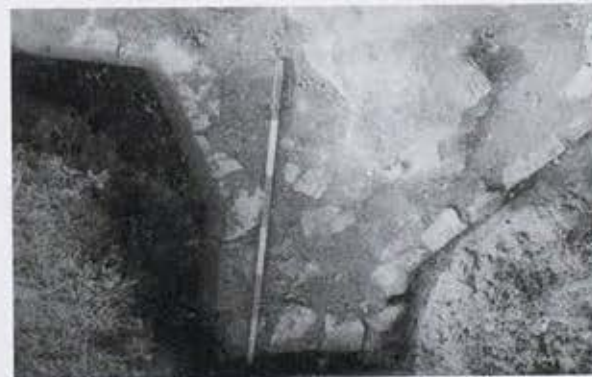
Fig 3.12 South transept: external buttress at south-east corner facing north, 1963

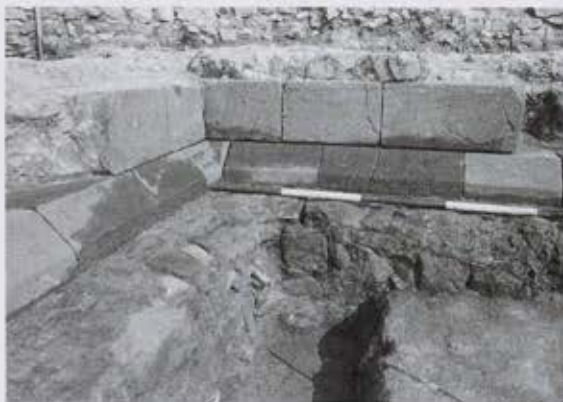
Fig 3.15 South transept chapels S1 and S2: footing, chamfered offset and wall face at external junction, trench 21 1971

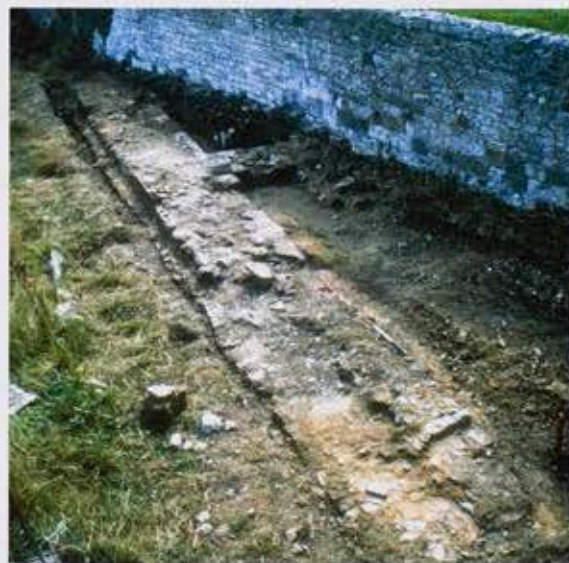
Fig 3.16 South transept chapel S1 cut by post-medieval farm wall, north-east corner facing south-east, 1968

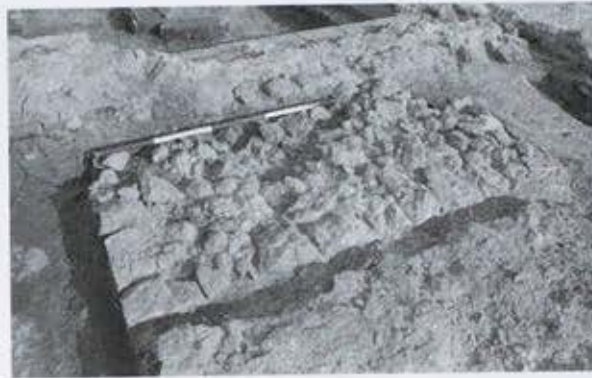
Fig 3.17 South transept chapel S2: altar base, 1971

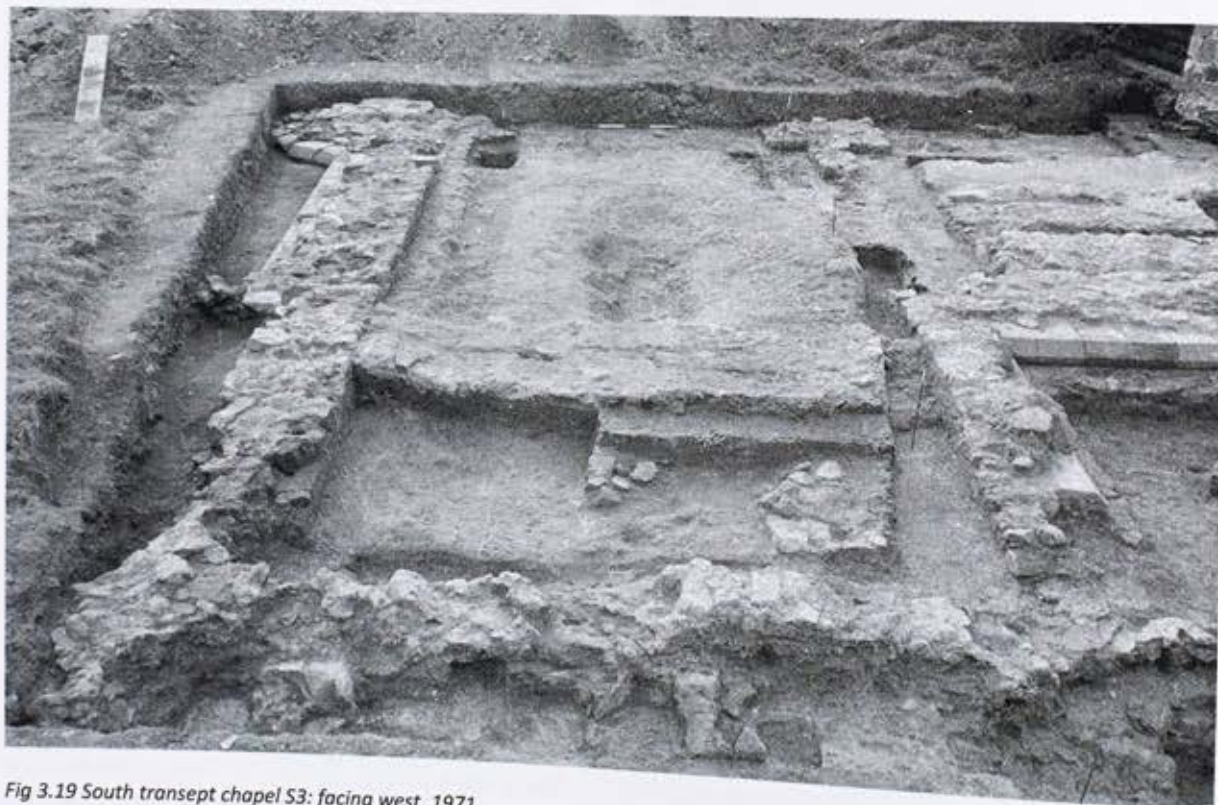
Fig 3.19 South transept chapel S3: facing west, 1971

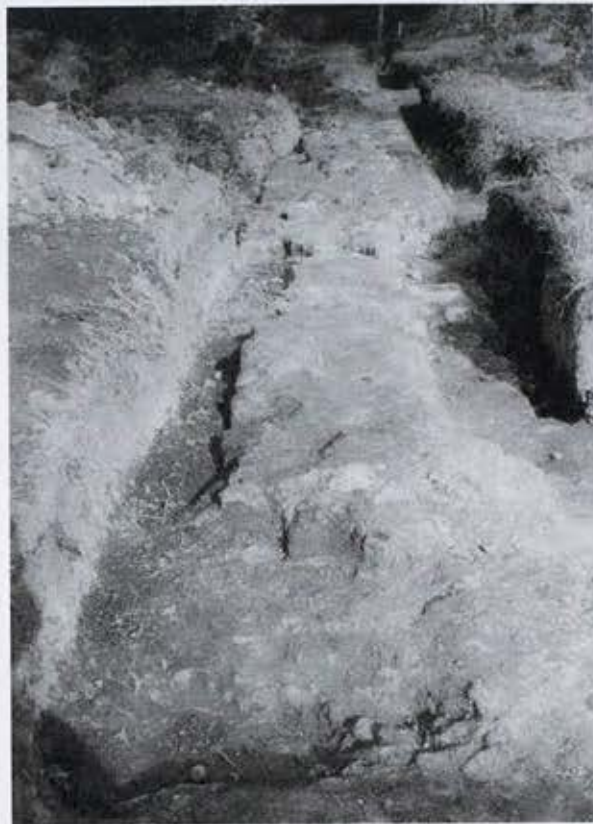
Fig 3.22 South transept chapels: south walls of S4 (foreground), south transept and chapel S3 facing east, 1963

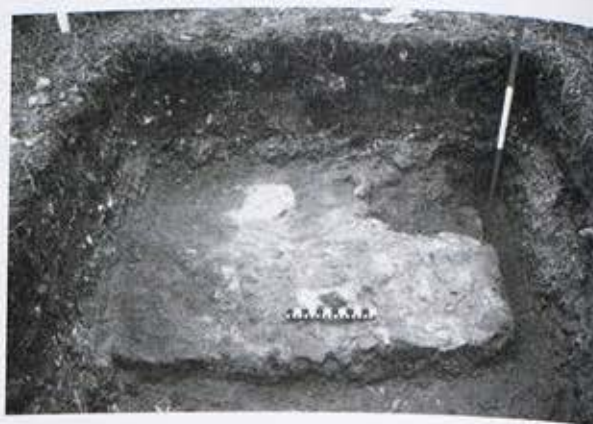
Fig 3.25 North transept chapel N1: north wall corner buttress facing south, 1969

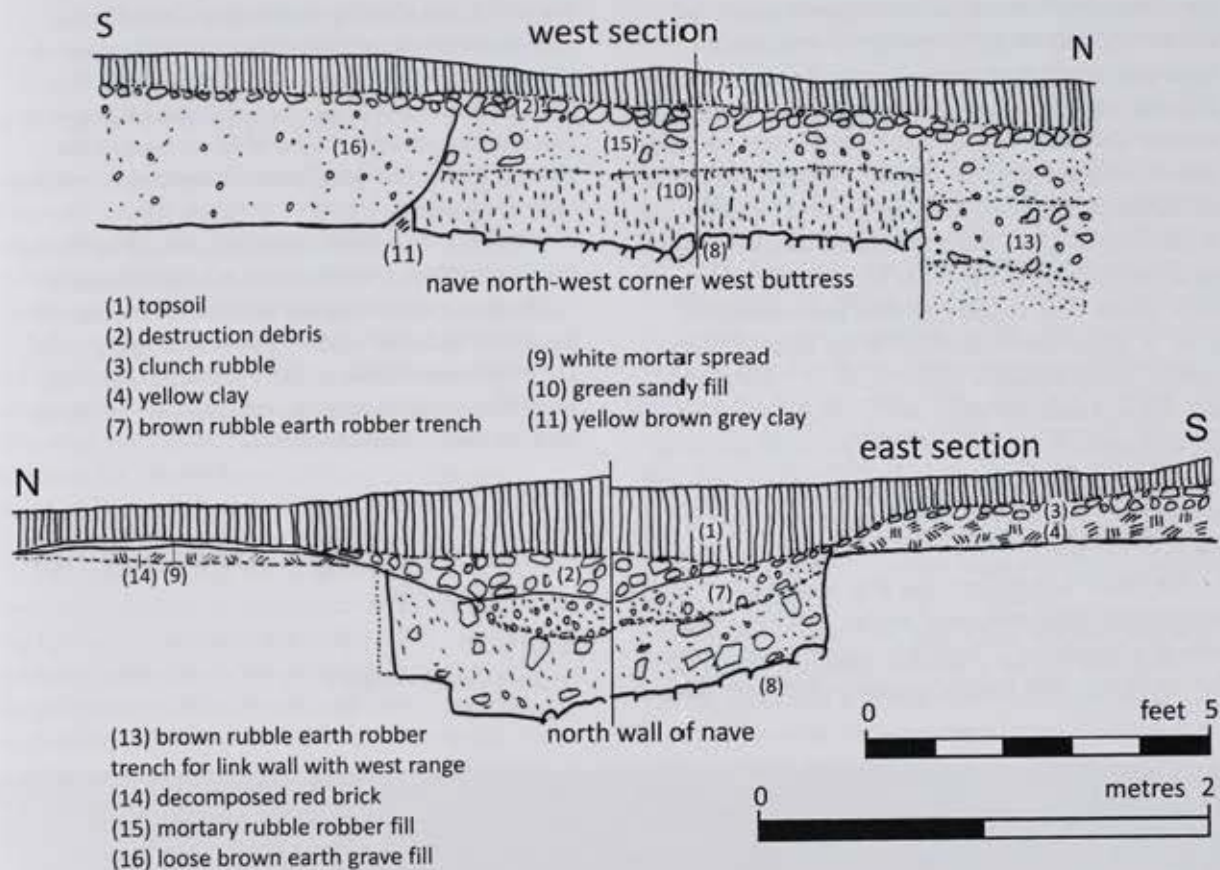
Fig 3.33 Nave: west and east sections, trench 6 1970

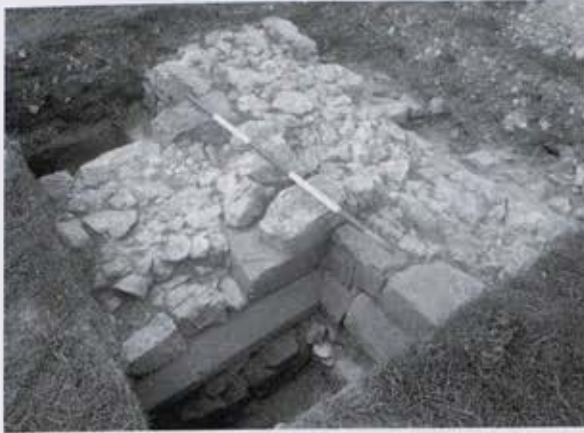
Fig 4.2 Sacristy: east wall at left, south wall of chapter house at right, beyond is east edge of internal sleeper wall, trench 4 1970

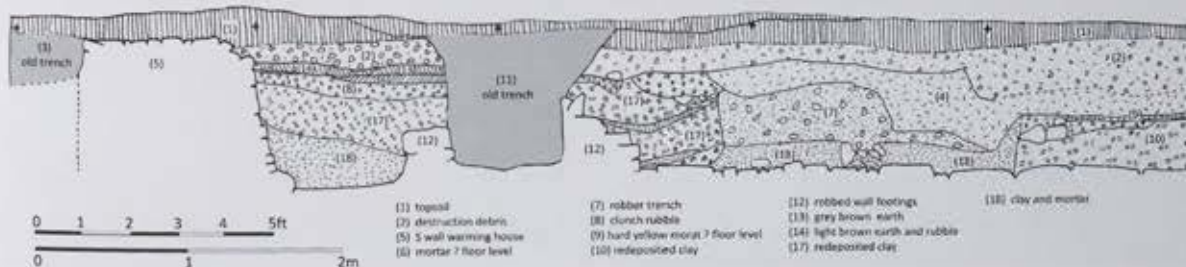
Fig 4.3 East section trench 23 1971

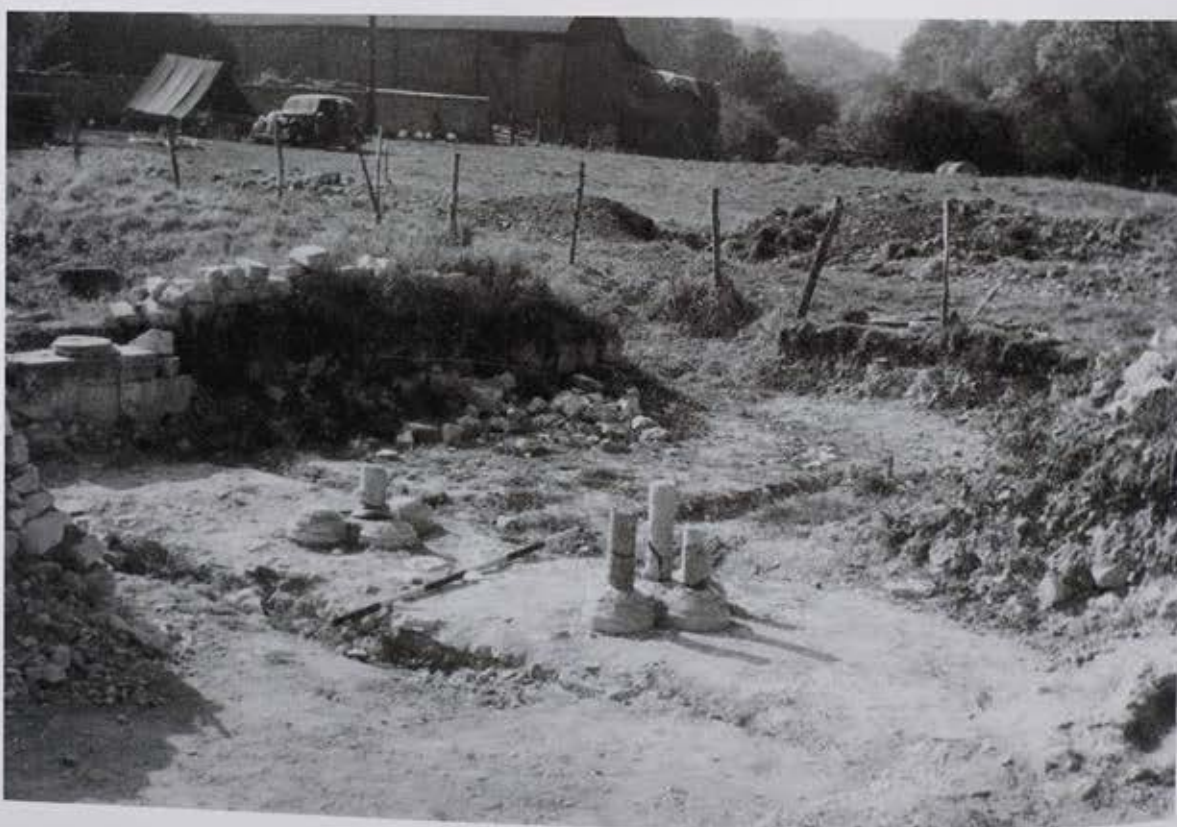
Fig 4.4 Chapter house: central sleeper wall pillar bases, facing south-west, 1958 (Edwin Plomer)

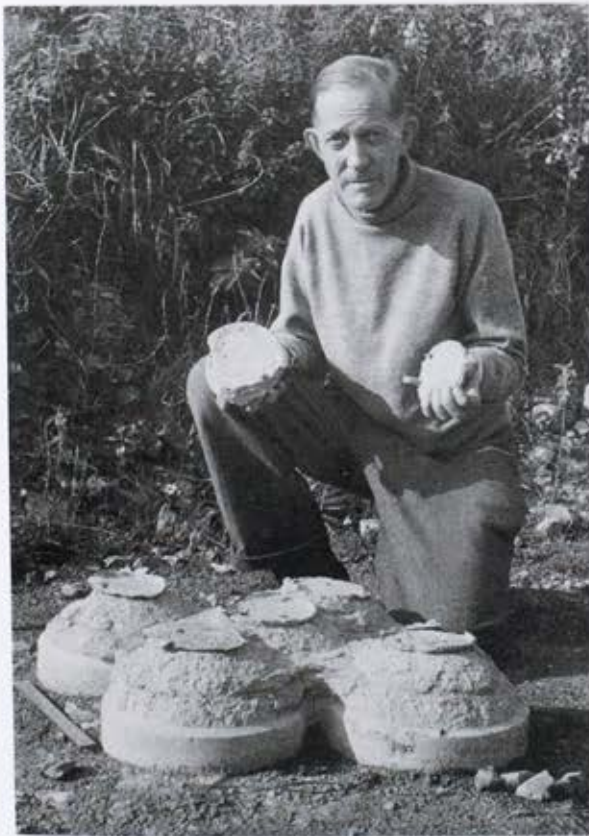
Fig 4.5 Chapter house: Rev George Knapp with linked columns and lead joints, 1958 (AV Porter)

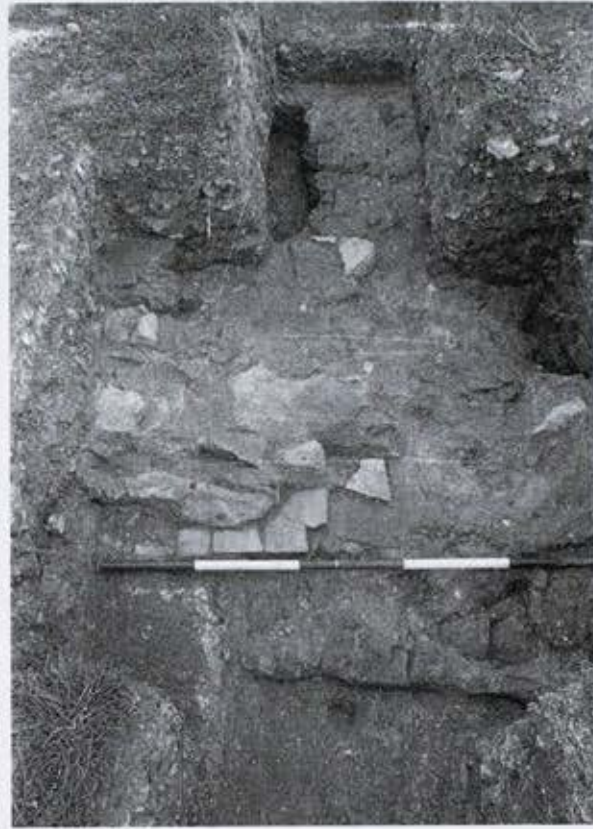
Fig 4.8 Warming house / inner parlour: east wall and buttress, facing east, 1970

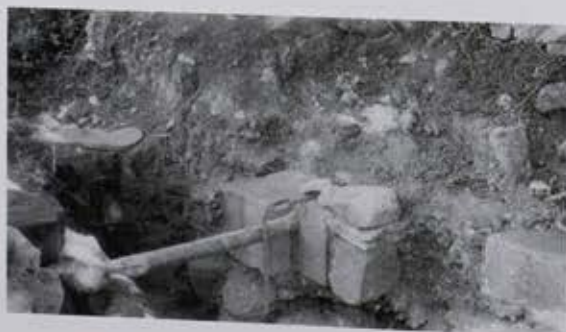
Fig 4.11 Canons' latrine: west doorway, probably facing south-east, 1960

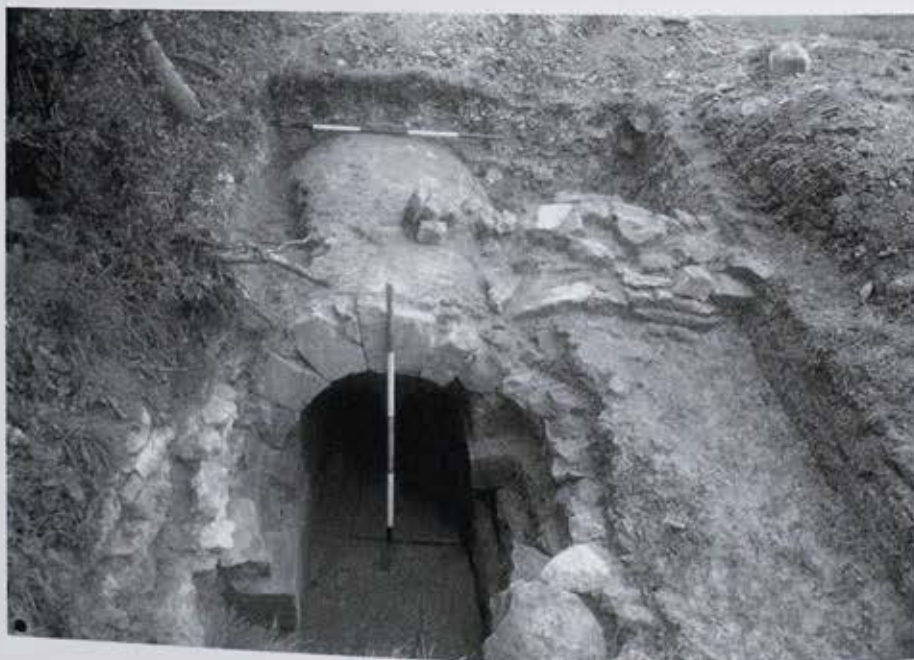
Fig 4.13 Main drain to east of warming house / inner parlour, facing south-east, trench 5 1970

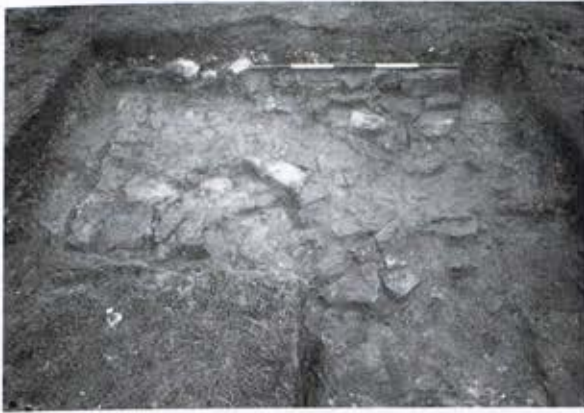
Fig 4.15 North range: north wall, facing south, external drain in foreground, buttress at left, trench 3 1970

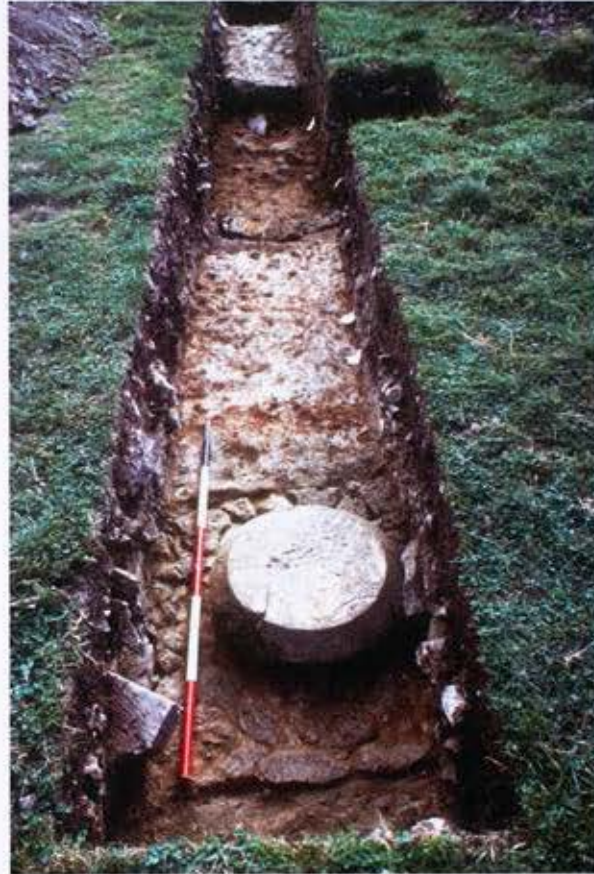
Fig 4.16 North range: central pier column base, facing east, trench 20 1970

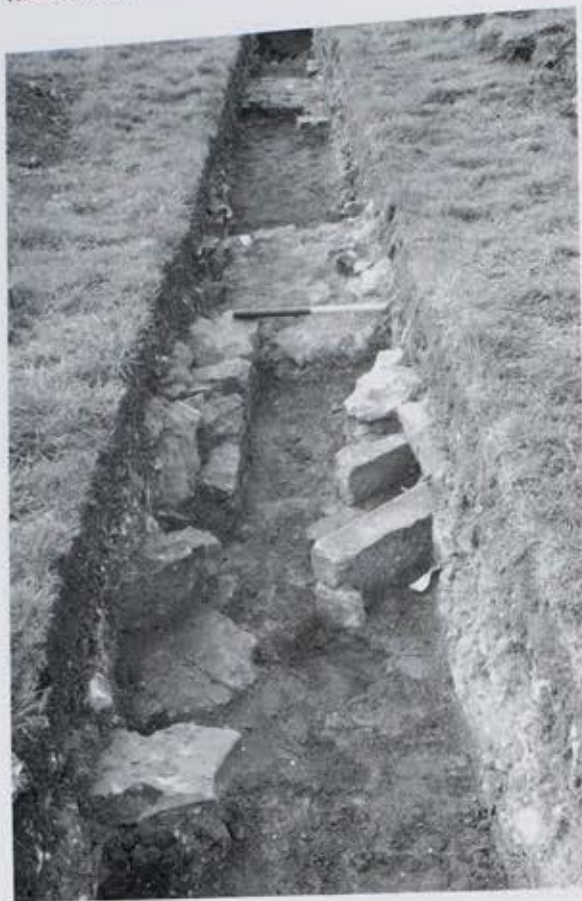
Fig 4.17 North range: north-west corner, facing east, trench 18 1970

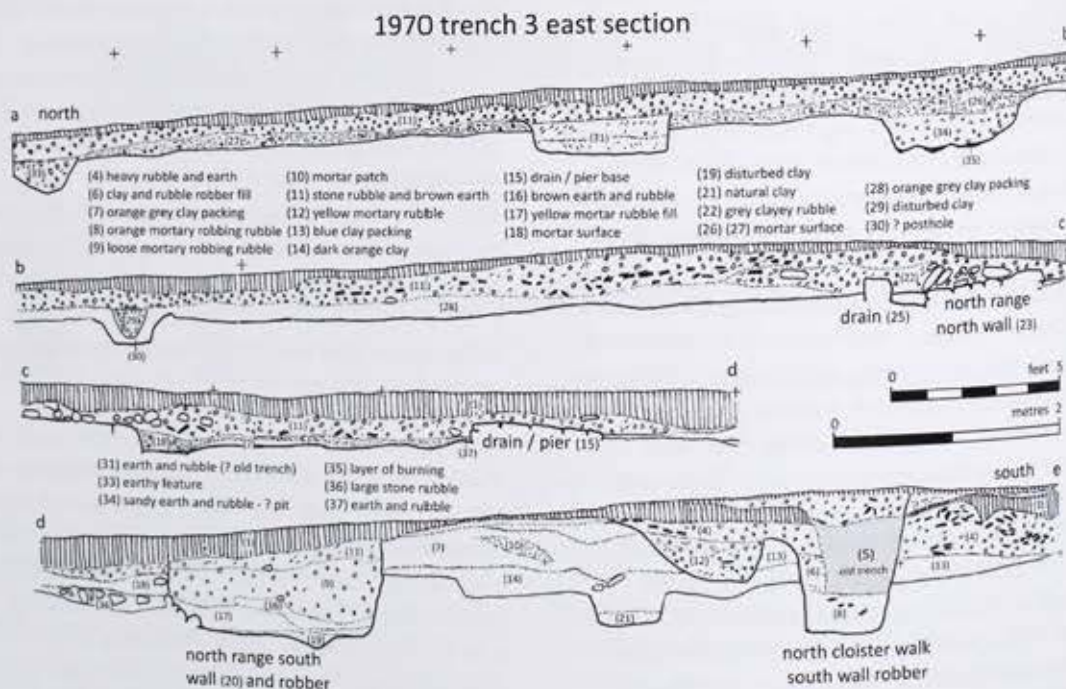
Fig 4.18 North range: east section of trench 3 1970

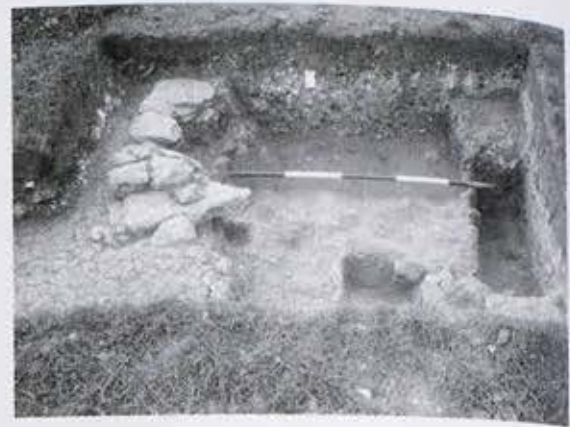
Fig 4.20 West range: robbed west wall, facing south, trench 5 1970

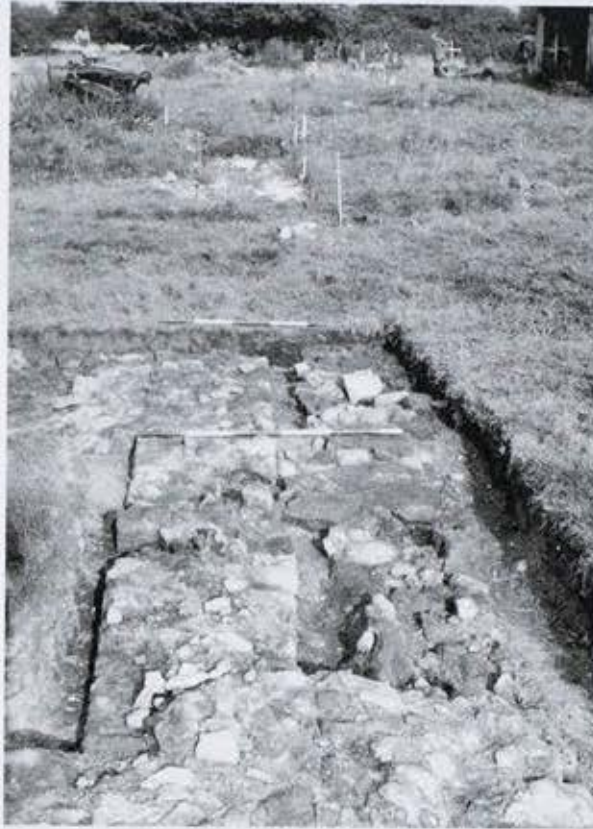
Fig 4.25 Cloister wall: south-west corner in bottom left-hand corner, facing east, 1966

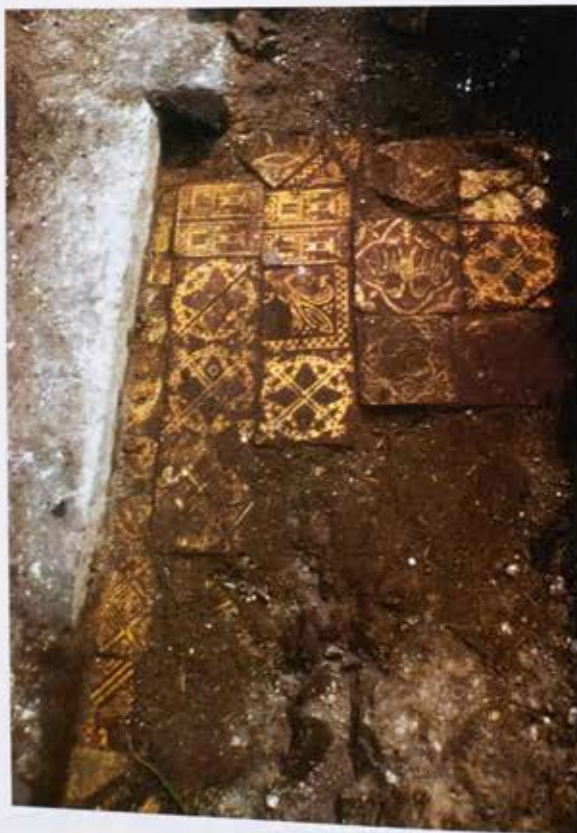
Fig 4.26 South-east corner of cloister: floor tiles outside door into north transept, 1957

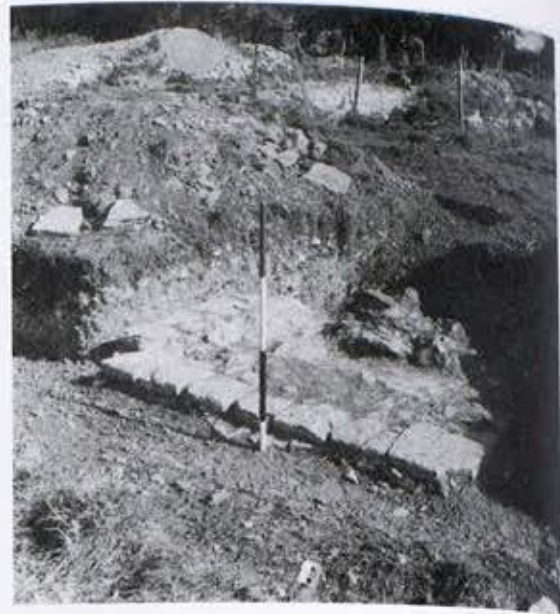
Fig 4.27 East cloister walk: buttress, facing north-east, 1959

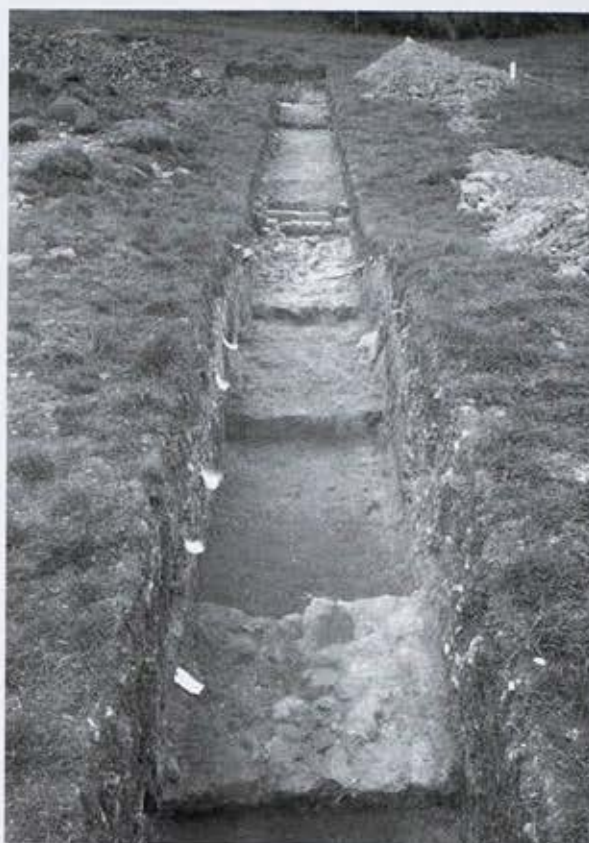
Fig 4.28 West cloister walk in foreground, facing west, trench 2 1970

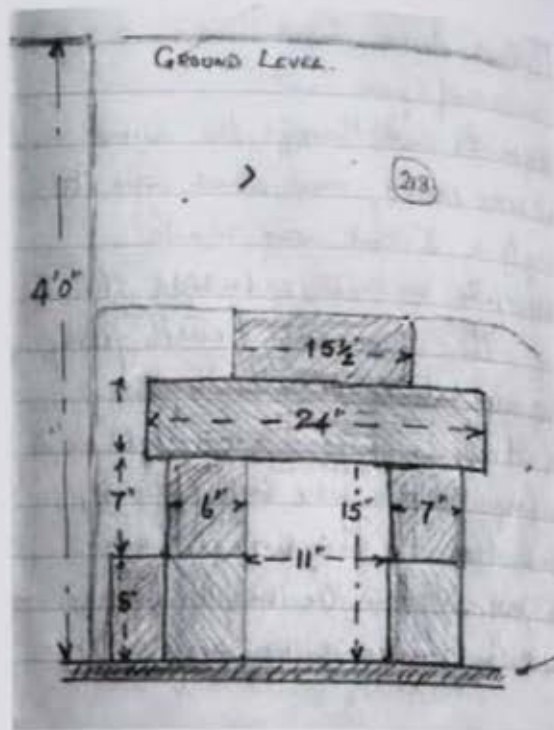
Fig 4.29 Section across drain on west side of canons' latrine, facing south, 1960

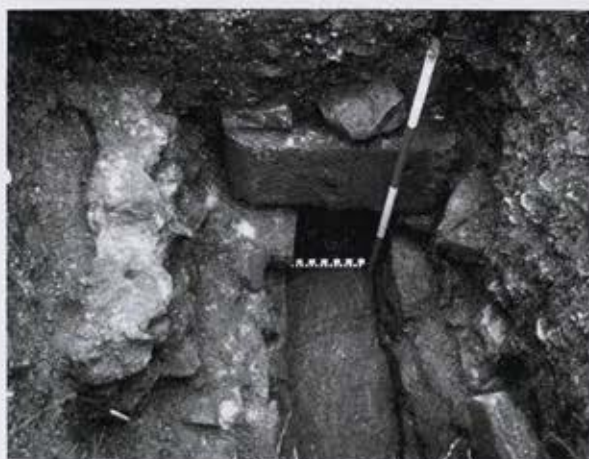
Fig 4.30 Drain: culvert and cap stone in section, east of north transept / chapel N3, Sq 3/93, facing south, 1969

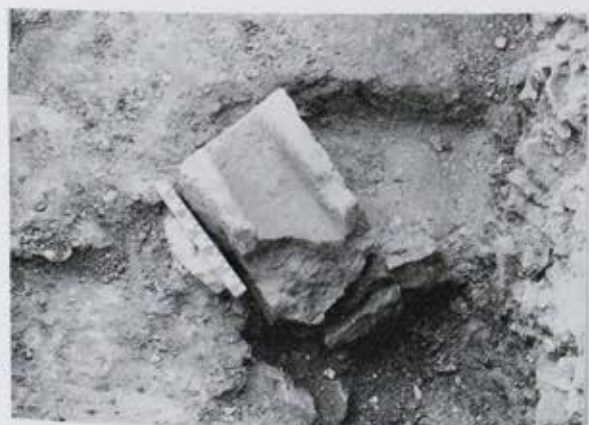
Fig 4.31 Drain: channel stone found in external area east of chapel N2 and north of chapel B1, Sq 3/73, 1969

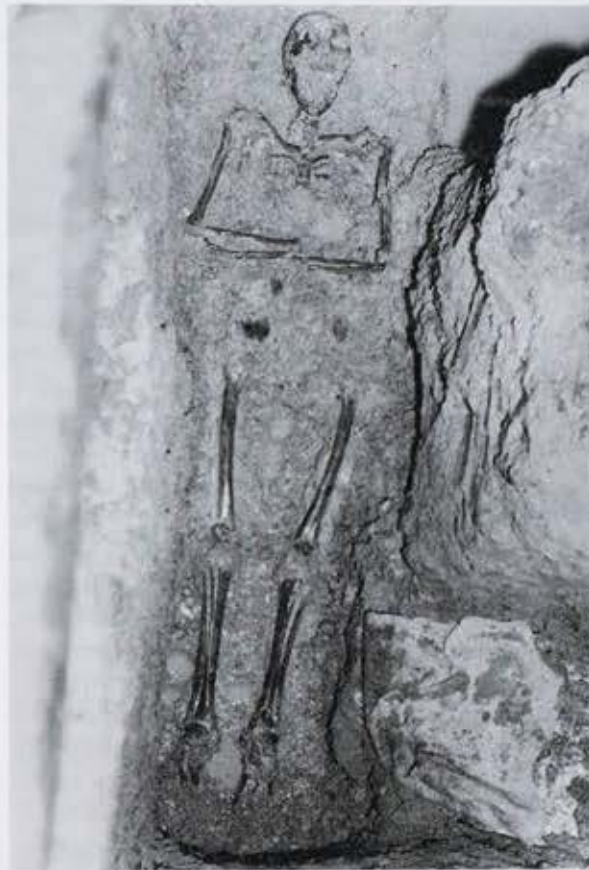
Fig 5.4 Burial 1: north transept, 1953

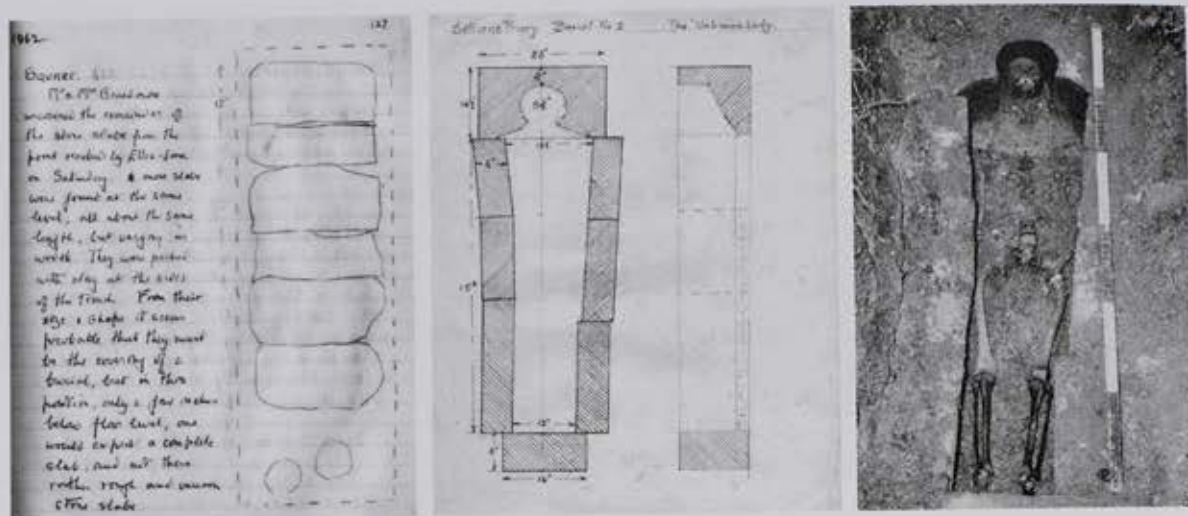
Figs 5.5-7 Burial 2 presbytery 1962: left, covering slabs; centre, coffin; right, burial in coffin

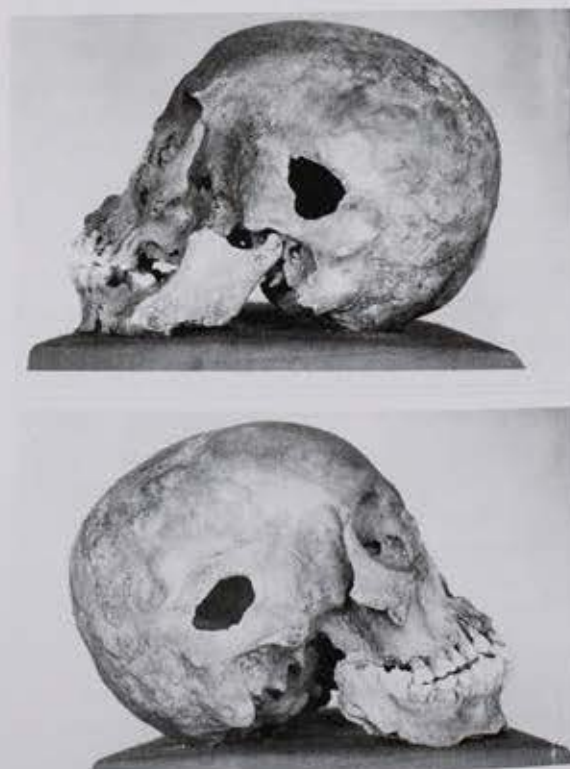
Fig 5.8 Burial 2: skull (Edwin Plomer), 1962

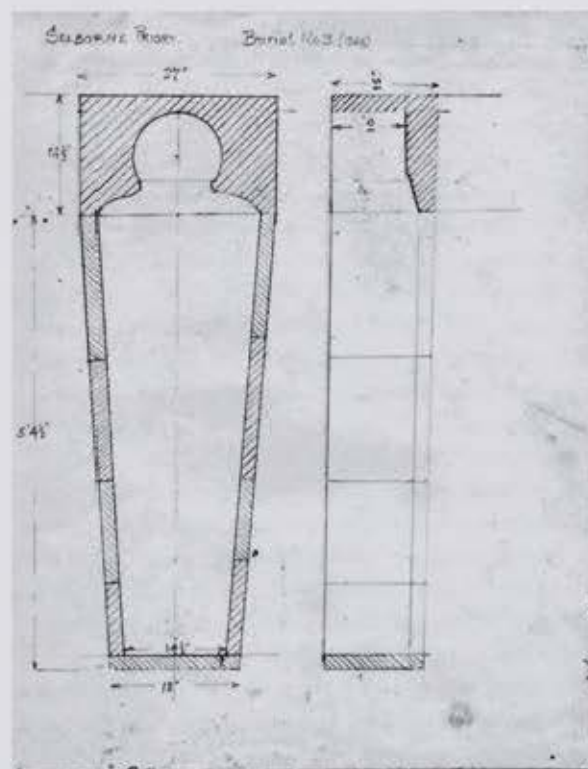
Fig 5.9 Burial 3: presbytery, coffin, 1966

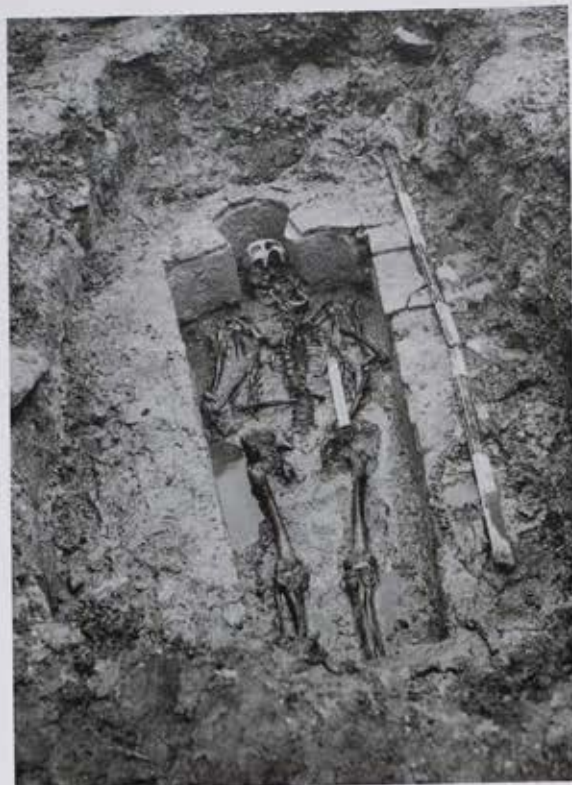
Fig 5.10 Burial 3: presbytery, coffin, 1966

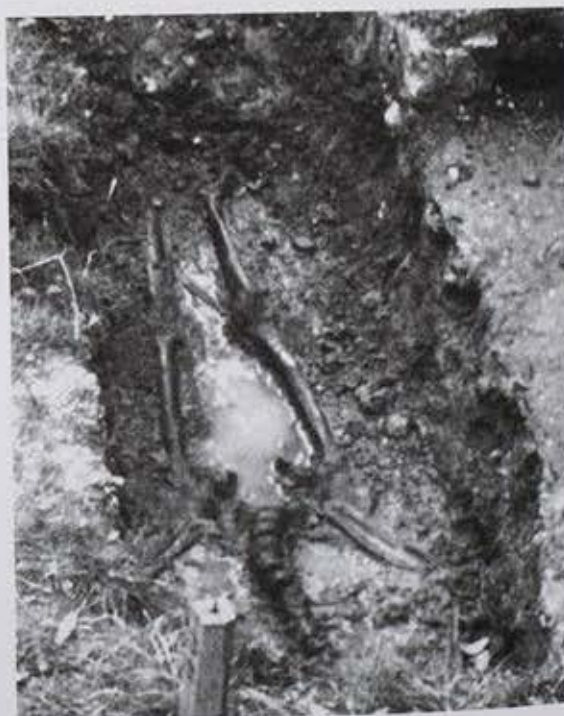
Fig 5.11 Burial 4: presbytery, 1967

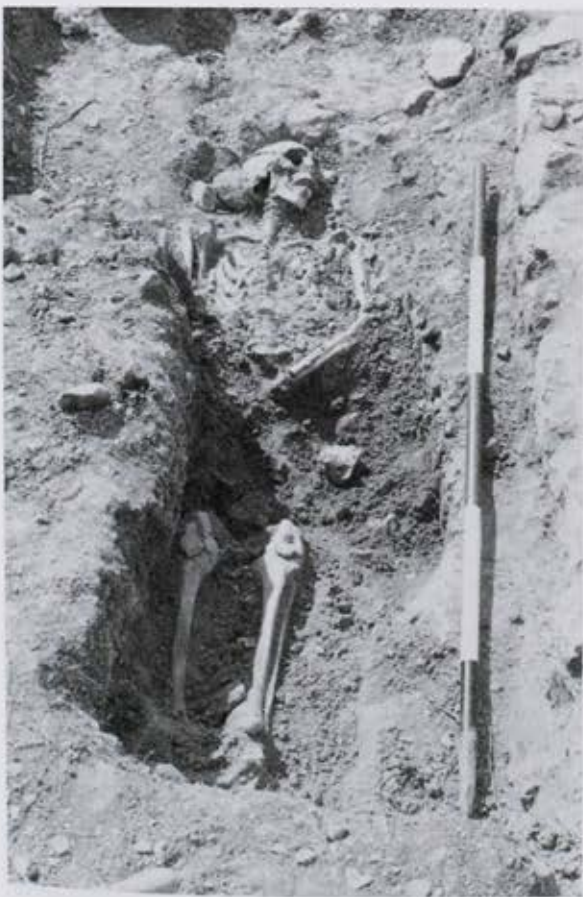
Fig 5.12 Burial 5: presbytery, 1967

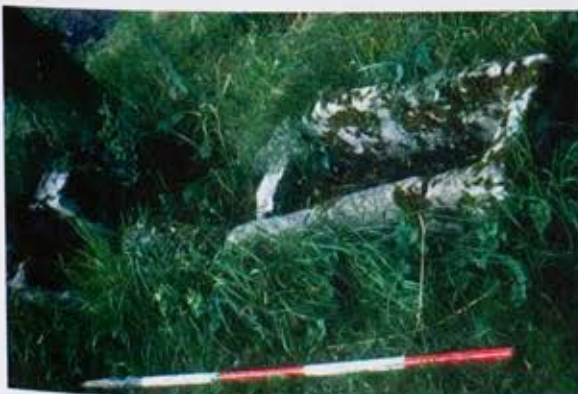
Fig 5.18 Stone coffin in orchard, photograph

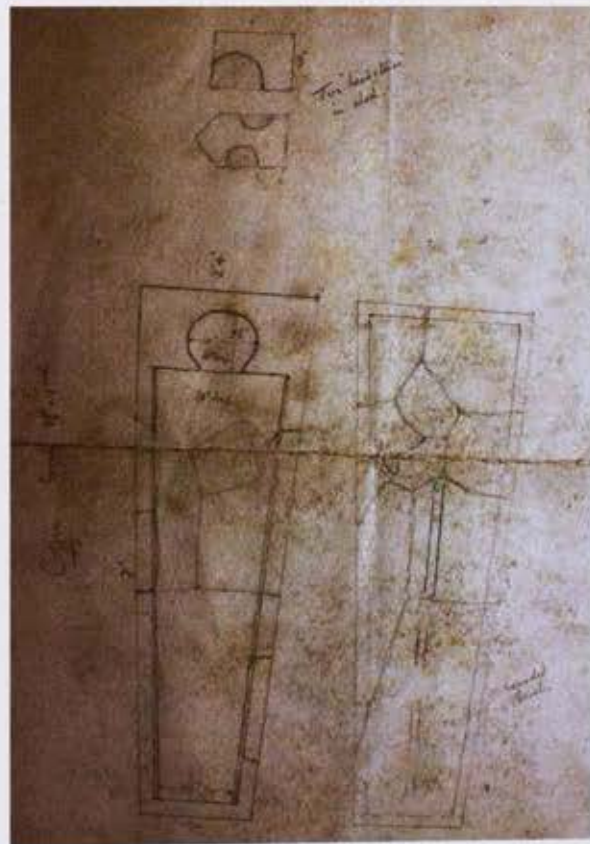
Fig 5.19 Coffin, the 'Tomb' in Gunther's 1905 sketch

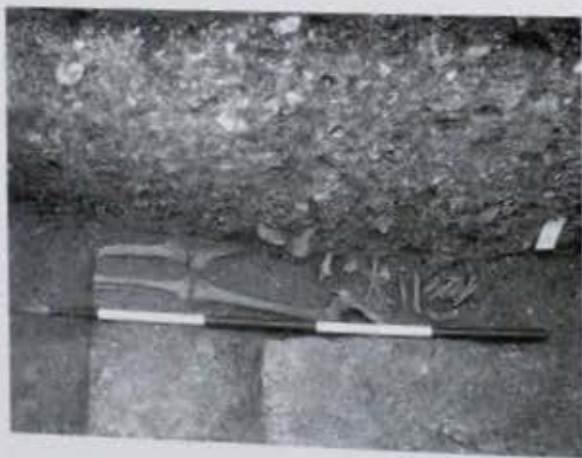
Fig 5.20 Burial 8 outside west end of church, trench 1 1970

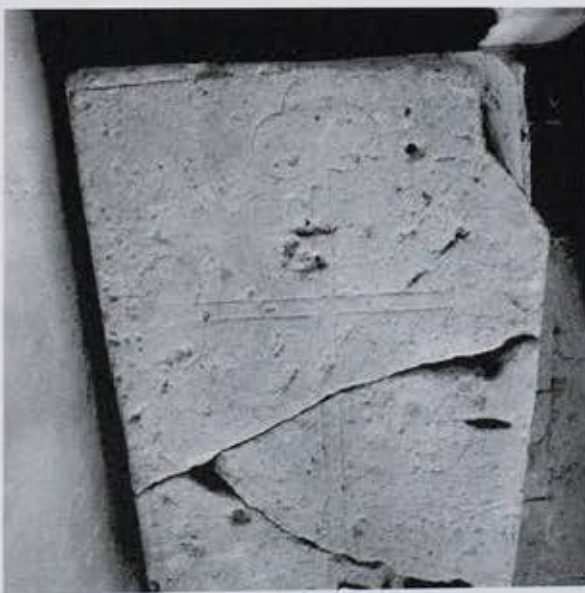
Fig 5.22 Burial 11: coffin lid incised cross head, 1971 (Brian and Moira Gittos)

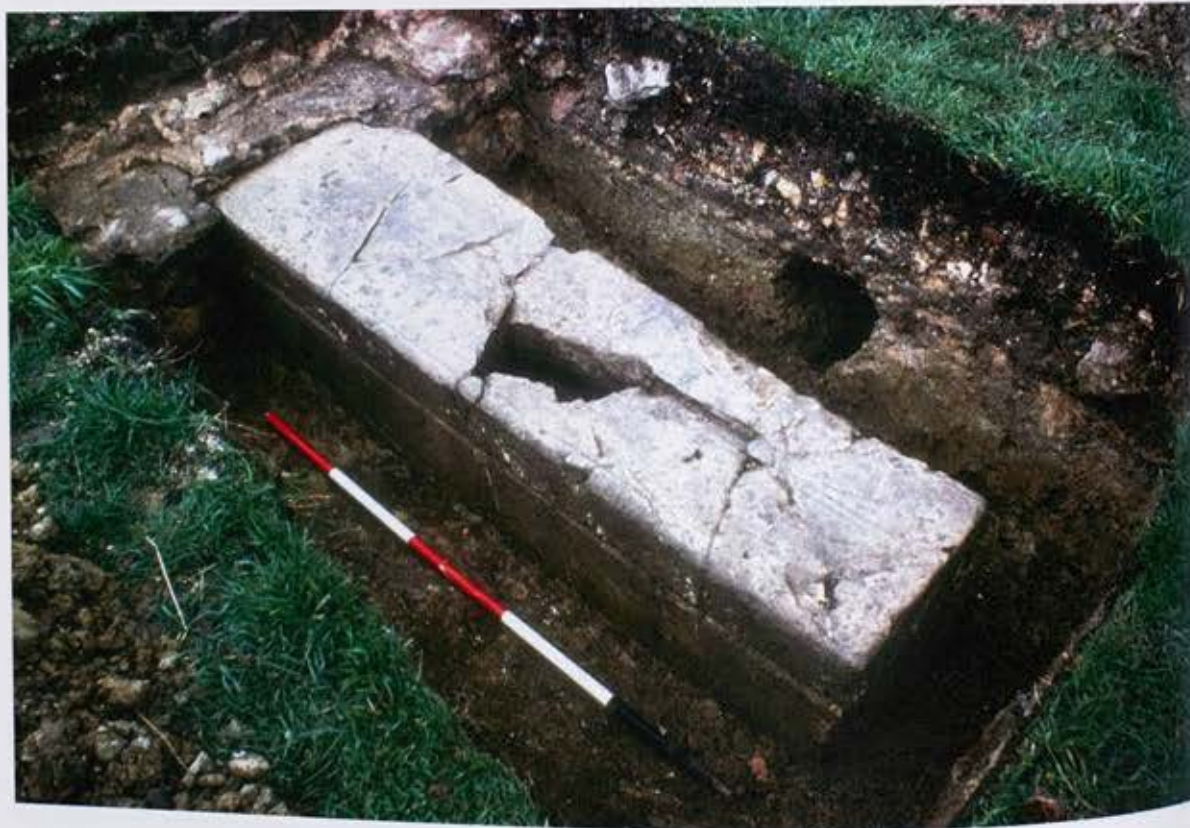
Fig 5.24 Burial 11: east cloister walk, coffin with lid, facing north-west, trench 16 1971

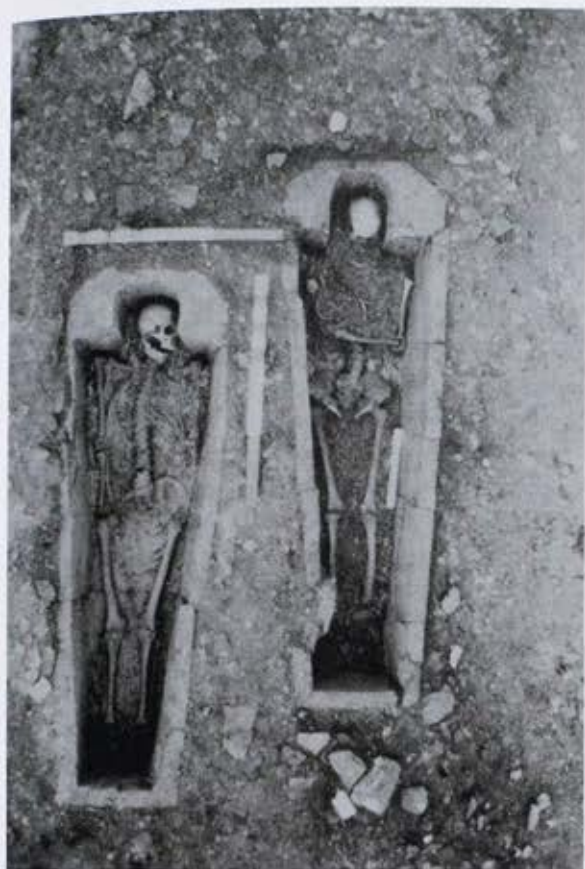
Fig 5.27 Burials at Chertsey Abbey, image supplied by R Gilyard Beer to Rev George Knapp

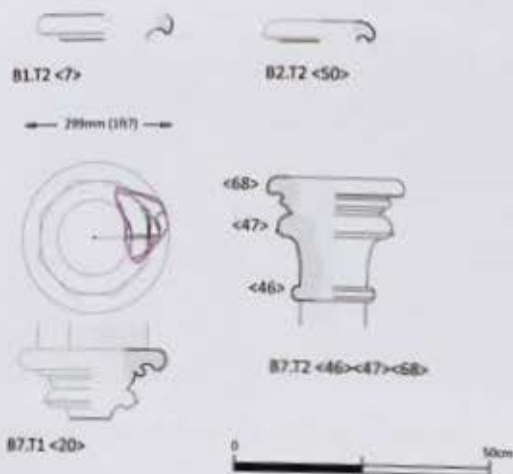
Fig 6.2 Various minor capitals (all building campaigns)

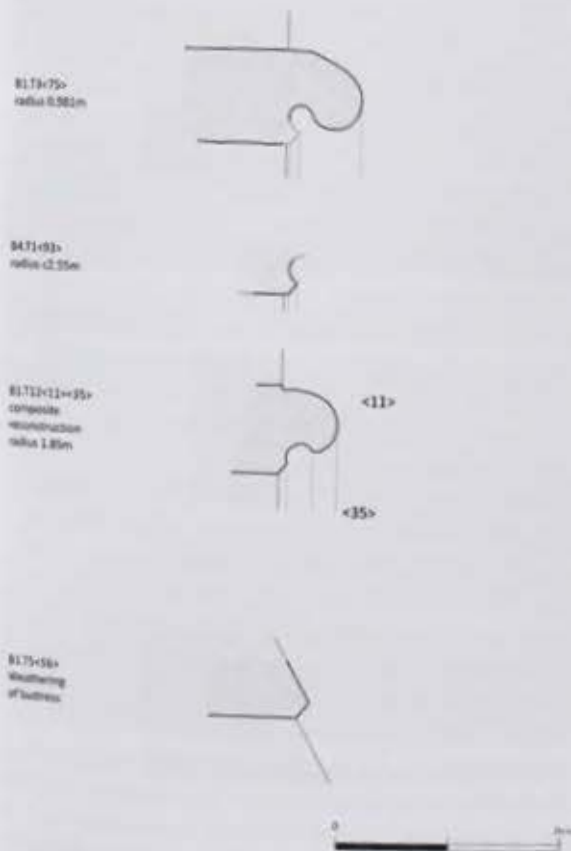
Fig 6.3 Drip labels and weathering of buttress

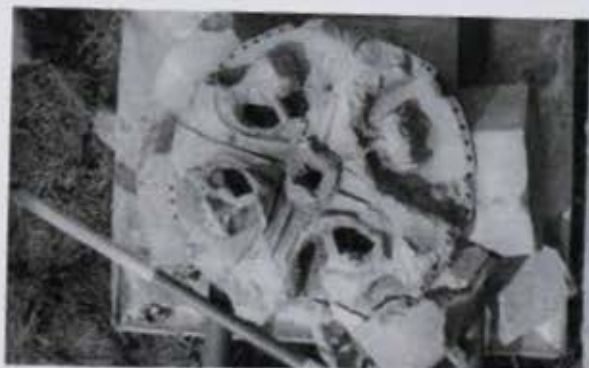
Fig 6.4 <102> Presbytery boss as excavated (scale in ft) 1966 (Edwin Plomer)

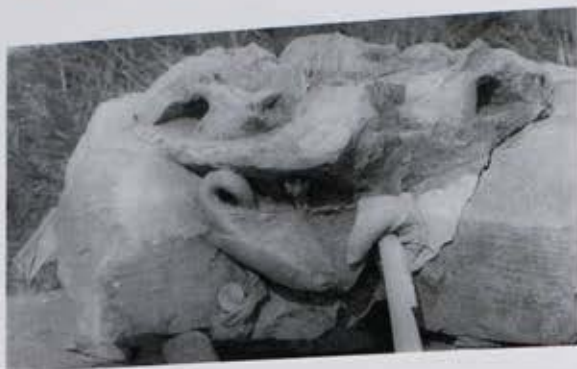
Fig 6.6 Presbytery boss (inverted) as excavated showing Wyvern sculpture 1966 (Edwin Plomer)

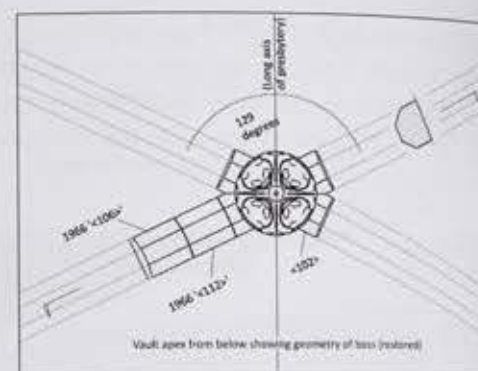
Fig 6.7 The presbytery vault boss and rib stones (lost) as excavated 1966
