# SELBORNE PRIORY

## Excavations 1953–1971

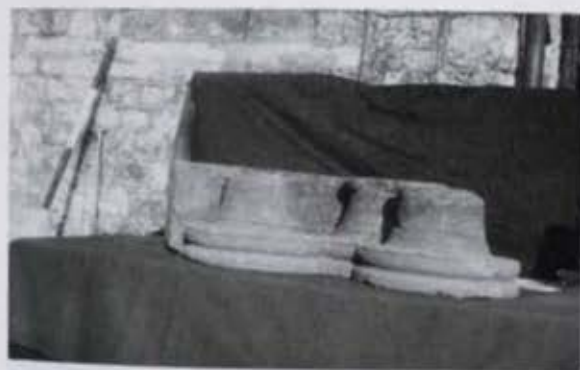
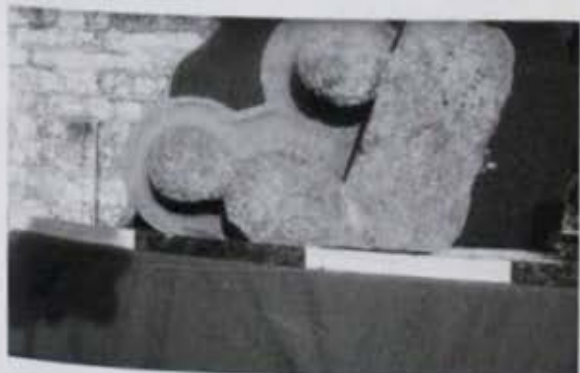
Fig 6.9 Chapter house respond capital found 1957 (lost)

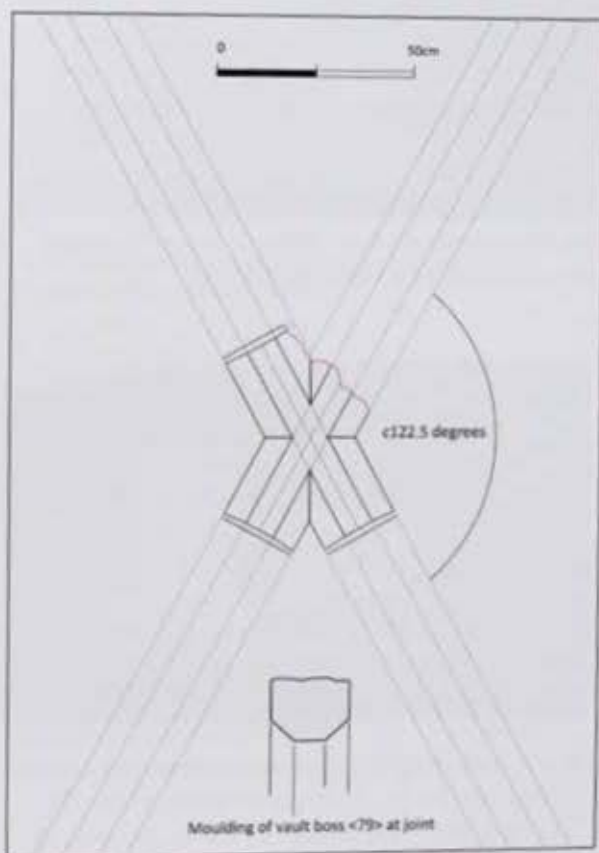
Fig 6.10 Chapter house vault intersection from below

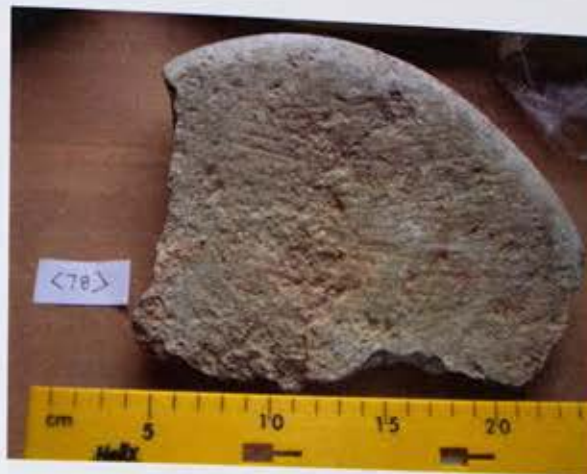
Fig 6.13 Claw tool marks on impost of coupled capital <78>

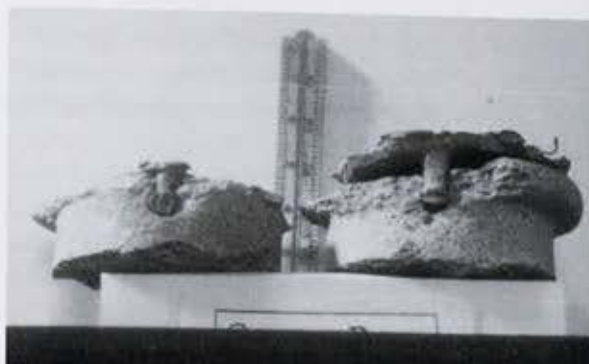
Fig 6.14 <90> as found (left) as part of a coupled capital (inverted) with in situ lead keying

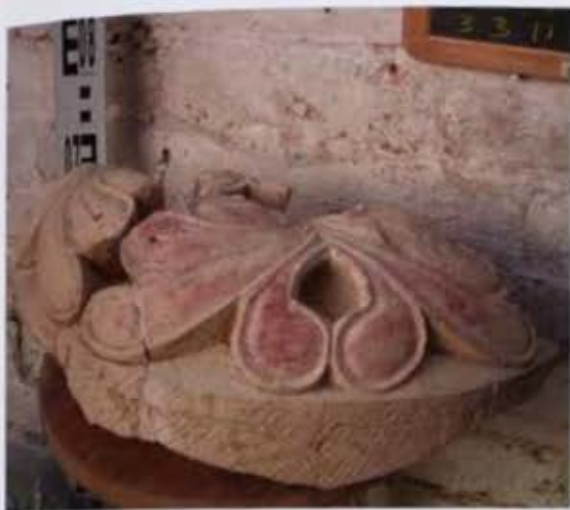
Fig 6.17 Decorative roundel 17/19 assembled oblique view (inverted)

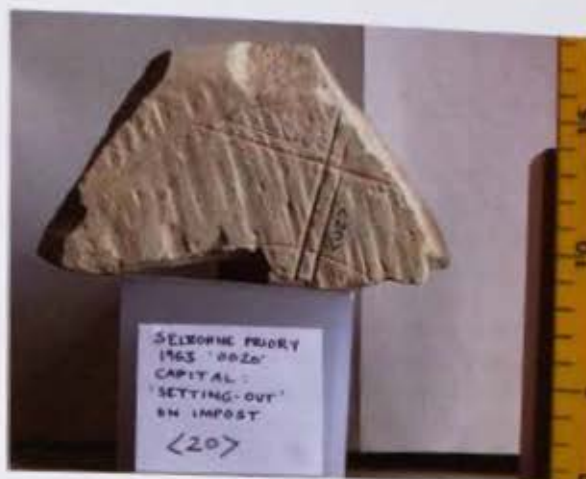
Fig 6.18 View of capital <20> impost, showing setting-out lines

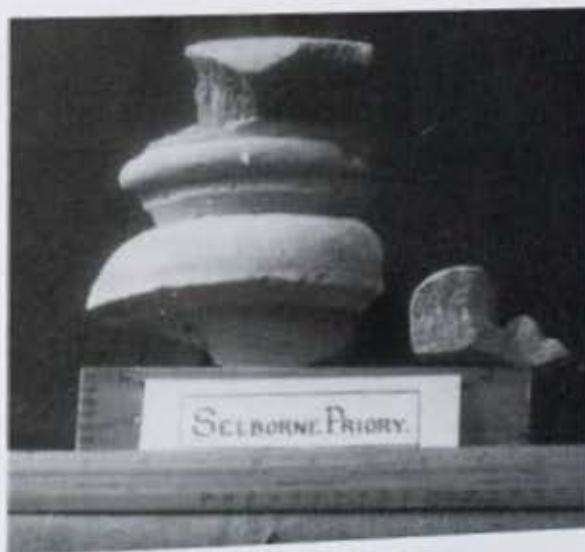
Fig 6.19 Assembled B7:T2 capital as excavated

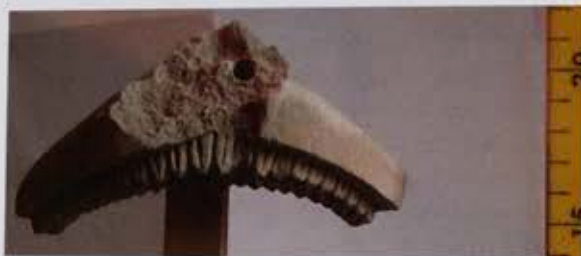
Fig 6.20 <92> Mouth of Lion from South Transept

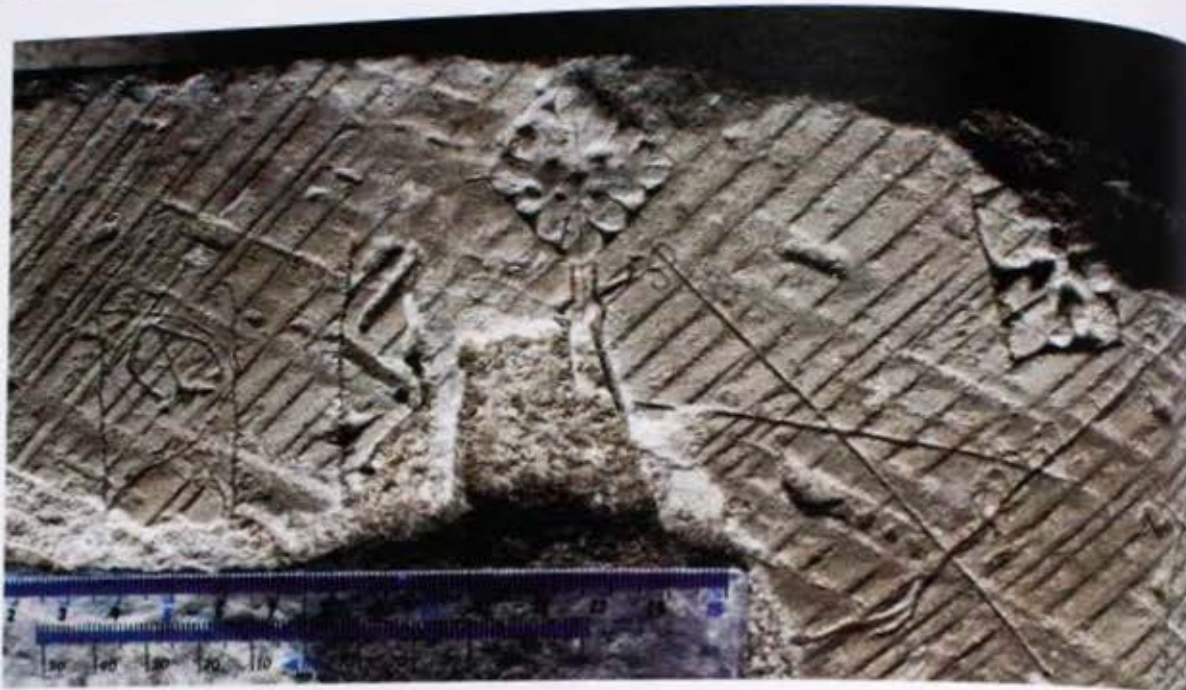
Fig 6.22 Graffiti on stone from main drain, mason's banker mark, zig-zag design and floral / leaf designs

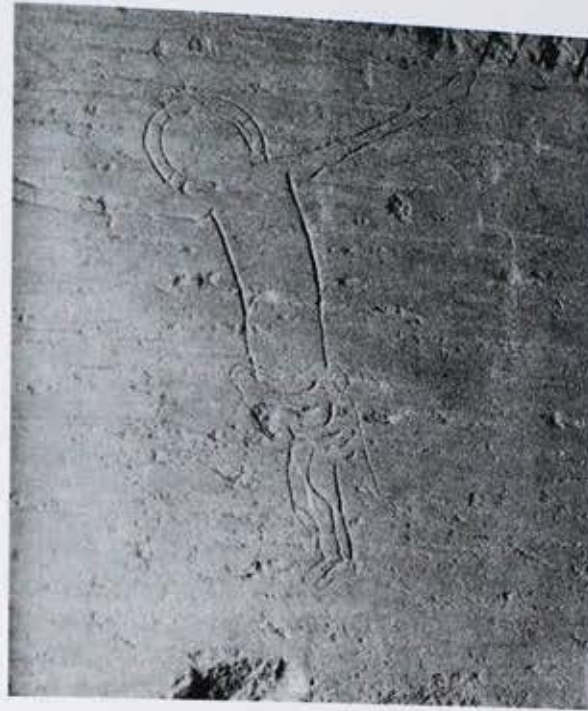
Fig 6.24 Graffiti on in situ stone in main drain, crucifixion (Edwin Plomer)

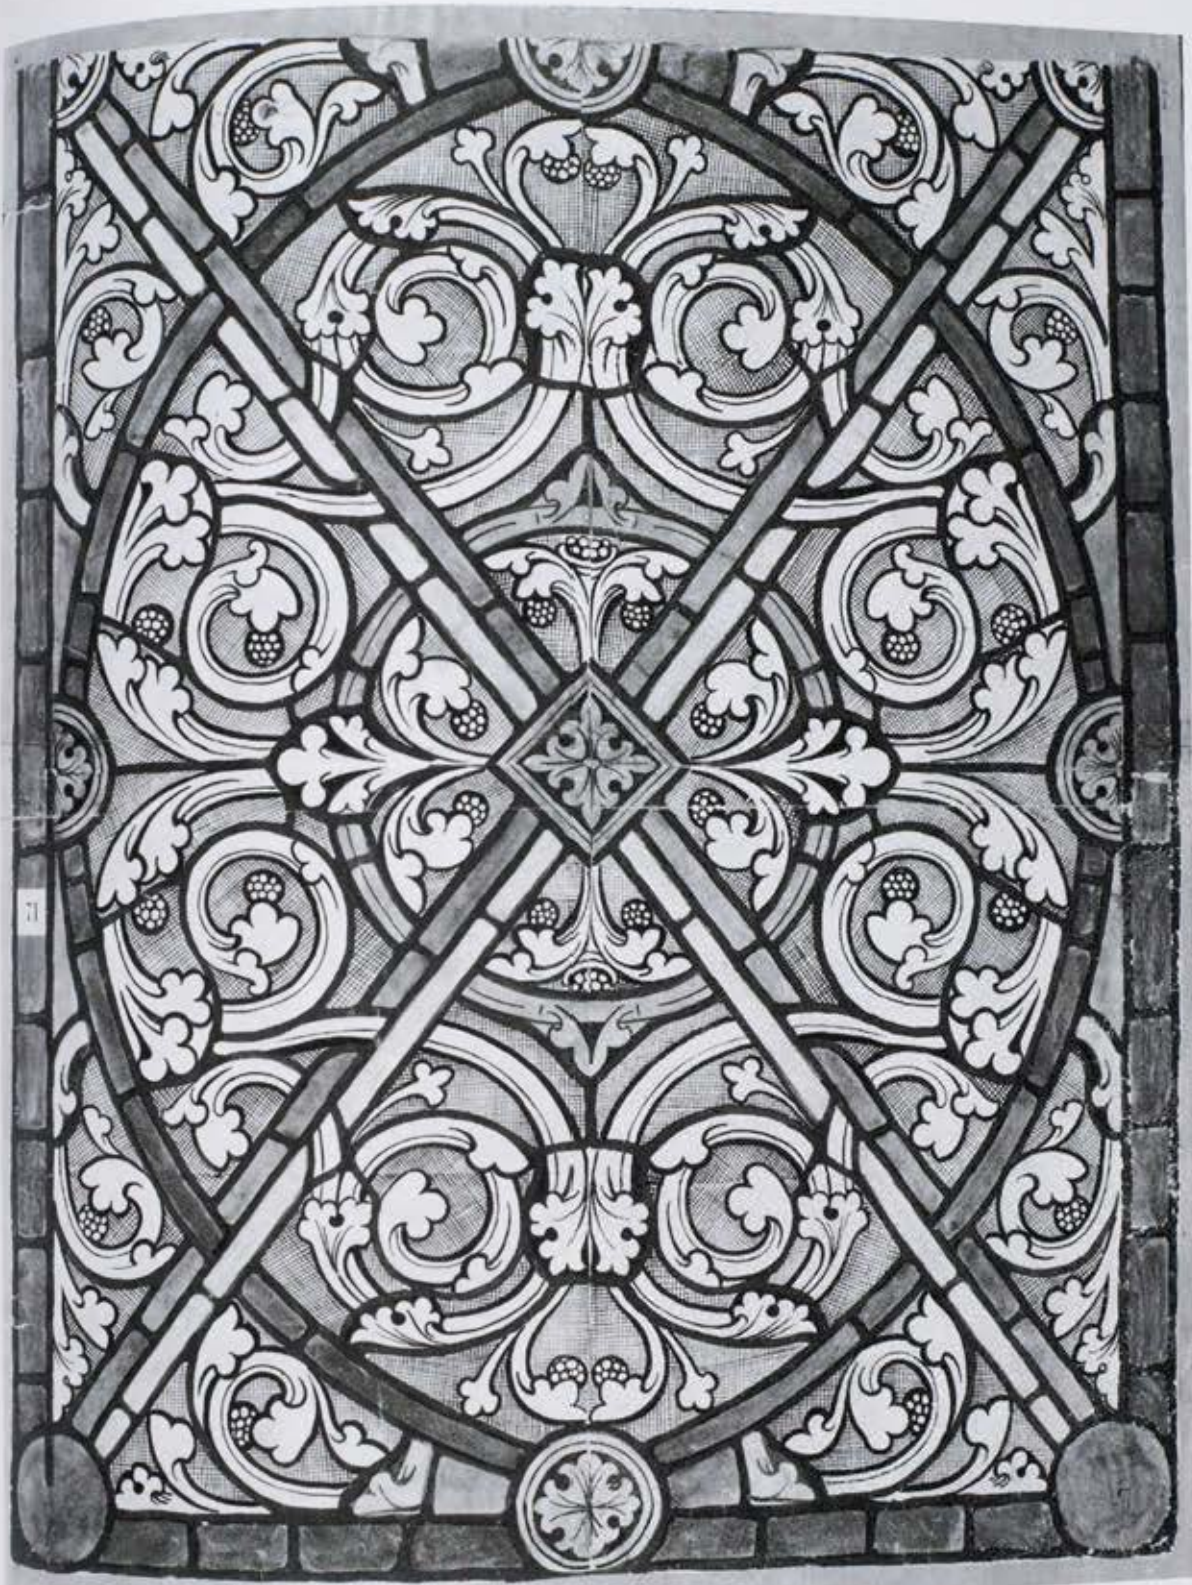
Fig 6.27 Early 13th century grisaille window at Salisbury Cathedral, published by Octavius Hudson in 1848, (courtesy of the Victoria and Albert Museum, London)

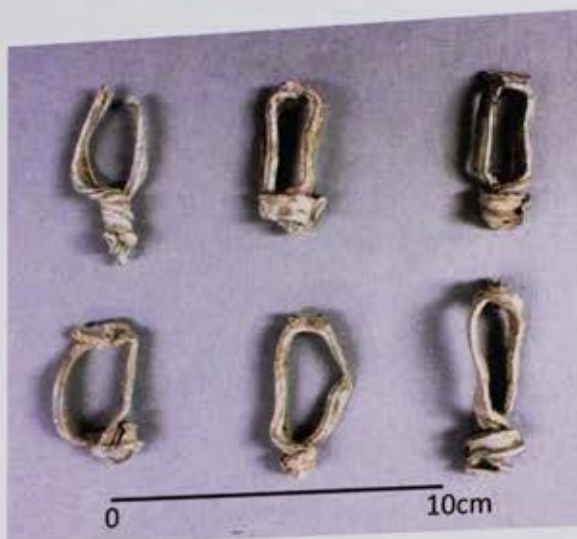
Fig 6.34 Group I type (soldered to the net in the centre, the two arms tied together), mostly intact with tied ends and preserving the shapes of the saddle-bars around which they were tied

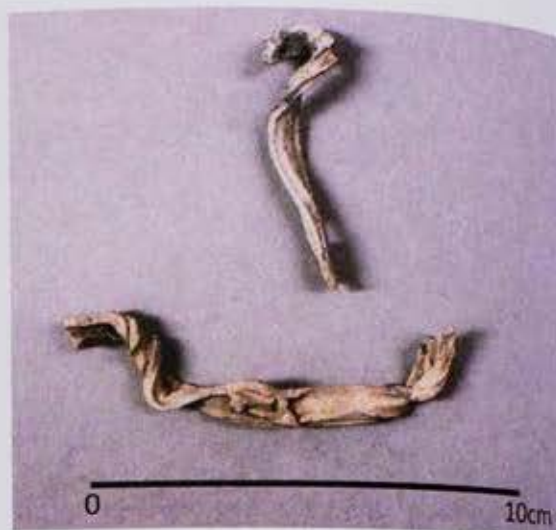
Fig 6.35 (Top) one complete arm of a Group II type (soldered to the net at one basal end, the free end tied to its (missing) pair), showing typical curvature of the formerly tied end; Undane Group I tie (bottom)

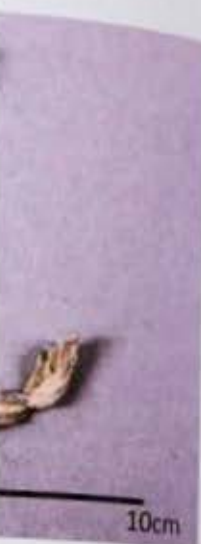
Group II type (soldered to lead to its (missing) pair), only tied end; Undone

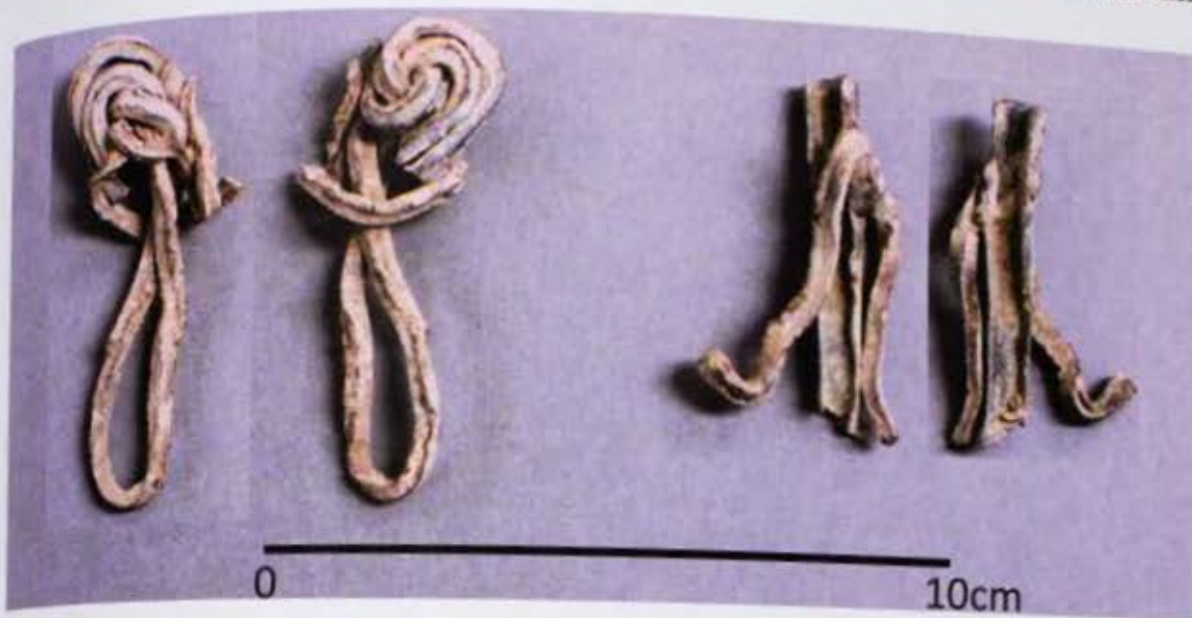
Fig 6.36 Made from halved came: (left) an unused bundle of halved came ties; (right) a halved came Group I tie, undone, attached to a straight length of window-came

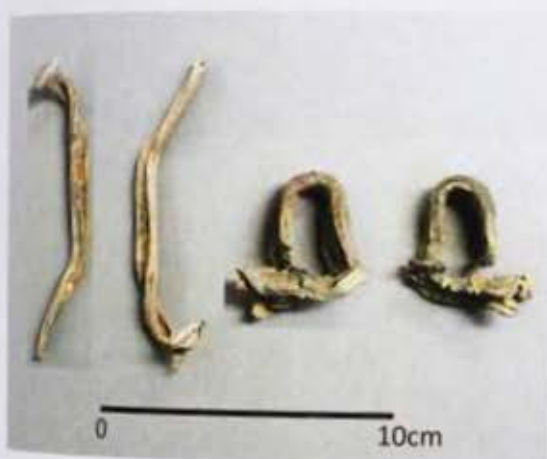
Fig 6.37 (Left) One complete arm of a Group II type, undone; (right) a complete Group III type – a form of in situ repair (soldered to the net at both basal ends); each tie is still attached to a small fragment of lead window-came

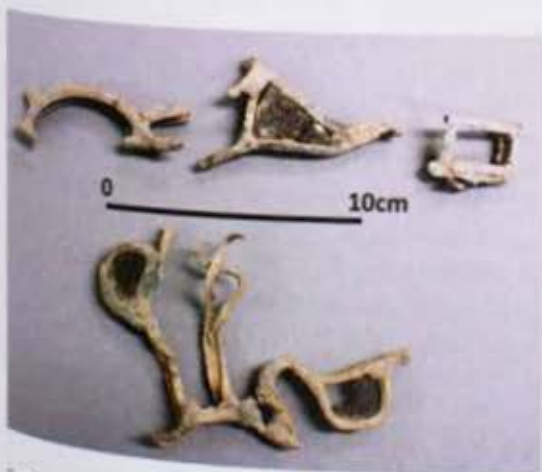
Fig 6.38 Net fragments, two containing glass

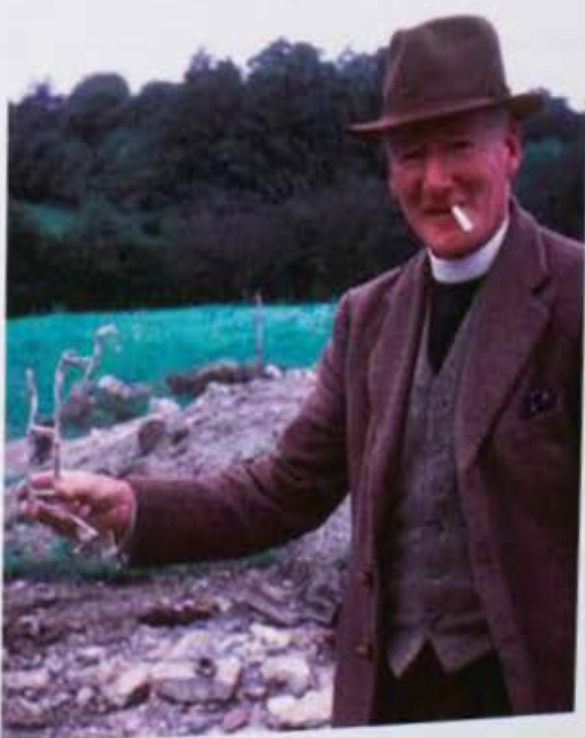
Fig 6.39 Rev W S Scott holding partly glazed net fragment, 1953

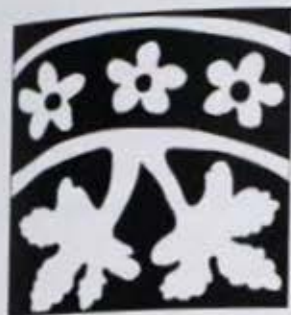
The pattern is  
 ... up of late 15th- or  
 ... l in central and  
 ... e as a border tile. The  
 ... ton Abbey, Fordington,  
 ... en 1977, design 193;  
 ... There is also one  
 ... (Eames 1991, 93-139,  
 ... , of the Dorset tiles  
 ... he base. These do  
 ... No other tiles of this  
 ... e Selborne piece is  
 ... ublish this design,  
 ... ing of the identical  
 ... led 'Milton Abbey' it  
 ... arian piece, perhaps  
 ... s somehow found a  
 ... ever, late medieval  
 ... rised by isolated  
 ... gh artistic and/or  
 ... e been commissioned  
 ... It is not impossible

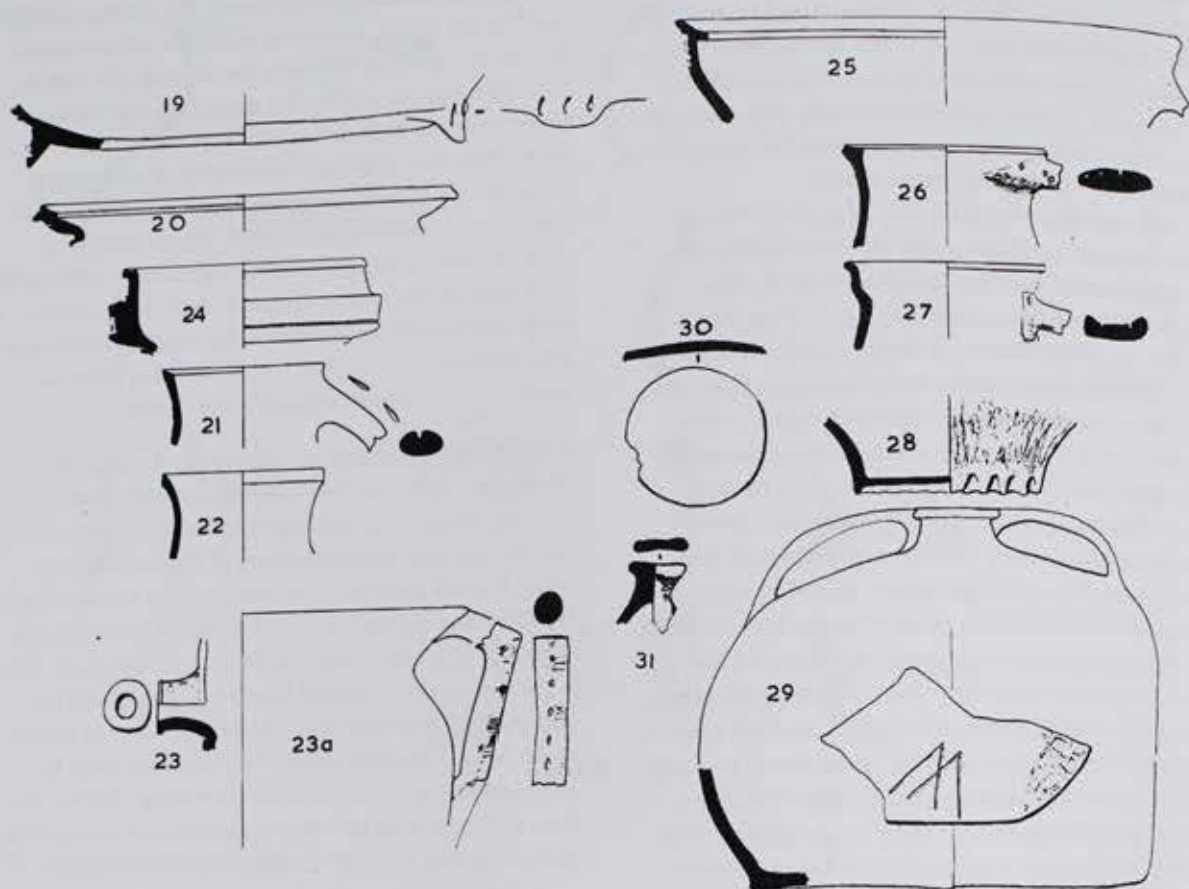
Fig 7.4 Pottery: fine sandy oxidised unglazed wares and fine sandy glazed earthenwares

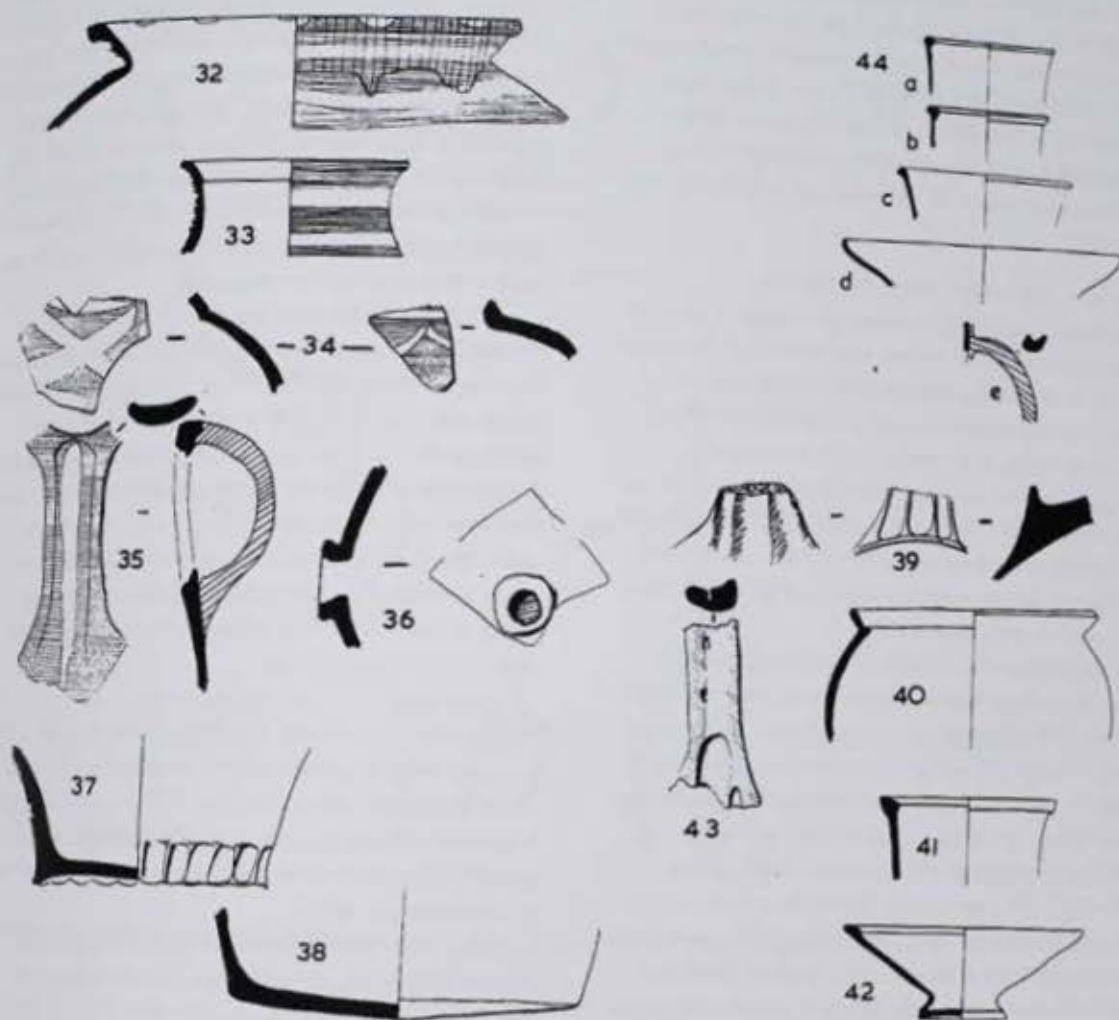
Fig 7.5 Pottery: "black and white wares" and reduced wares", unglazed white fabric wares

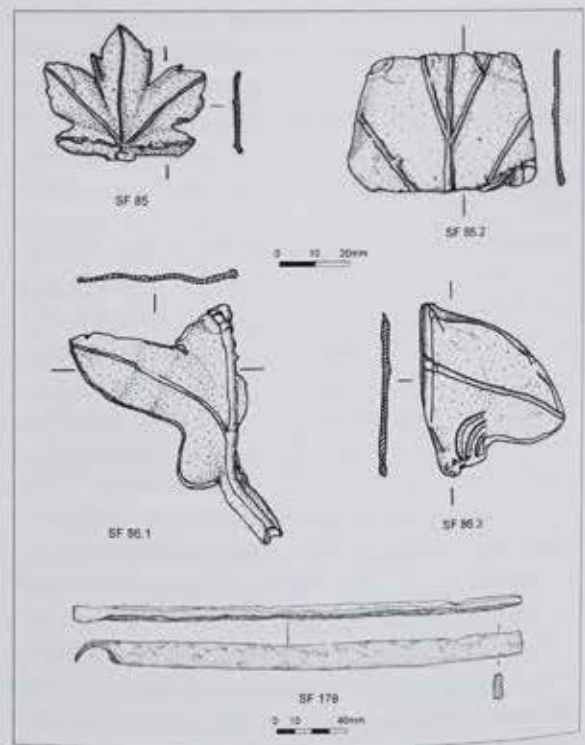
Fig 7.11 Building materials, lead wall furnishings and window bar

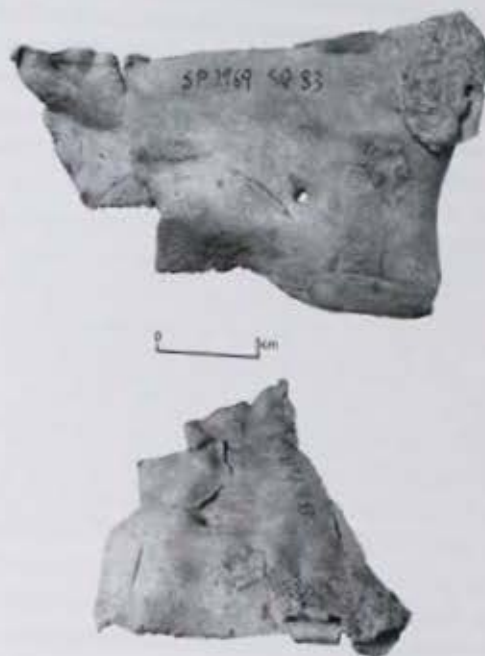
Fig 7.12 Lead roofing sheet SF369

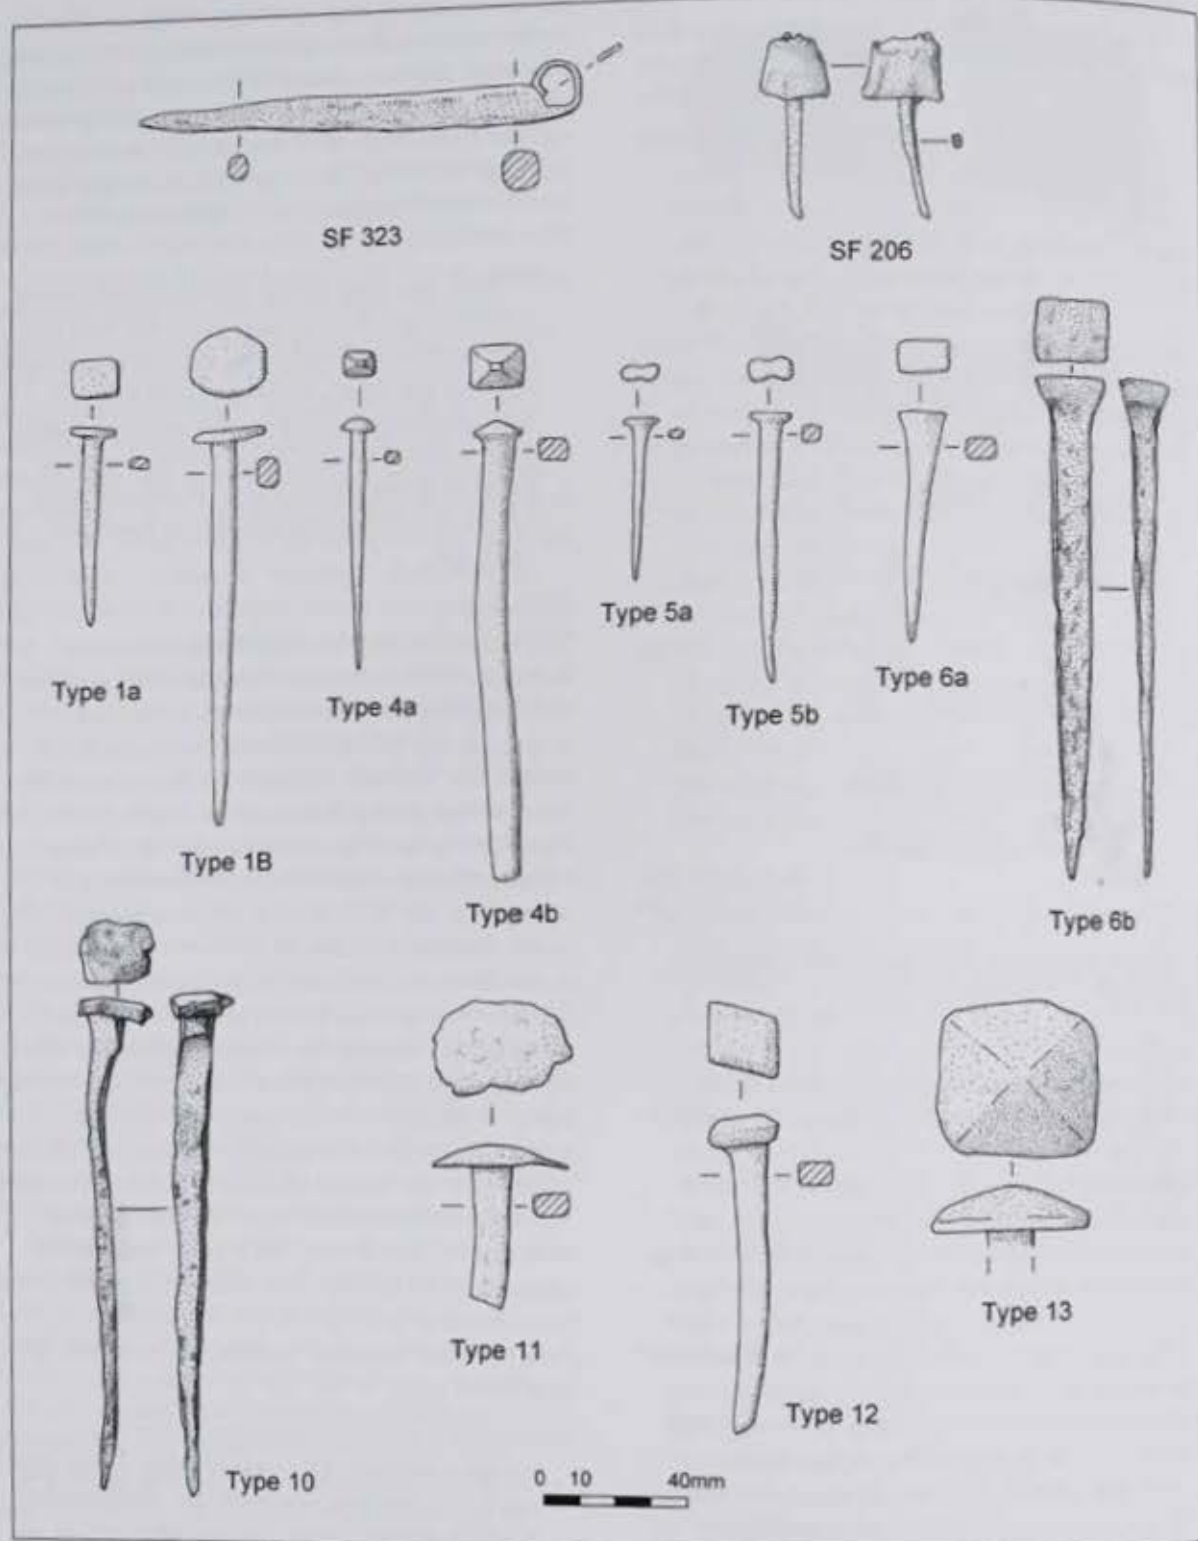
Fig 7.14 Fasteners and fittings, eyed spike, nail with lead knob and nail types

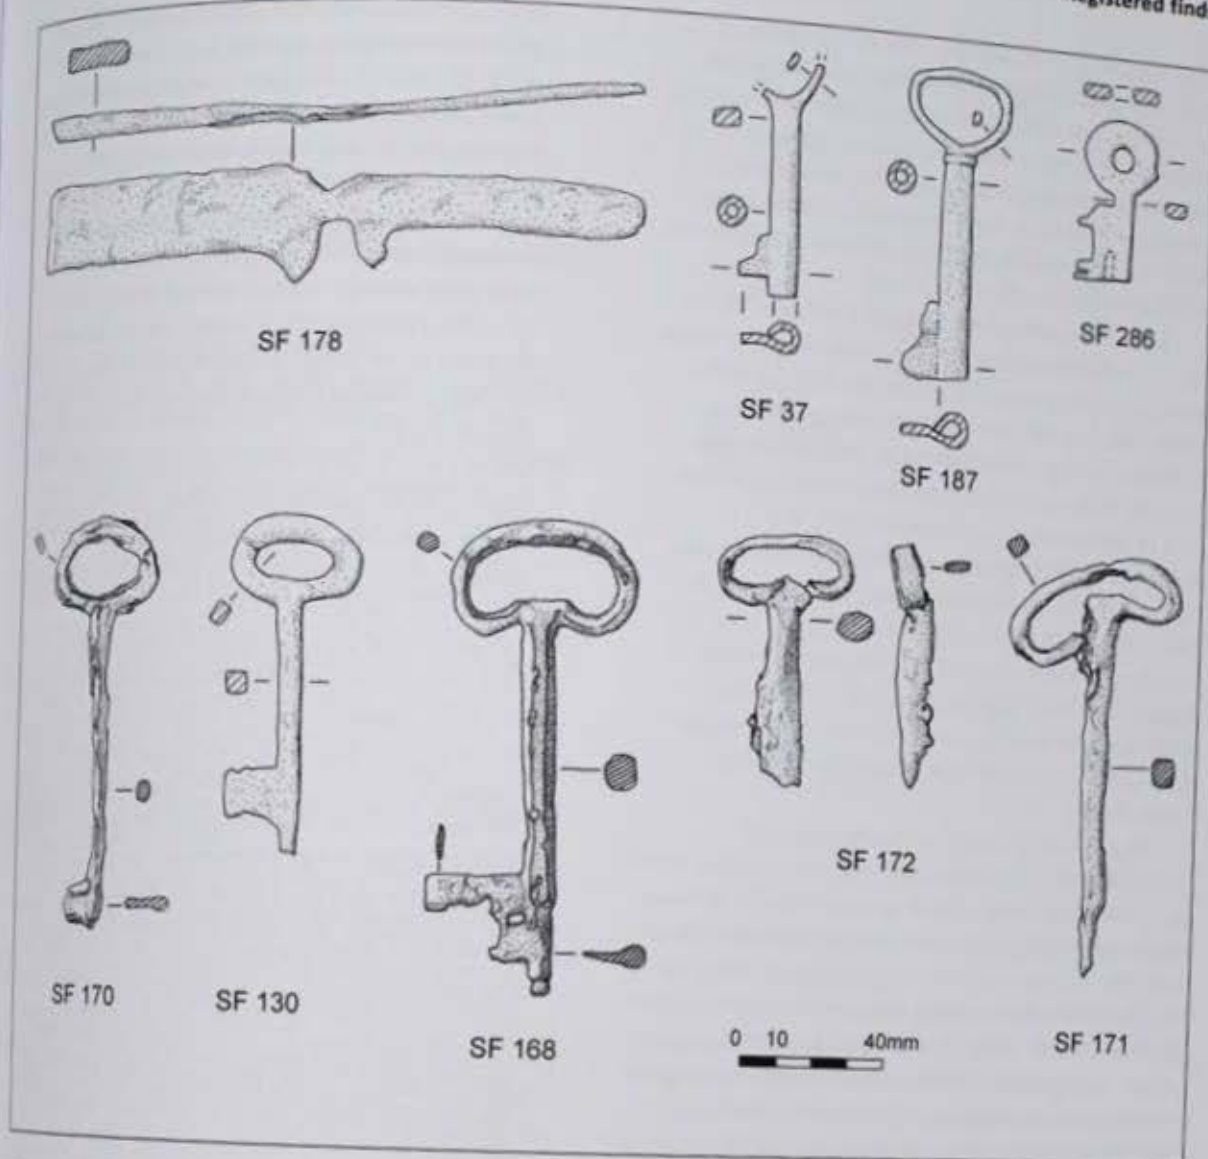
Fig 7.16 Door fittings, lock, bolt and keys

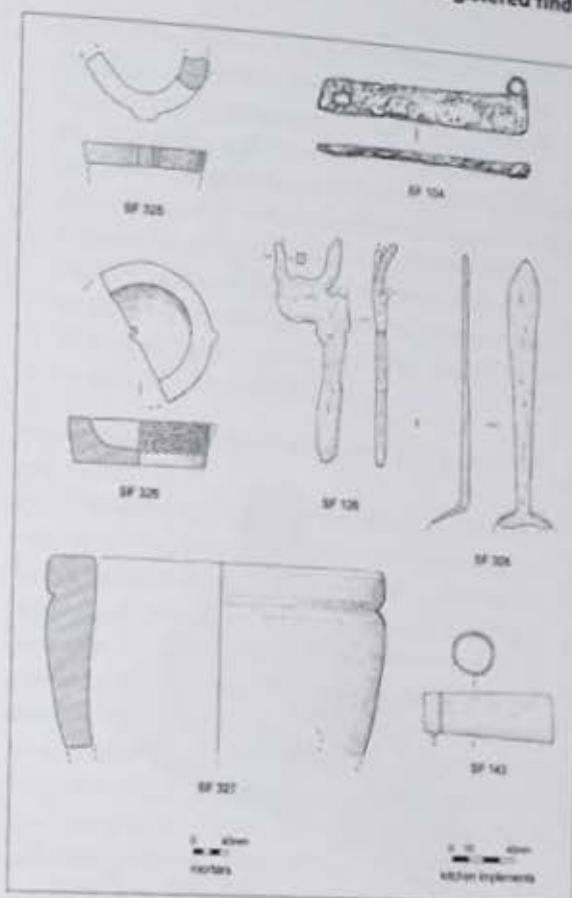
Fig 7.17 Kitchen implements, mortars and kitchen implements

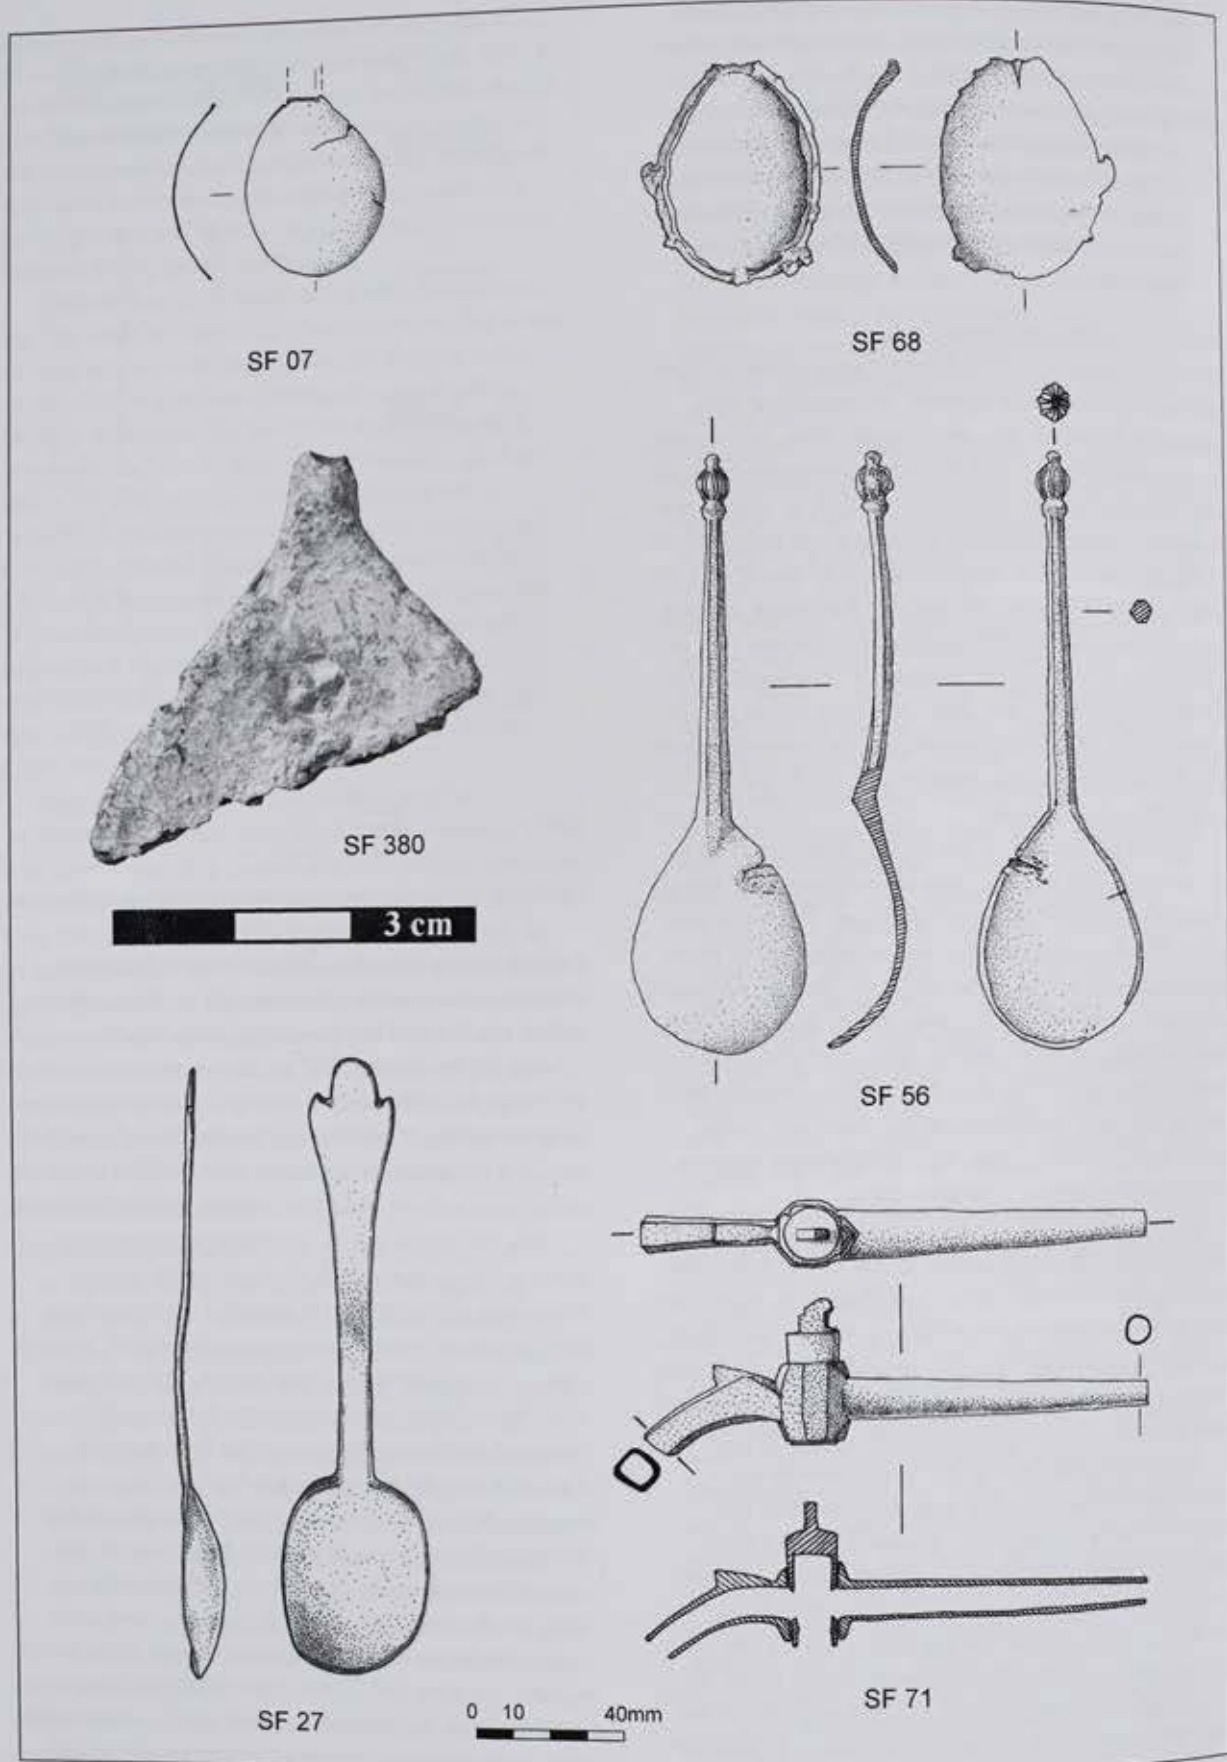
Fig 7.18 Spoons and tap and spigot

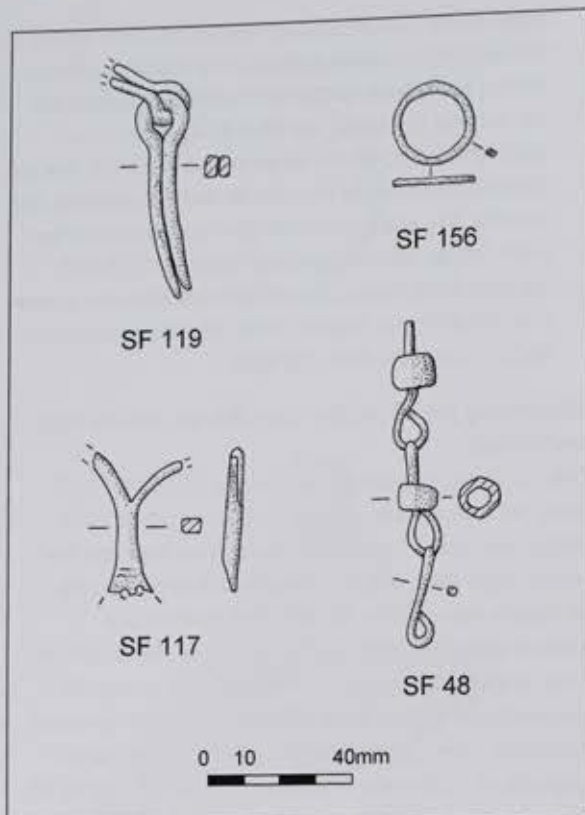
Fig 7.19 Household fixtures and fittings

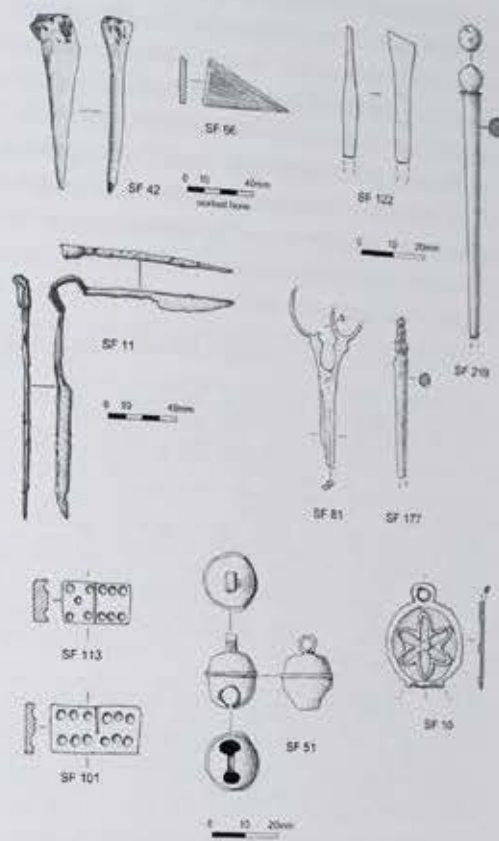
Fig 7.23 Bladed cutting tools and sharpeners, styli, dominos and harness trappings

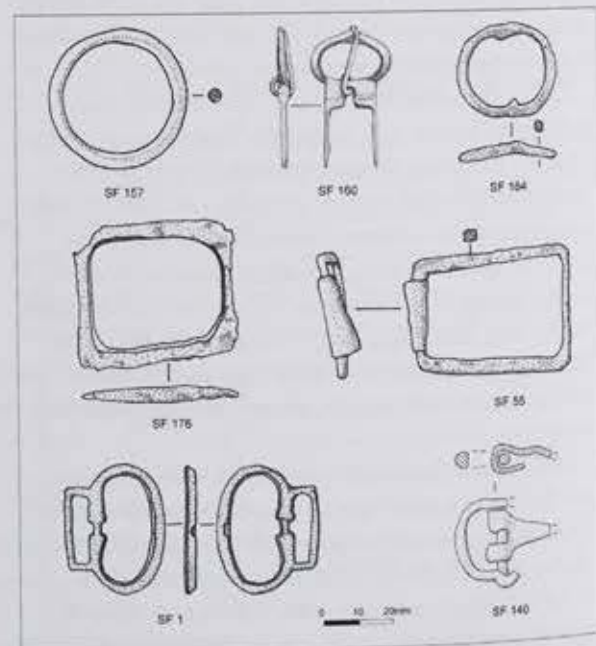
Fig 7.26 Dress and adornment, buckles

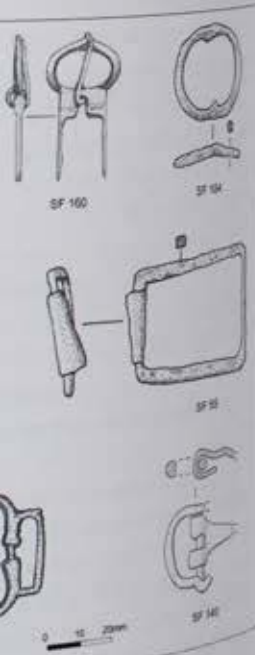
## Artefacts and ecofacts

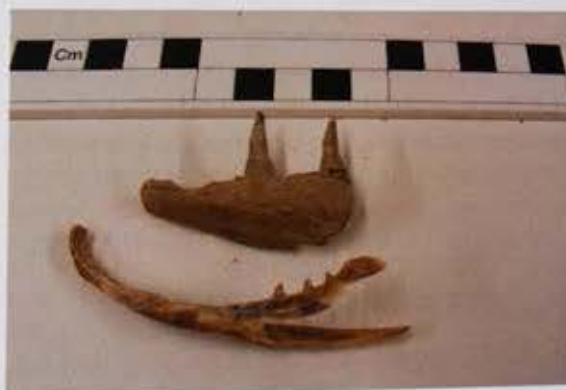
Fig 7.31 Dentary of pike, Selborne Priory specimen (top), modern reference skeleton (bottom)

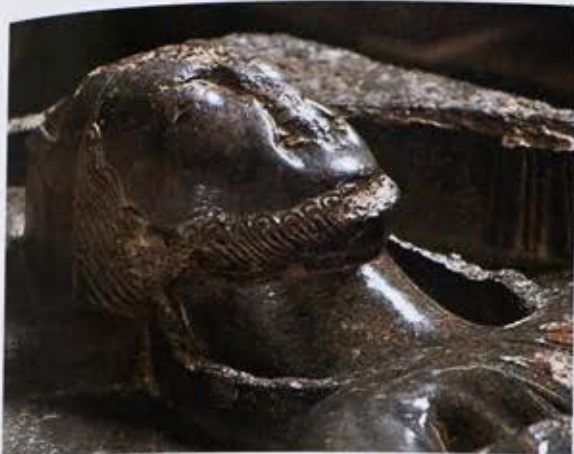
Fig 8.1 Head of effigy of Peter des Roches, bishop of Winchester 1205-38 or Geoffrey de Lucy 1189-1204, Winchester Cathedral (David Baker)

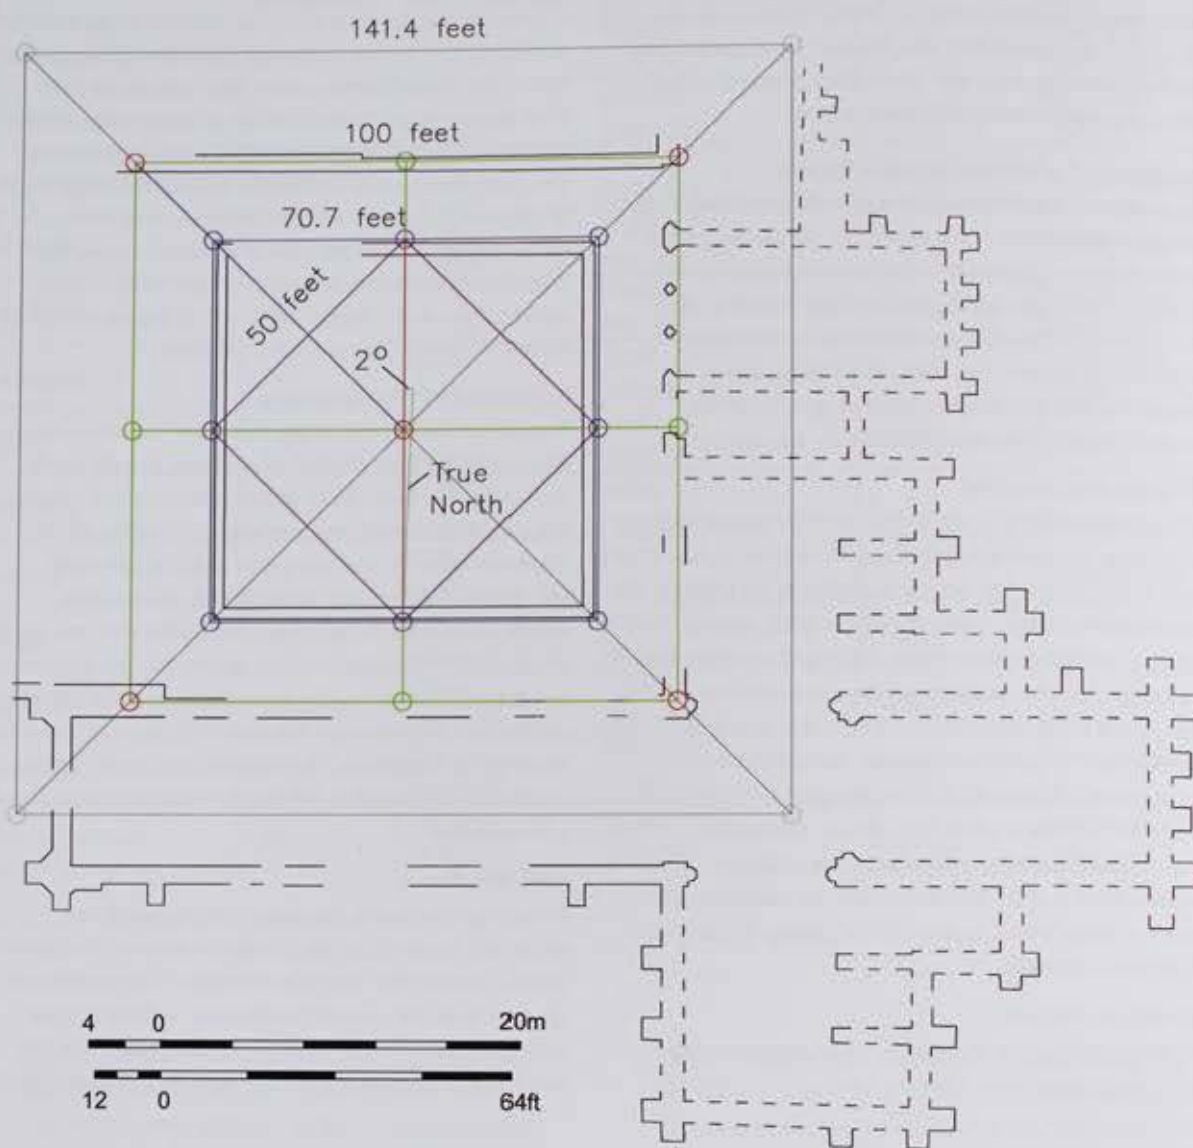
Fig 8.4 Apparent relationship of Titchfield Abbey to rotated squares based on 100ft cloister

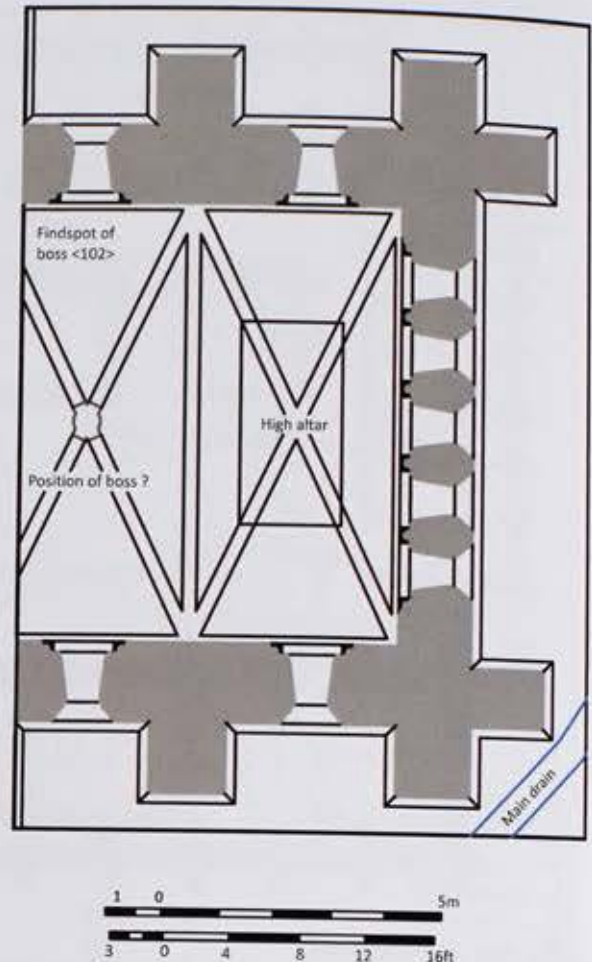
Fig 8.7 Reconstruction of presbytery vault compartment based on fragments and dimensions recorded during excavation

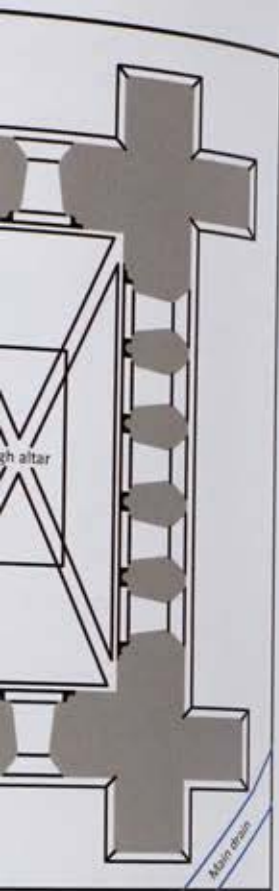
...bityery vault compartment based  
...s recorded during excavation

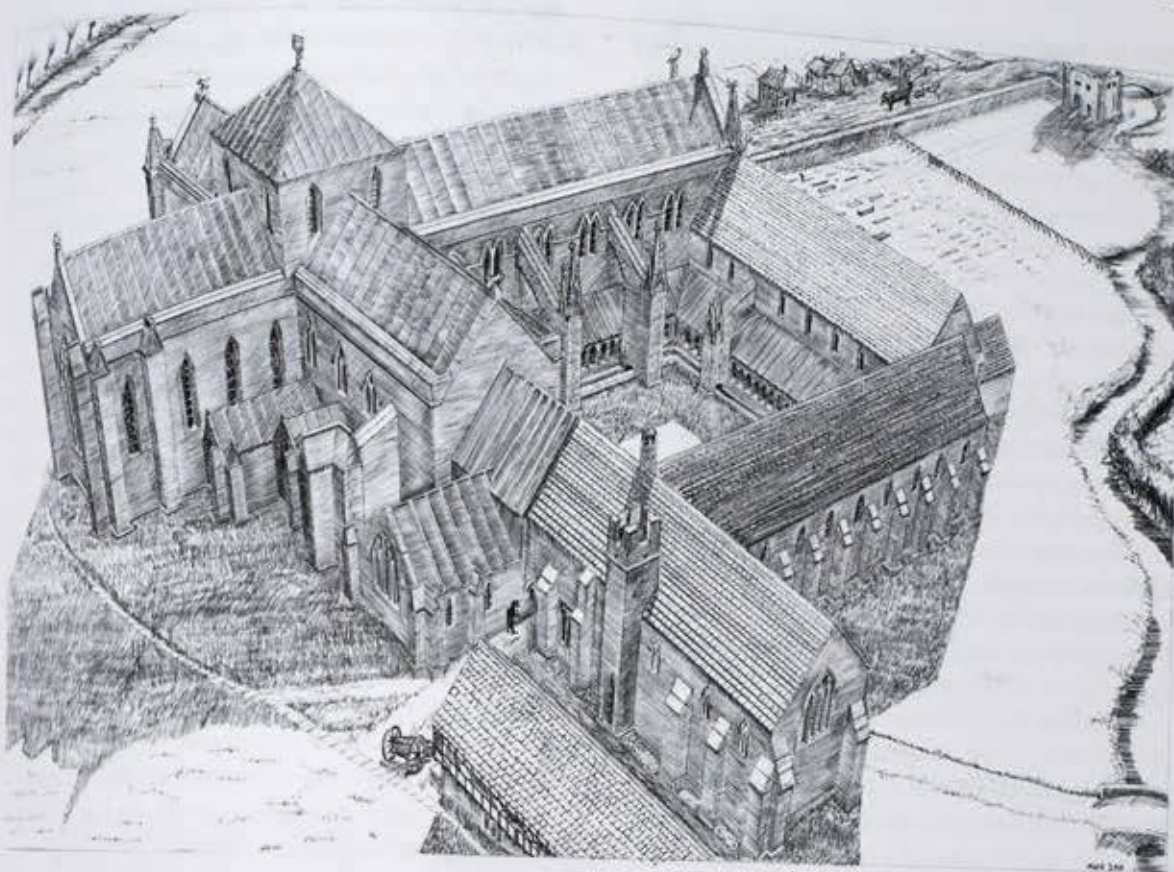
Fig 8.8 Suggested reconstruction of church (top) and claustral ranges in the 15th century, dormitory and canons' latrine at bottom. Church roofs shown as lead here and on the cover though repairs of 1467 refer to tiles (Mark Samuel)
