# SELBORNE PRIORY

## Excavations 1953–1971

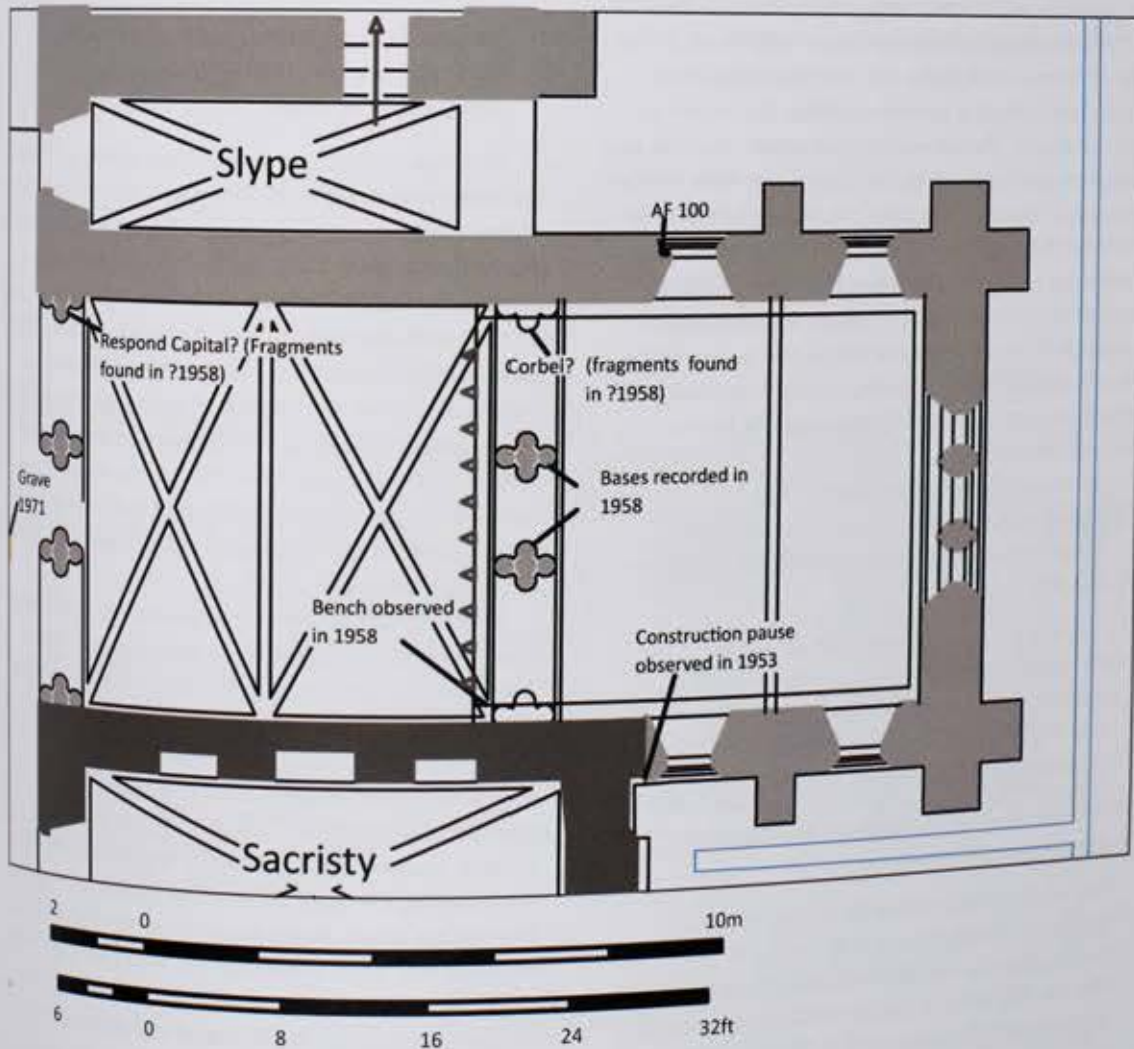
Fig 8.9 Conjectured reconstruction of chapter house vestibule ground plan showing vault and arcades

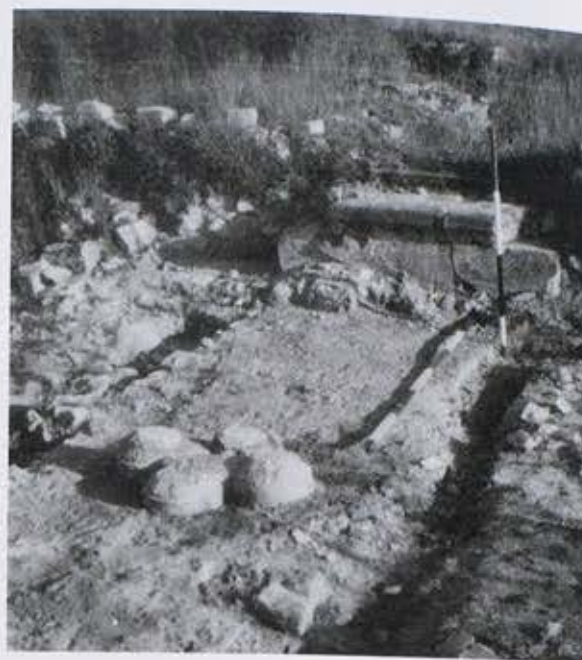
Fig 8.10 Chapter house, arcade pillars and wall bench, facing south, 1958

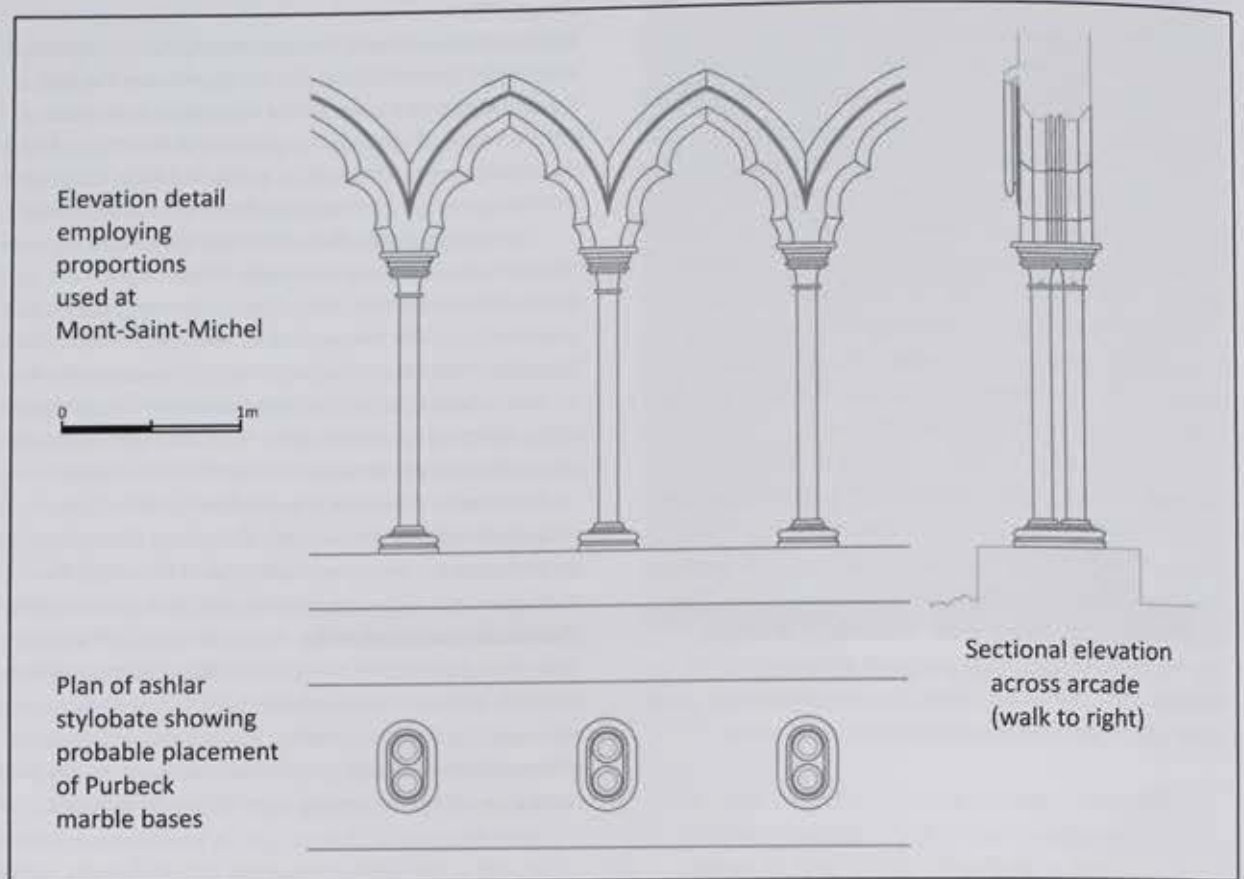
Fig 8.12 Reconstruction of cloister arcade based on excavated foundations, architectural fragments and comparative analysis

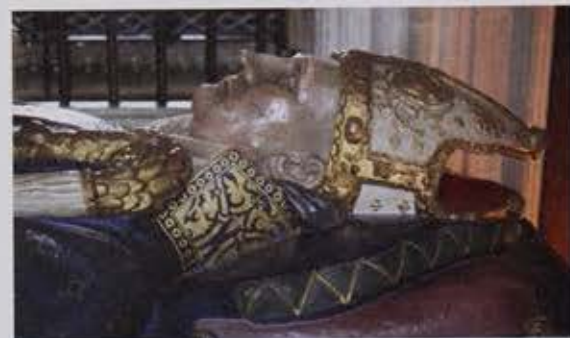
Fig 8.13 Head of effigy of William Waynflete, bishop of Winchester 1447–86, Winchester Cathedral (David Baker)

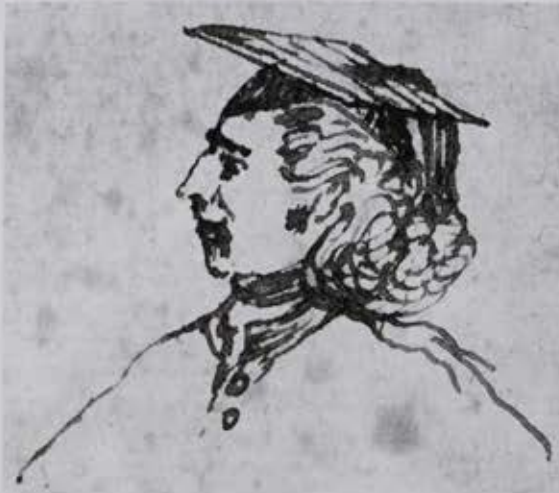
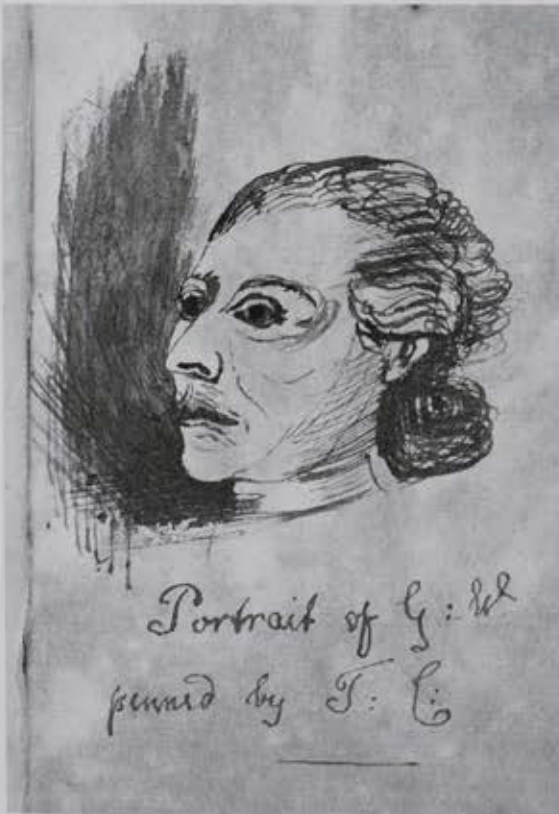
Fig 8.14 The only known drawings of Gilbert White (1720–1793) from life (British Library)

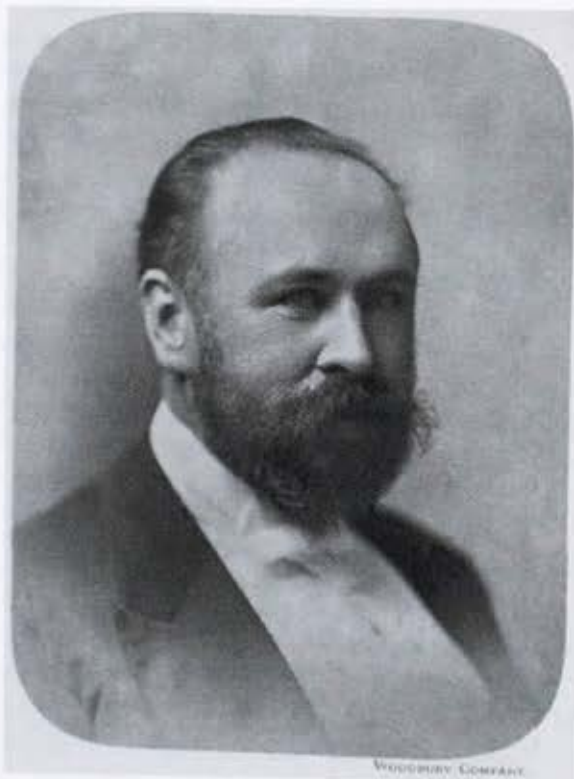
Fig 8.15 Dr Richard Bowdler Sharpe (Woodbury Company)

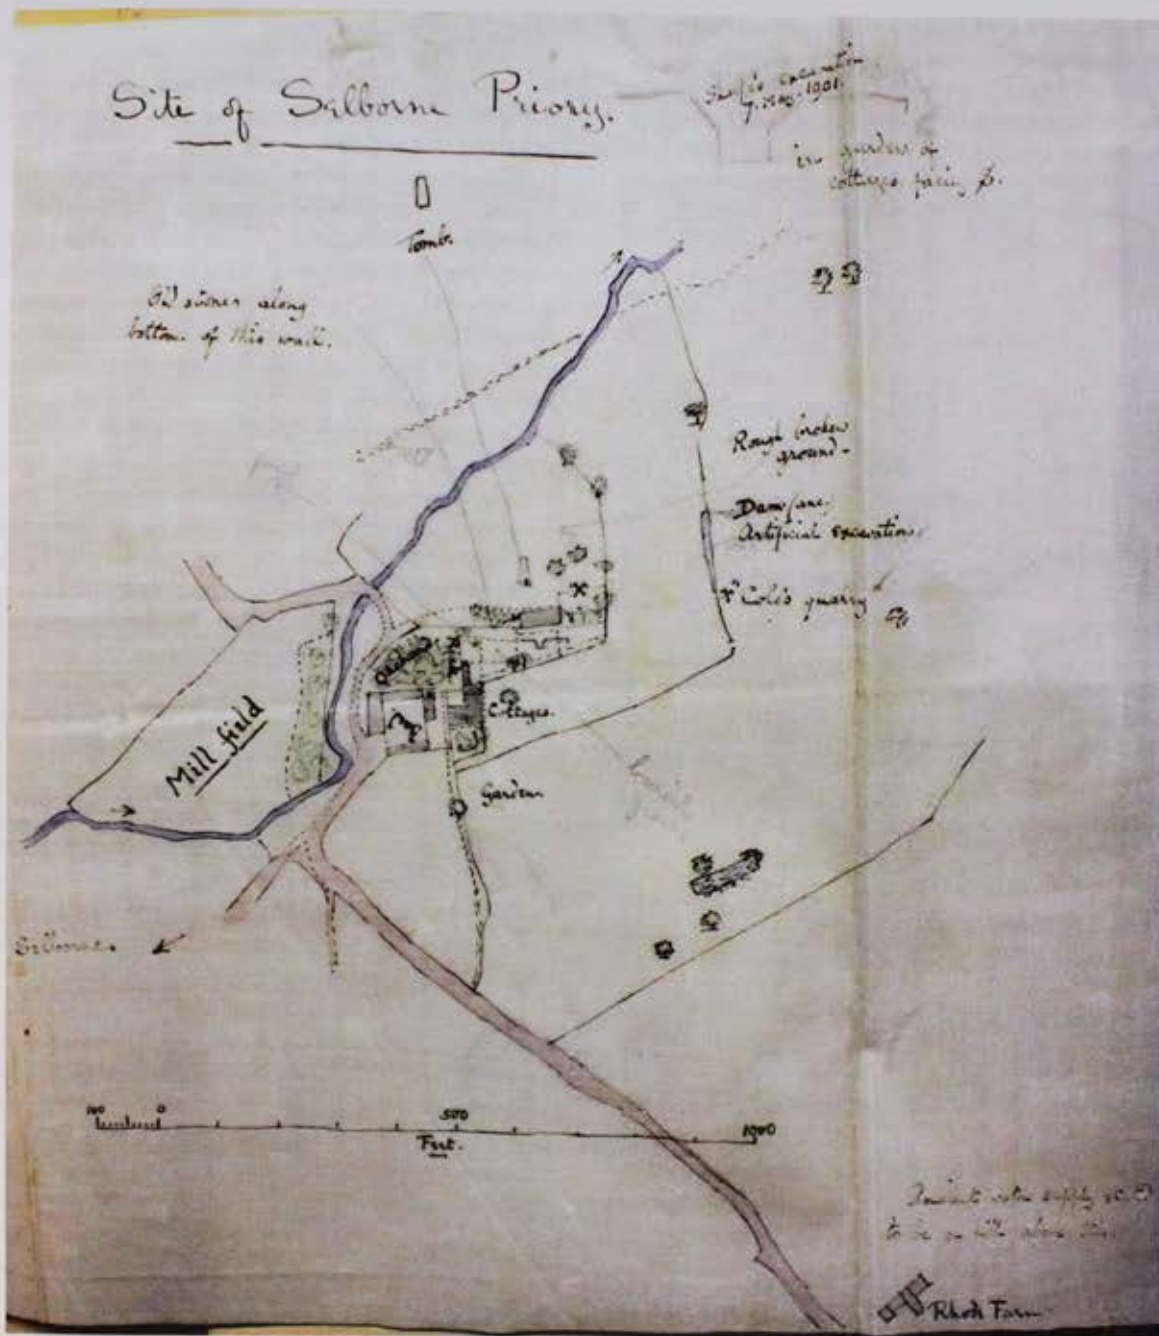
Fig 8.16 Sketch by Dr RT Gunther in 1905 of Bowdler Sharpe's 1901 excavations (Magdalen College P233/2/MS2/1)

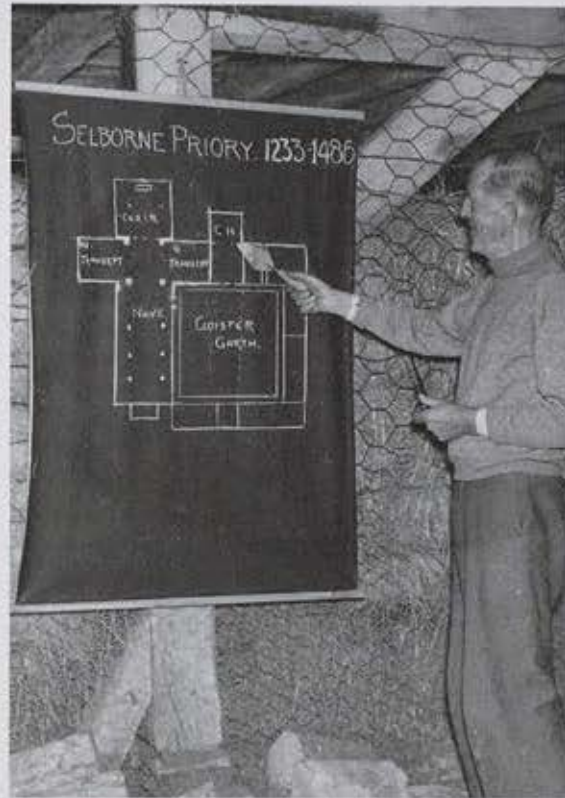
Fig App A.1 Rev George Knapp and original plan hypothesis of a northern church

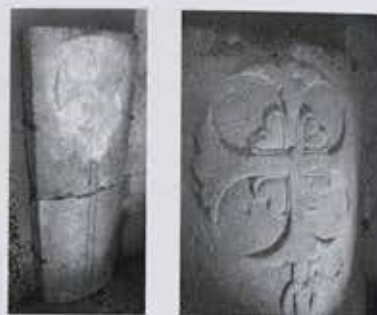
Fig App C.3 Coffin lid B Fig App C.4 Coffin lid B cross  
(photographs: Brian & Moira Gittos)
