# ROMSEY ABBEY

## Report on the Excavations 1973-1991

by Ian R Scott

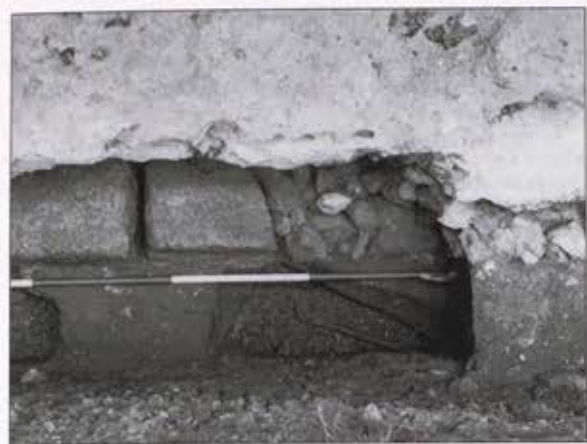
Plate 1. RA 1975: Grave 3257 (Phase 6). See Fig 14 for location. (Photograph Kevin Stubbs/TVAT)

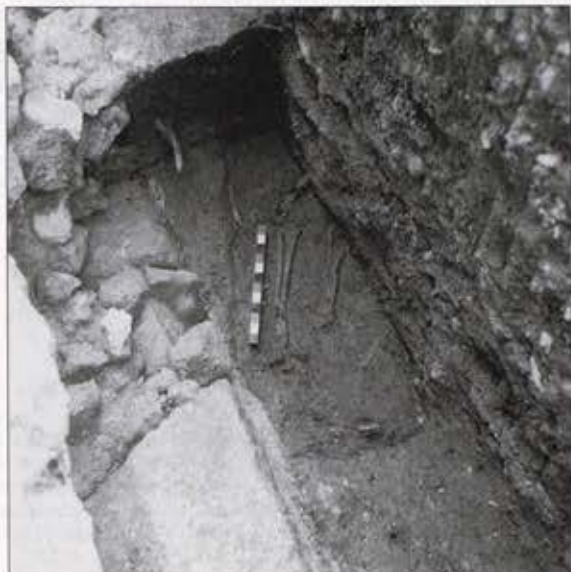
Plate 2. RA 1975: Grave 3259 (Phase 6). See Fig 14 for location. (Photograph Kevin Stubbs/TVAT)

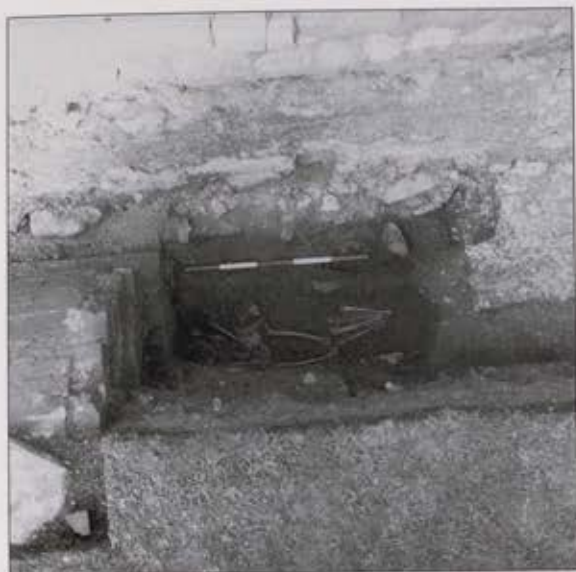
Plate 3. RA 1979: Grave 5119 (Phase 7). See Fig 16 for location. (Photograph Kevin Stubbs/TVAT)

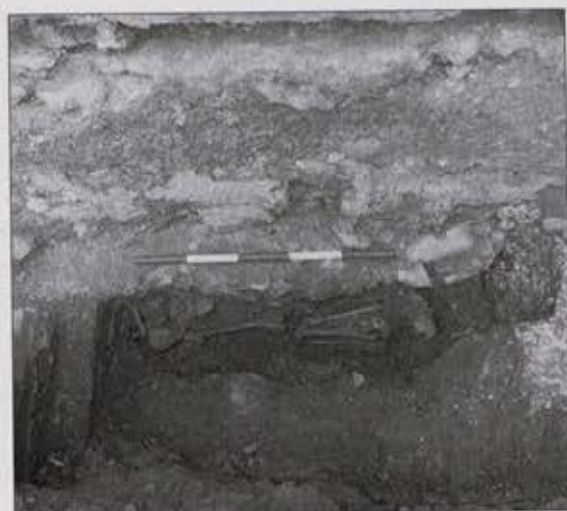
Plate 4. RA 1979: Grave 5127 (Phase 8). See Fig 16 for location. (Photograph Kevin Stubbs/TVAT)

An end date for Phase 7 is provided by the radiocarbon date for the charcoal burials interpreted as belonging to Phase 8. One of these graves (context 5127 = 5124) actually cuts the 1979 chalk structure. Although a radiocarbon sample can be assigned to grave 5127, this cannot be done with complete confidence as has been noted above. The radiocarbon date assigned to this burial gives calibrated date ranges of Cal AD 885–1010 (1 sigma) and Cal AD 780–1030 (2 sigma) (HAR 3760) (for full citation and discussion of the evidence see p 9 and p 41). The radiocarbon date for the charcoal burial excavated in 1975 (context 3120) gives similar date ranges: Cal AD 895–1025 (1 sigma) and Cal AD 830–1155 (2 sigma) (HAR – 2527).

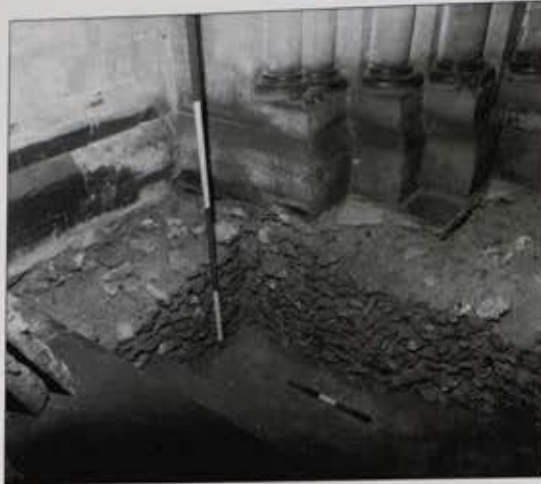
Plate 5. RA 1974: Trench FB viewed from SE, showing the mortared flint footings of the W wall and N arcade of the present Abbey. See Fig 25 for location. (Photograph Kevin Stubbs/TVAT)

Various sections of the footings of the Abbey church were exposed and recorded during the 1974 excavations. In each excavated section the upper footings at least were built of mortared, coursed flints, and there is some, admittedly slight, evidence that the lower portions of the footings were trench-built.<sup>2</sup> The footings of the north wall were recorded in Trench G (Fig 25), and those of the south wall in Trenches D and E (Fig 25). In Trenches FB, FA and A the footings, or piers, supporting the columns of the nave arcades were recorded. Sections of the footings of the west wall of the Abbey church were uncovered in Trenches G, FB, FA and A, but in no case was the profile, or any usable detail, of the footings recorded, and therefore it is not possible to draw conclusions about the structure of the west wall footings.

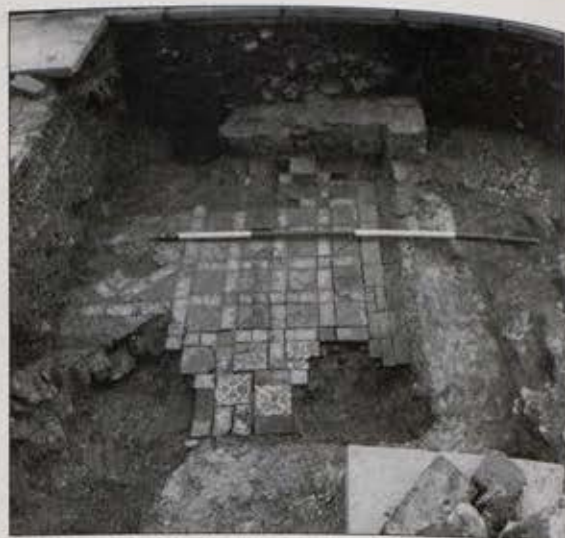
Plate 6. RA 1974: Area J: Decorated floor tiles (context 2157) in the doorway in the west range at the NW corner of the cloister viewed from N. Note the threshold (context 2169) to the right of the tiles. The first course of the west range wall (context 2172) is visible in the facing section. See Fig 29 for location. (Photograph Kevin Stubbs/TVAT)

About 3.1m south of the Abbey, there were further in situ tiles (context 2157). These lay within the western walk of the cloister, and were aligned diagonally to the axes of the abbey

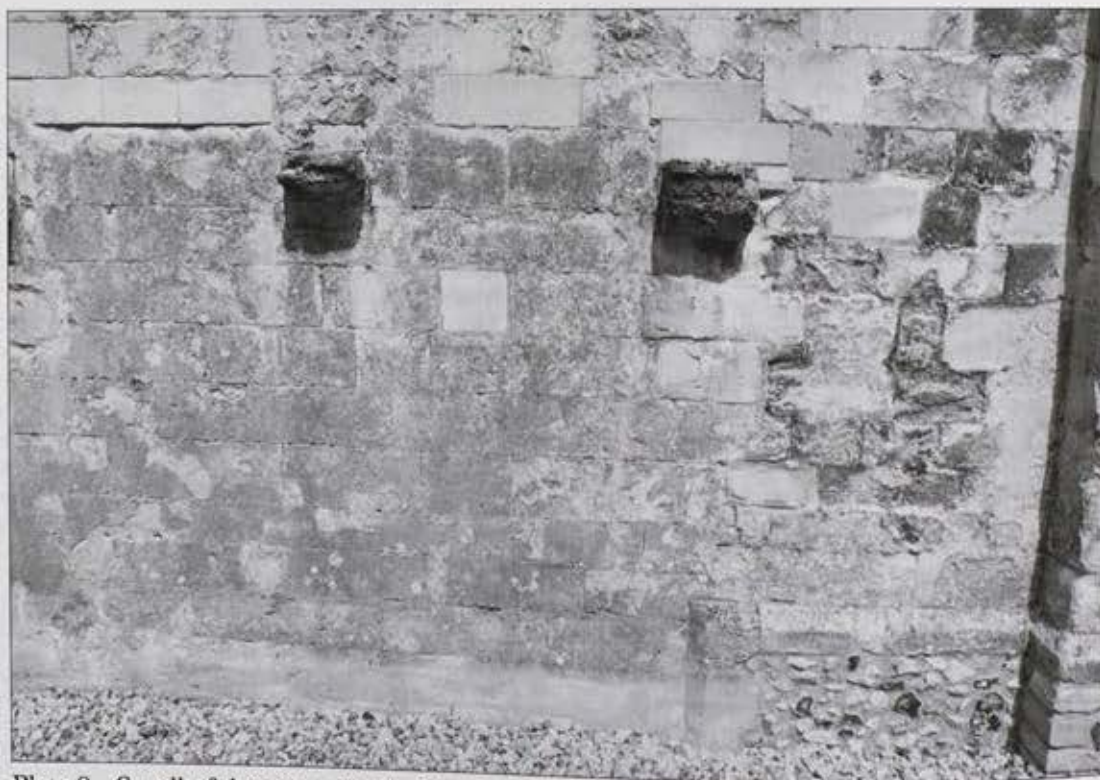
Plate 8. S wall of the nave, detail of bay 4. (Photograph TVAT)

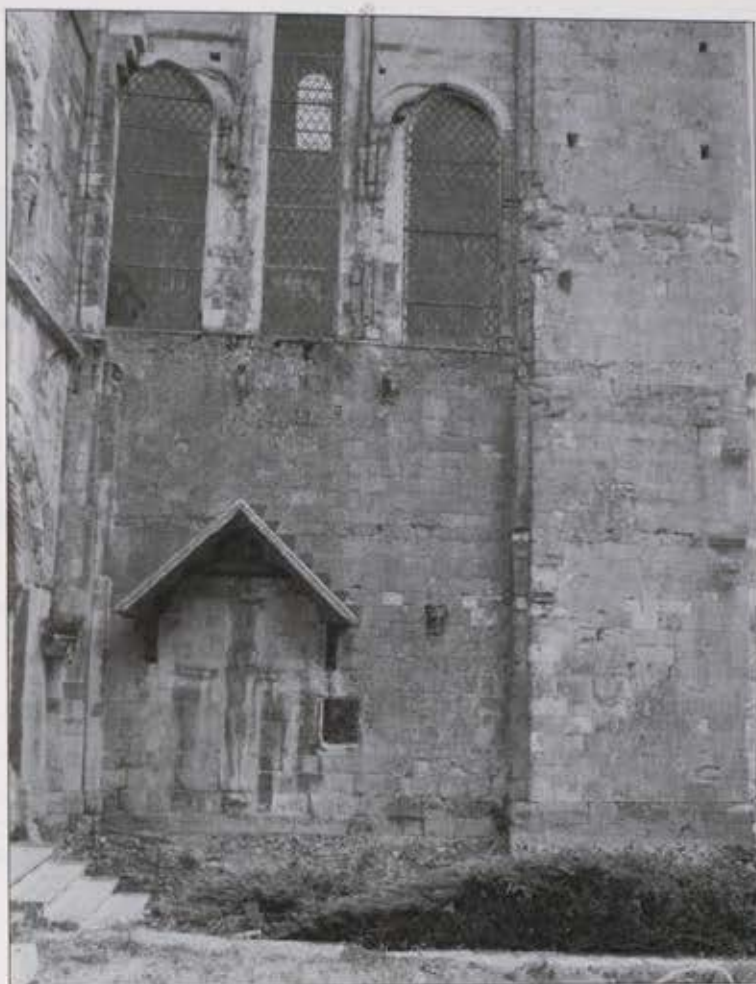
Plate 9. The W side of the S transept, showing two sets of corbels set into the wall. Note the position of the large rood. (Photograph TVAT)

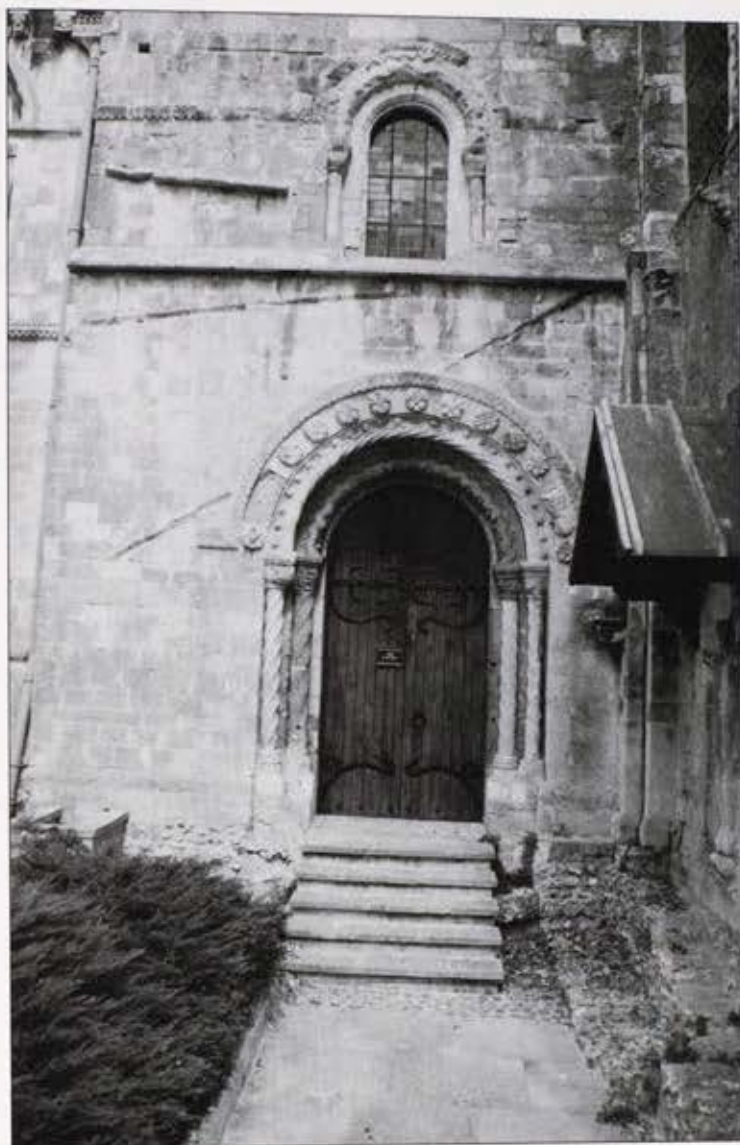
Plate 10. S wall of the nave, showing bay 1 with the Abbess's doorway. Note the evidence for at least three roof lines. The date of the rooflines is uncertain, and some, or all, may belong to the period after the Dissolution. Earlier photographs show the steep lower roofline cutting through the arch over the doorway. The arch has been restored. (Photograph TVAT)

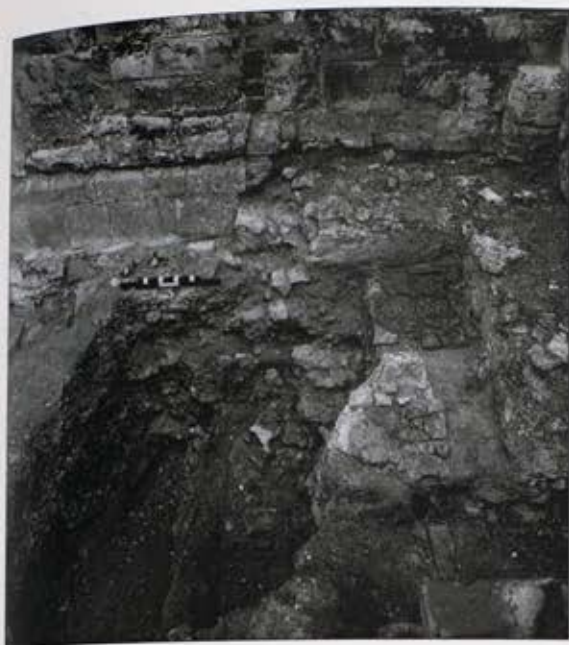
Plate 11. RA 1973: NW corner of the east end chapels viewed from the E. The post-Dissolution blocking (1009) of the retro-choir wall is clearly visible to left of the picture. The remains of the respond (context 1003) in the NW corner are visible. (Photograph Kevin Stubbs/TVAT)

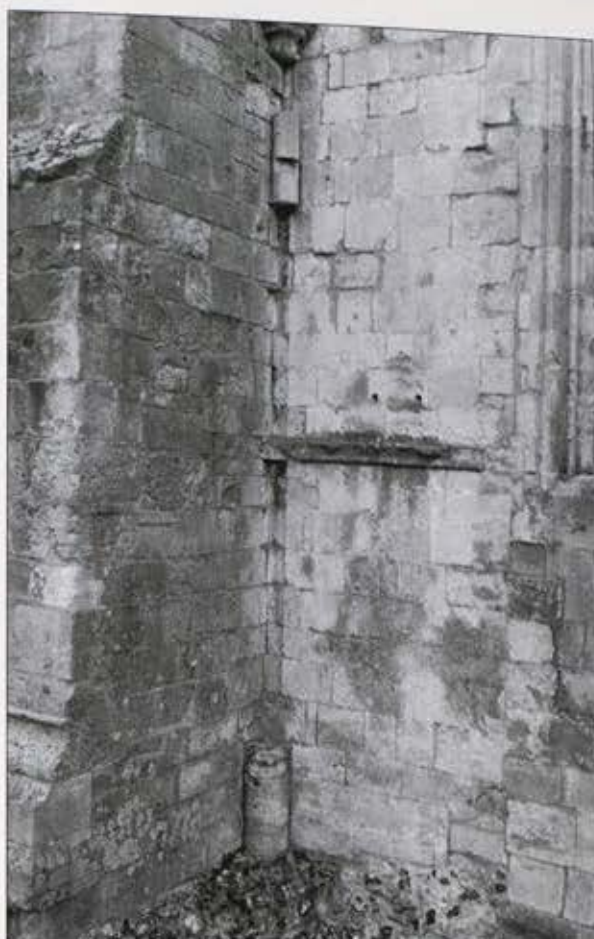
Plate 12. Detail of the respond (RA 1973, context 1037) in the SW corner of the chapel viewed from the NE. (Photograph TVAT)

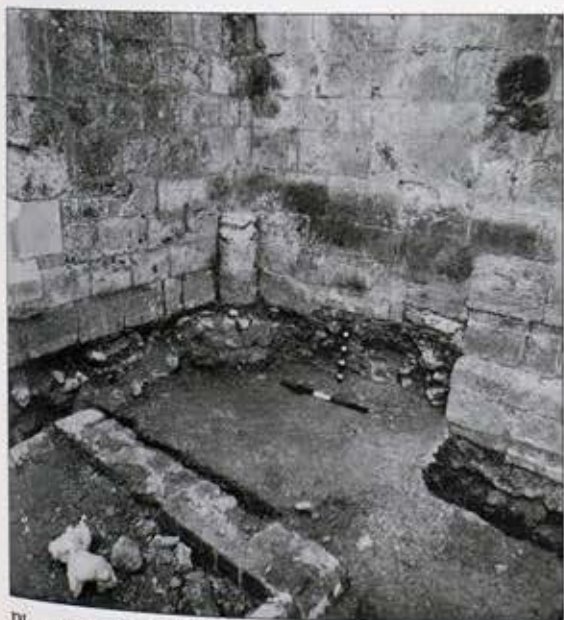
Plate 13. RA 1973: SW corner of the east end chapels viewed from the NE. The post-Dissolution blocking (1039) of the retro-choir wall is clearly visible to right of the picture. The remains of the respond (context 1037) in the SW corner are visible. (Photograph Kevin Stubbs/TVAT)

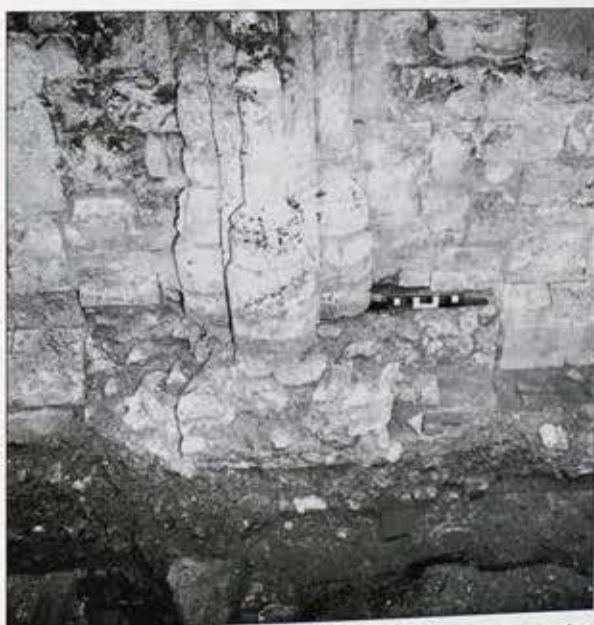
Plate 14. RA 1973: E end Chapels. The central pier between the openings through the retro-choir wall viewed from the E. The post-Dissolution blocking of the retro-choir wall is clearly visible to right (1009) and left (1039) of the picture. (Photograph Kevin Stubbs/TVAT)

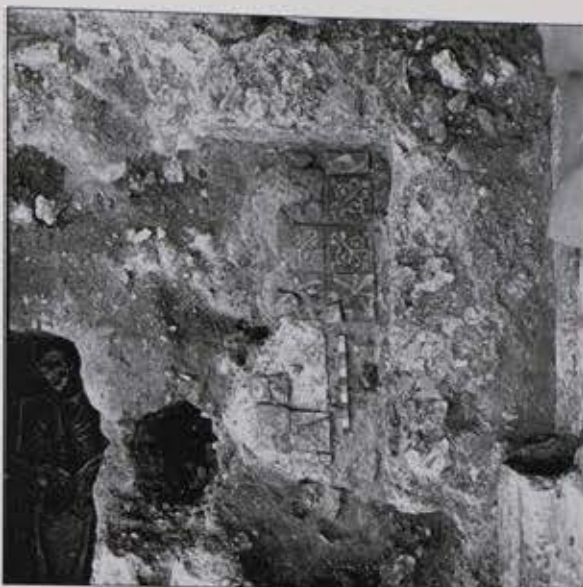
Plate 15. RA 1973: NW corner of the east end chapels. Decorated floor tiles (context 1002) set in the angle of the plinth (context 1091). See Fig 39 (b) for location. (Photograph Kevin Stubbs/TVAT)

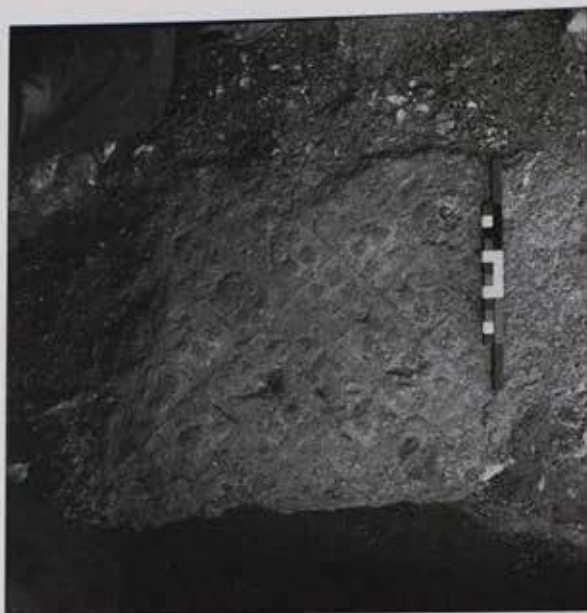
Plate 16. RA 1973: SW corner of the east end chapels. The mortar bedding for decorated floor tiles with impressions of the tiles (context 1038). See Fig 39 (b) for location. (Photograph Kevin Stubbs/TVAT)

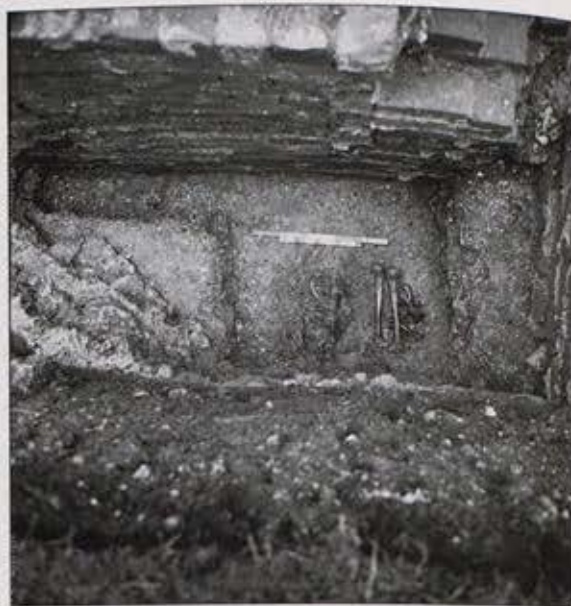
Plate 17. RA 1973: Grave 1084 (Phase 15-16). See Fig 39(b) for location. (Photograph Kevin Stubbs/TVAT)

**The Graves in the Southern Chapel.** Graves 1084, 1085 and 1086, of the southern group, are all orientated east-west with their heads to the west. Their pits cut the footings of the Norman chapels. This strongly suggests that they belong to the rebuilt chapels, although there is no record of their relationship with the floor levels. The grave pits were all cut at the west end by brick-built vaults, but not in such a way as to totally destroy the upper parts of the skeletons. In graves (1085) and (1086) there were remains of skull and jaw bones, together with bones from the upper torso. Grave (1084) contained no skull fragments, and therefore it may be suggested that the west end of this grave, containing the skull, was destroyed. The eastern portions of these three burials lay outside the excavated area, and few bones below the pelvis were recovered.

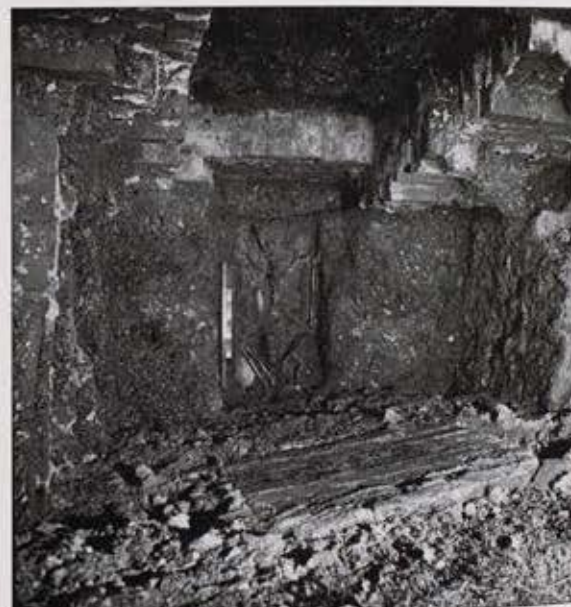
Plate 18. RA 1973: Grave 1085 (Phase 15-16). See Fig 39(b) for location. (Photograph Kevin Stubbs/TVAT)

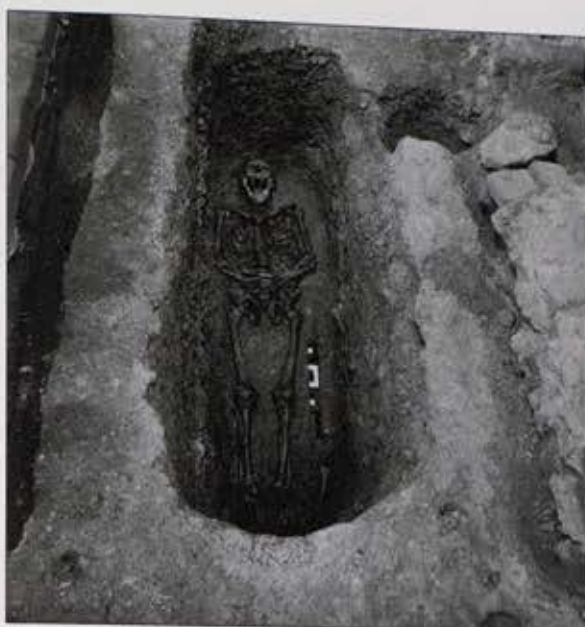
Plate 19. RA 1973: Grave 1083 (Phase 15-16). See Fig 39(b) for location. (Photograph Kevin Stubbs/TVAT)

**The Grave in the Northern Chapel.** The fifth, and best preserved, grave (context 1083) was in the northern chapel. Its relationship to the Lady Chapel is not completely clear, in that the evidence is contradictory. On the one hand, it seems that the grave was sealed by the gravel and mortar subfloor of the chapel, and certainly, except for a mortar patch (context 1008), there is no indication that this level was visibly disturbed when it was first cleared. On the other hand, the patch of mortar which partially, but by no means completely, sealed the grave, was marked with tile, or similar, impressions. These were much larger than the floor tiles found elsewhere on the floors of the chapels. The most satisfactory interpretation is that the grave was inserted through the chapel floor, and that

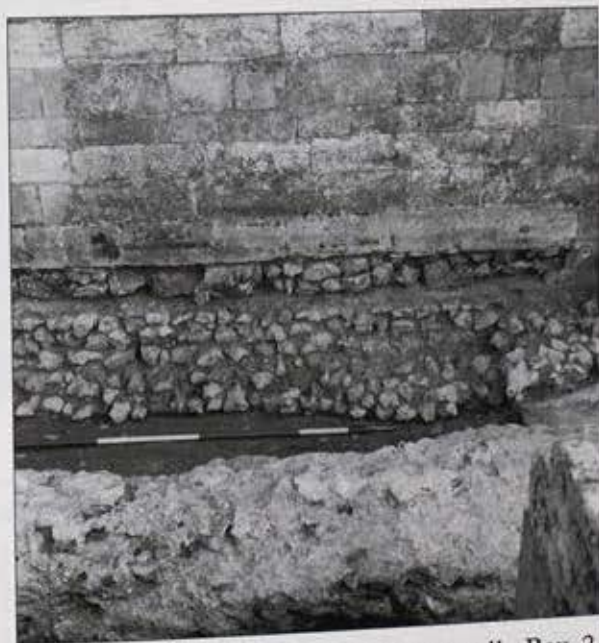
Plate 20. RA 1975: N nave aisle wall, Bay 2, viewed from the N. The Norman flint rubble footing (context 3188=3180) is sealed by a thin mortar layer (context 3081). Above this is the rubble footing (context 3246) of the post-Dissolution blocking of Bay 2. In the foreground is part of the late Saxon north transept. See Fig 27 (a) for location. (Photograph Kevin Stubbs/TVAT)

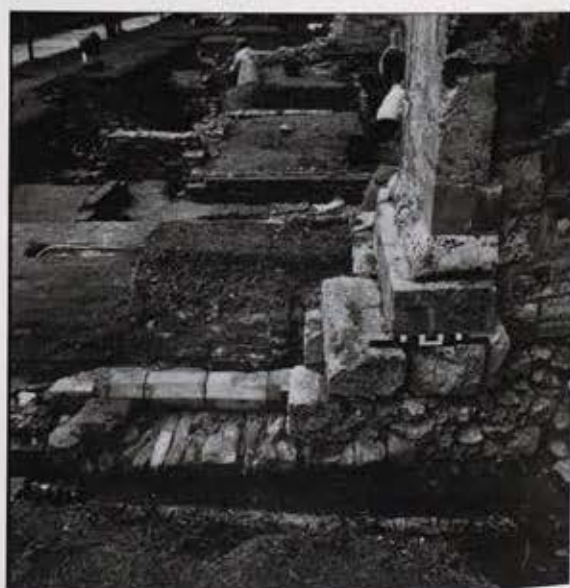
Plate 23. RA 1973: E end Chapels. The N buttress to the retro-choir wall formed from the cut down N wall of the chapels viewed from the N. The photograph shows the ill-fitting post-Dissolution facing (context 1053) and the threshold (context 1001) of the door through the N wall of the east chapels. (Photograph Kevin Stubbs/TVAT)

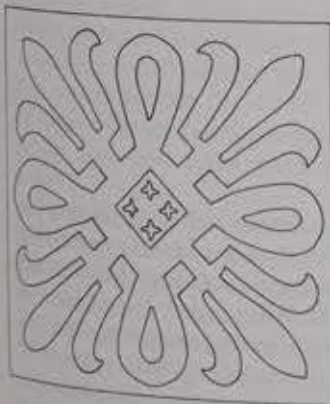
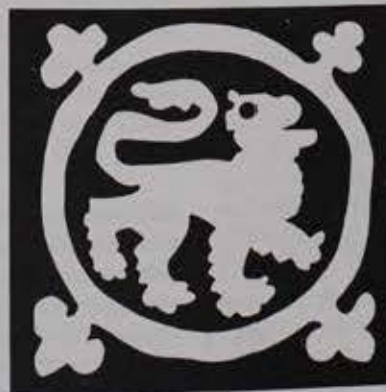
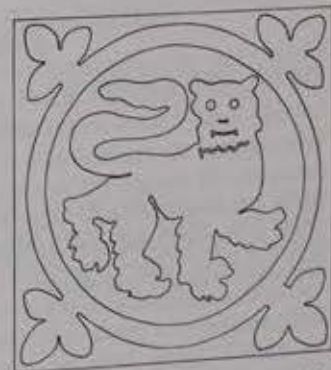
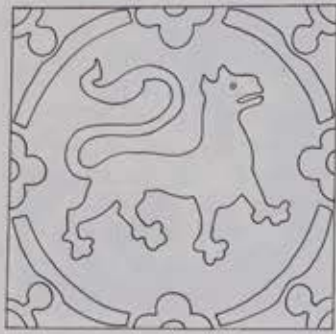
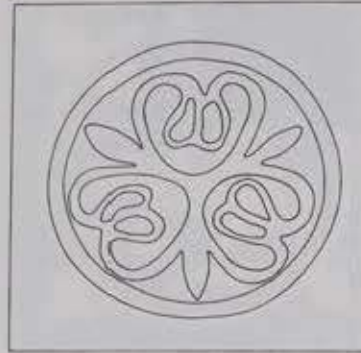
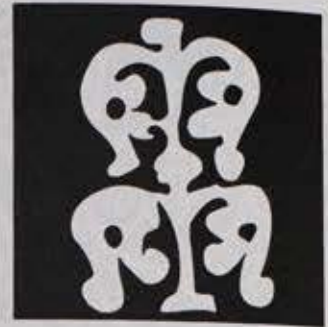
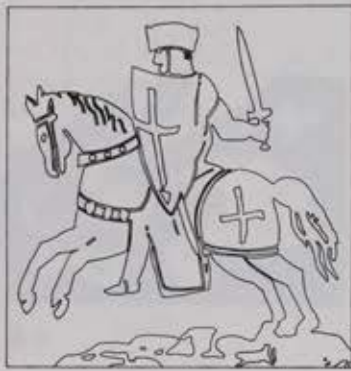
Fig 63 Group 5 tiles (i)

**Tiles of unknown fabrics. (Figs 63 & 64)**
