A STUDY OF THE STADDLE STONE GRANARY IN HAMPSHIRE

By JOY PEACH

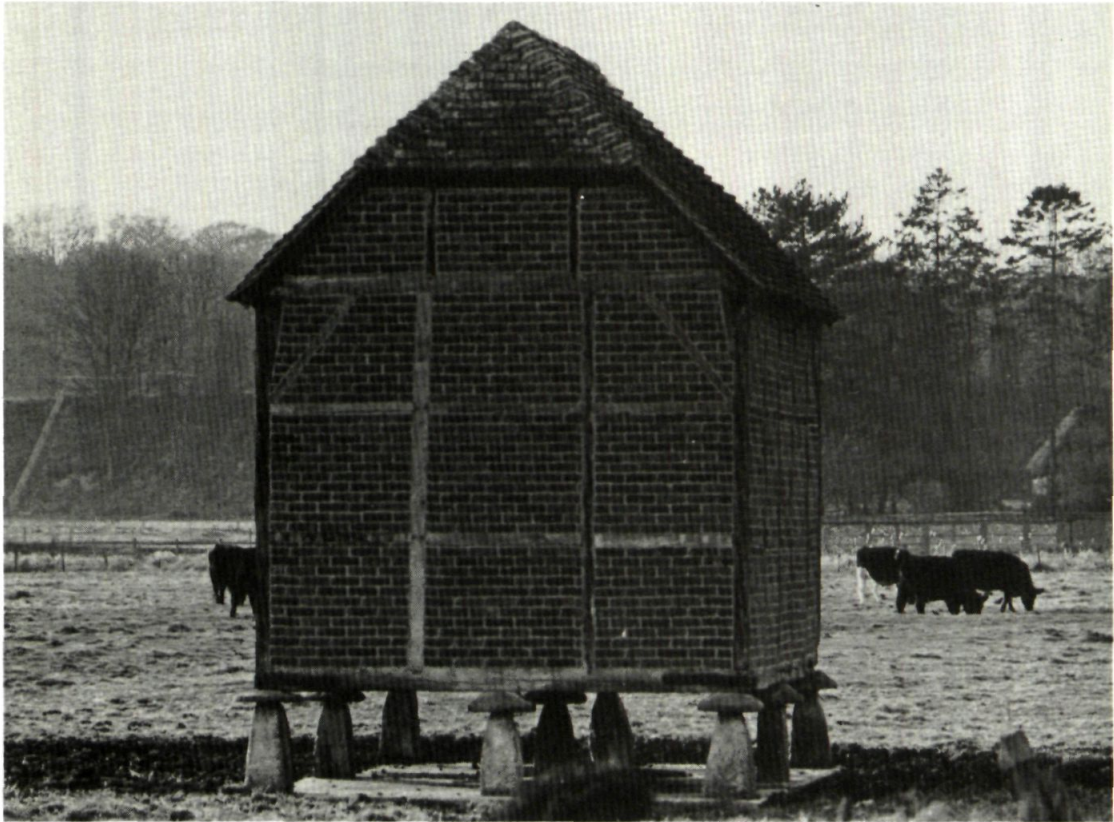
Fig 1. A small timber framed granary with brick infilling at Charlcot Farm, Whitechurch, recently renovated by the owner, Lord Denning. (Photo: D G Dine).

At Whitchurch there are two splendid examples of the timber-framed granary with brick infilling, both recently renovated by Lord Denning. One is on the three-by-three pattern, three panels high at the eaves, with a tiled roof, half-hipped at the gable ends (Fig 1). The other is of unusually large proportions and supported by fifteen staddle stones arranged five-by-three. This granary is two panels high with a thatched roof of the same half-hipped style as the smaller one.

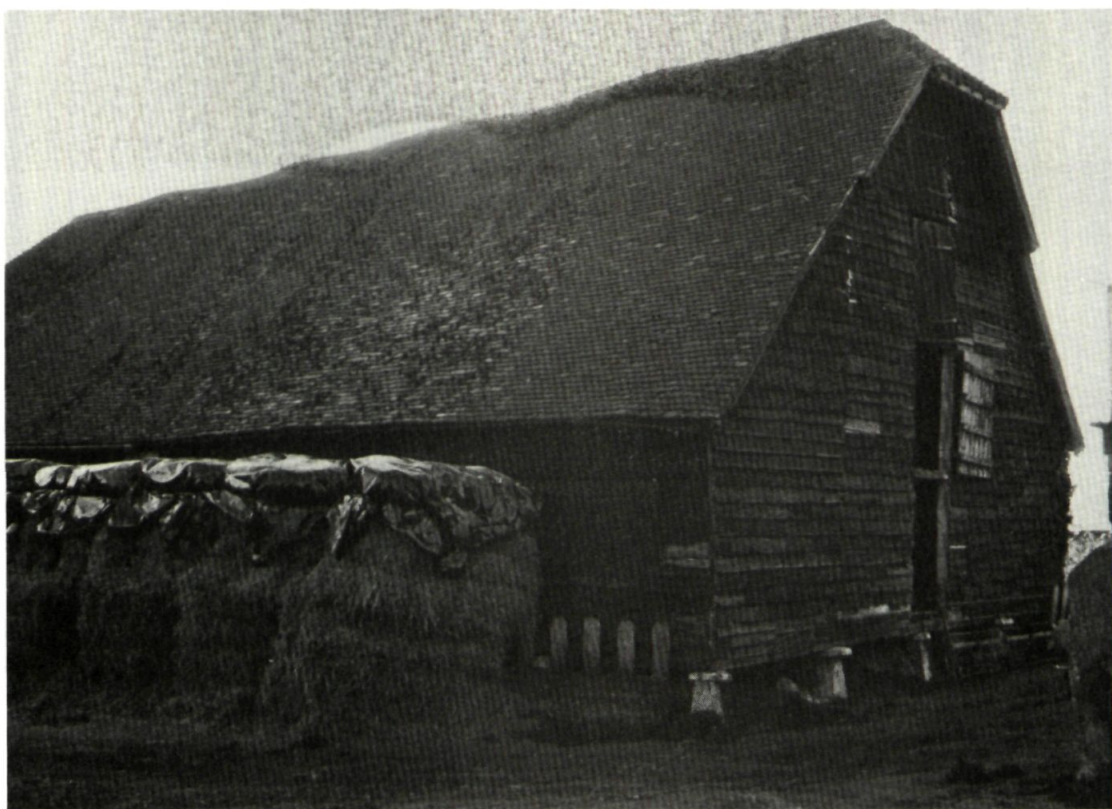
Fig 2. The weatherboarded barn on staddles at Michelmersh Manor Farm.

The largest barn on staddles in the county is at Manor Farm, Michelmersh, in the Test Valley (Fig 2). The Manor Farm granary is about 30ft high, 30ft wide and 70ft long. It stands on fifty-five staddle stones. It is an aisled barn with five bays. A pair of double doors face each other across the central aisle,

which is where the corn would have been threshed in the cross draught when the doors were pinned open. The weight of the old peg tiles on the low-swept steep-pitched roof must be enormous, quite apart from the weight of the massive timbers. It is not surprising, therefore, to find that each of the staddles is resting on a large stone plinth, without which the shafts would undoubtedly be driven deep into the ground. High up in the gable and nearest the farmhouse is an opening now covered with a perspex panel. Mr A Holden who lives in the Manor House explained that when he was a boy a horse was used to tramp the corn into a firm stack inside the barn. The stooks of corn were hoisted up from the cart below and dropped through this high door onto the growing stack in the barn. The horse gradually rose higher and higher as the stack grew, until it reached the height of the hoisting machinery, when it was slung from the pulley and lowered to the ground outside, to start the process all over again. The Manor Farm granary is said to date from 1700. It is now in a sorry state: the roof sags drunkenly along its ridge beam: a large section of the threshing floor has collapsed. It is to be hoped that it will not be allowed to disintegrate further.
